MONTHLY CONSTRUCTION WATER QUALITY MONITORING REPORT

Project No.: 3200-0645

Project: Transgrid Maragle 500/330 kV Substation

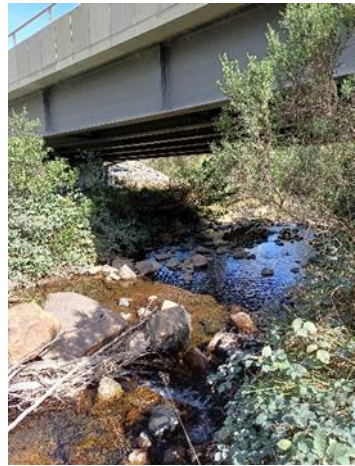
CG-IS	No flow, dry

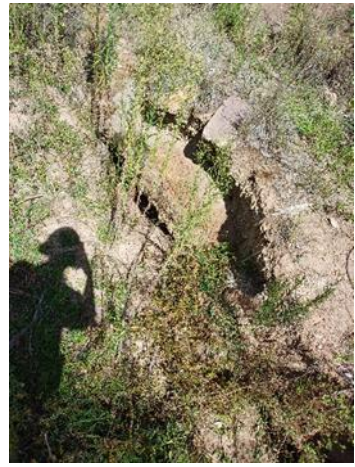
YR1-IS	<p>Clear water</p> <p>Low volume with high flow rate</p> <p>Minimal vegetative detritus</p> <p>High weed density including Thistle and Blackberry (<i>Rubus fruticosus</i>)</p> <p>Riparian vegetation consisted of groundcover, shrubs and trees</p> <p>Rocky banks with sections of exposed soil higher up the bank</p>

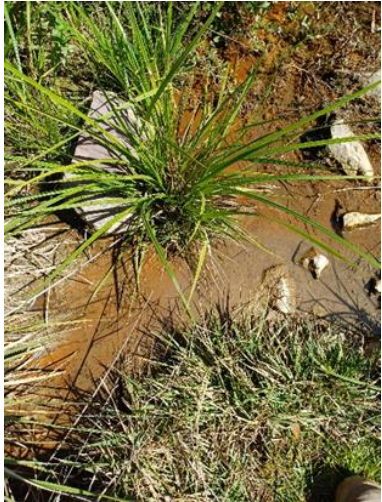
YR2-IS	<p>Presence of aquatic invertebrates, vegetation and algae</p> <p>Clear water</p> <p>Rocky bed and banks</p> <p>Low volume with moderate flow rate</p> <p>Riparian vegetation predominantly groundcover</p> <p>High weed density including Blackberry (<i>Rubus fruticosus</i>)</p> <p>Presence of vegetative detritus</p> <p>Monitoring location is adjacent to bridge and electrical transmission tower on top of rocky cliff and Snowy 2.0 laydown area</p>

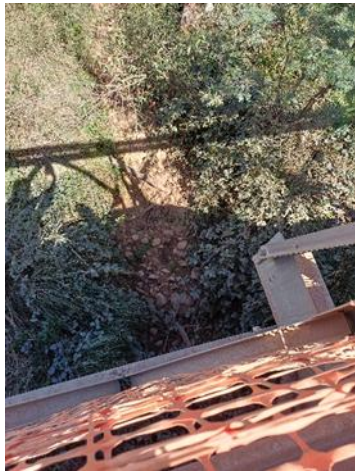
TR-RS	<p>Rocky banks and sandy bed</p> <p>Monitoring location is adjacent to publicly accessible O'Hares Campground and Talbingo Reservoir ancillary infrastructure</p> <p>Presence of aquatic vegetation</p> <p>Clear water</p> <p>High volume with minimal flow rate</p> <p>Riparian vegetation consisted of groundcover and trees</p> <p>Presence of landslips</p> <p>High presence of vegetative detritus</p>

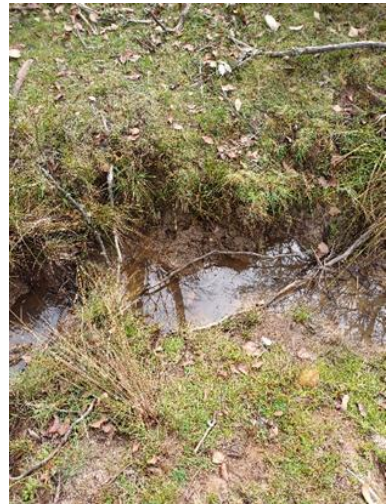
YK-IS (D/S)	<p>Presence of algae, water beetles, invertebrate, aquatic vegetation</p> <p>Clear water with slight yellow and brown tinge</p> <p>Vegetative detritus in water</p> <p>Potential burrows in banks</p> <p>Riparian vegetation consisted of groundcover and trees</p> <p>Low weed density including Blackberry (<i>Rubus fruticosus</i>)</p> <p>Low volume with moderate flow rate</p> <p>Undermined banks and rocky and sandy bed with mica</p> <p>Monitoring location is adjacent to publicly accessible 4WD track</p>

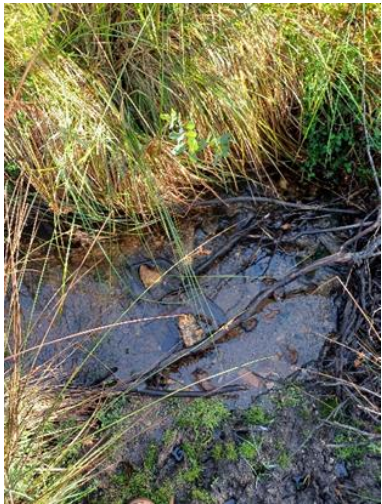
YK-IS	<ul style="list-style-type: none"> Murky water with slight brown tinge High presence of aquatic invertebrates and vegetation Low volume with low flow rate Eroded banks with mica in bed Overhanging vegetation Presence of vegetative detritus Riparian vegetation consisted of groundcover, shrubs and trees Low weed density Monitoring location is adjacent to Elliott Way, leading towards culvert

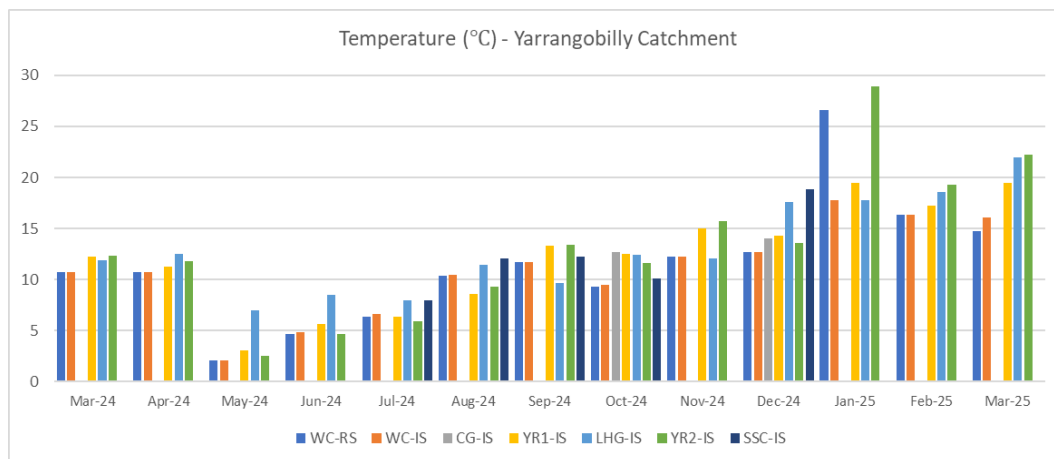
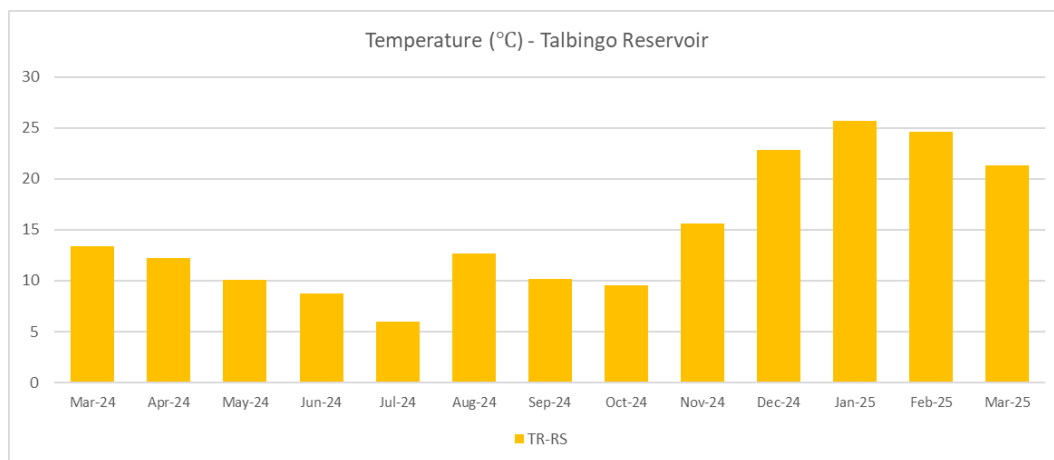
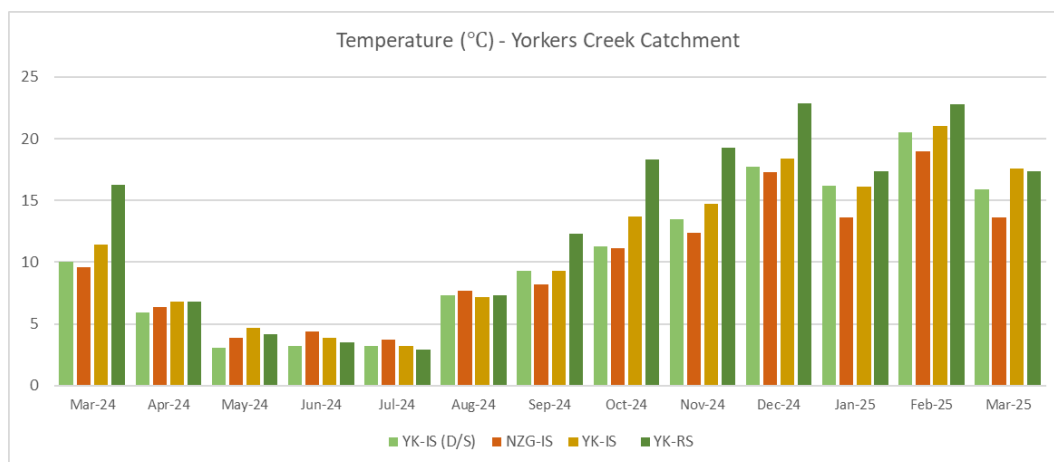
FIGURE 4 : TEMPERATURE FOR YARRANGOBILLY RIVER CATCHMENT

In March 2025, temperatures (°C) in the Yarrangobilly River catchment increased compared to February 2025, ranging from 14.7 °C to 22.2 °C, except for WC-RS and WC-IS which reduced 1.6°C and 0.2°C respectively, refer to Figure 4. In contrast, temperatures in Talbingo Reservoir decreased from 24.6°C in February 2025 to 21.3°C, refer to Figure 5. Temperatures in the Yorkers Creek catchment also reduced in March 2025, ranging from 13.6°C to 17.6°C, as illustrated in Figure 6.

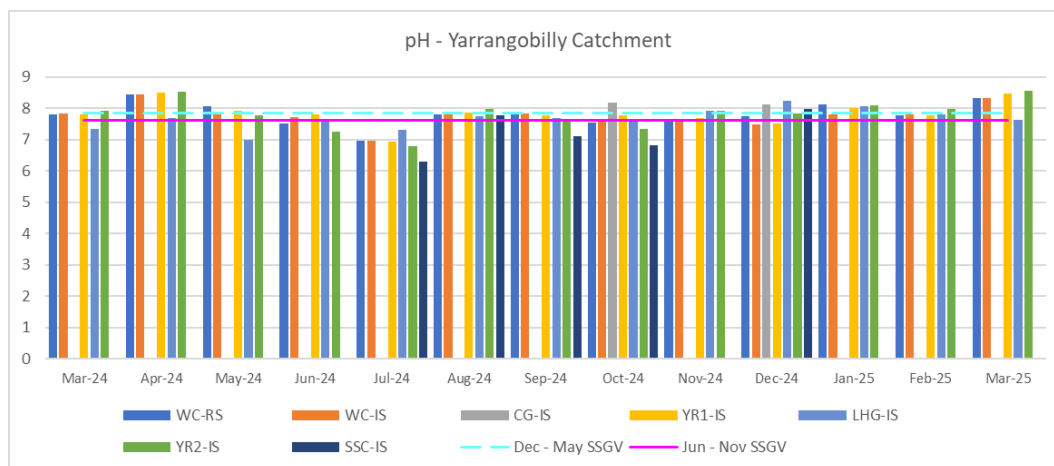
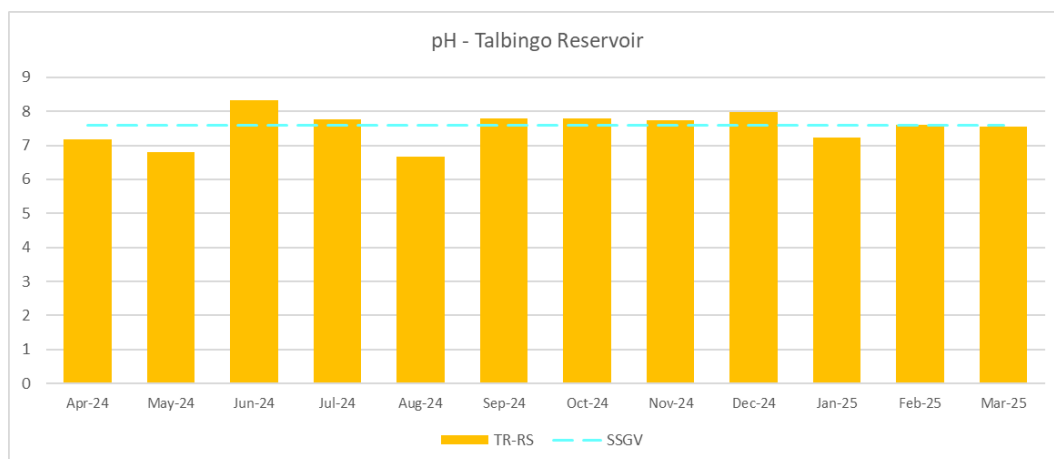
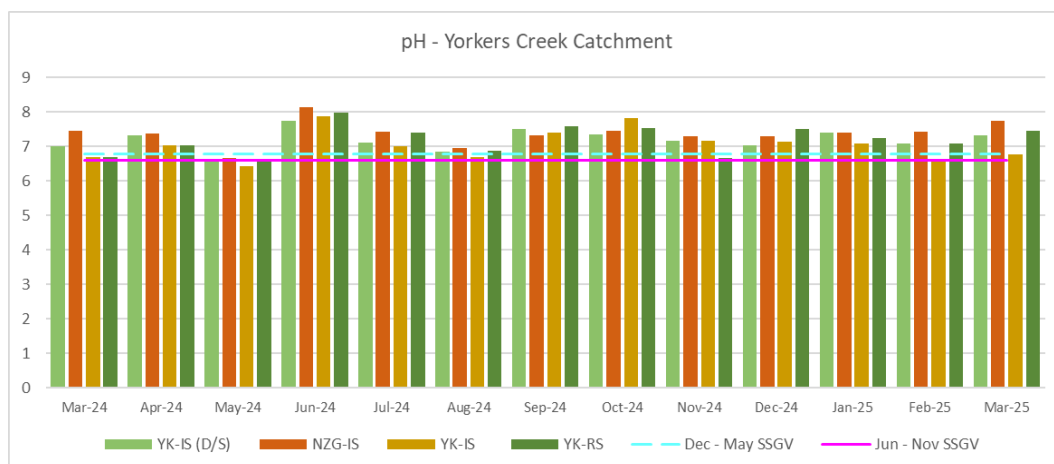
FIGURE 7: PH FOR YARRANGOBILLY RIVER CATCHMENT

pH values exceeded the December to May SSGV (7.85) in March 2025 for majority of the Yarrangobilly River catchment sites except for LHG-IS, refer Figure 7. In contrast, Talbingo Reservoir was within the SSGV, refer to Figure 8. All Yorkers Creek catchment sites exceeded the December to May SSGV (6.79), except for YK-IS, and Figure 9.

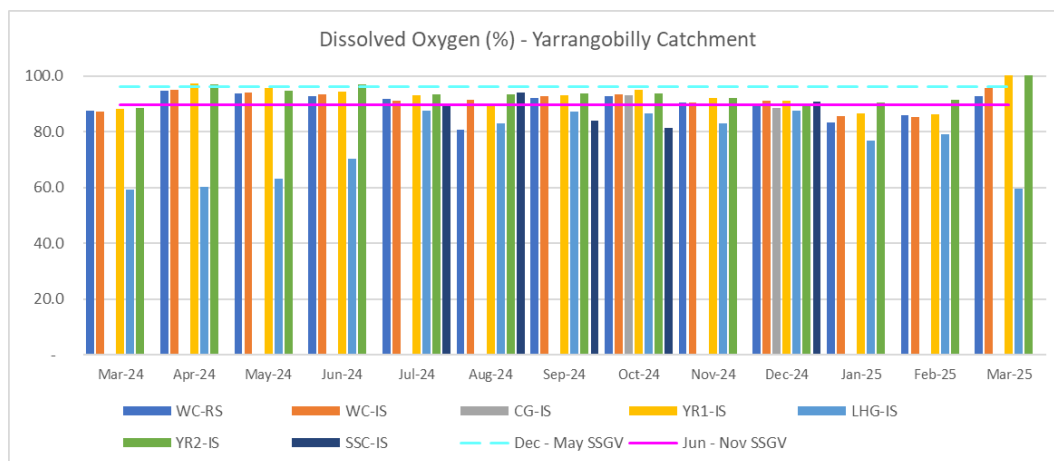
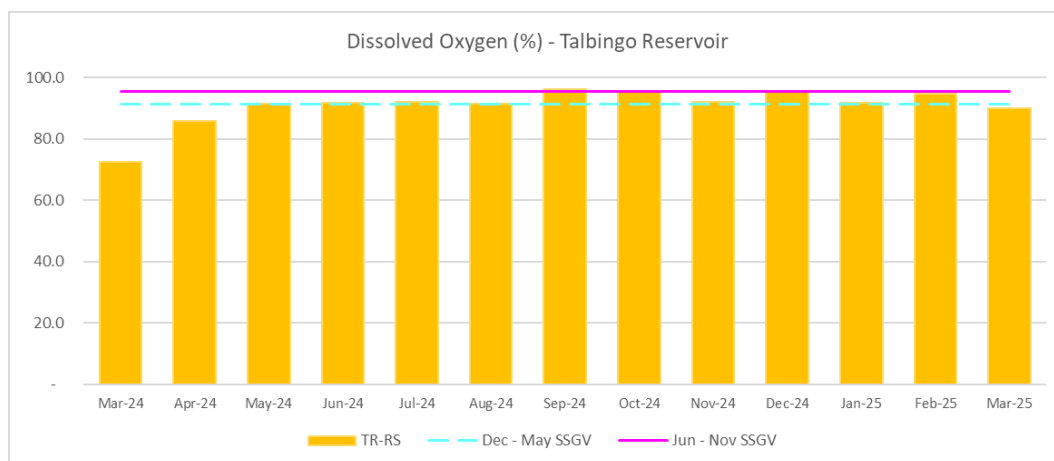
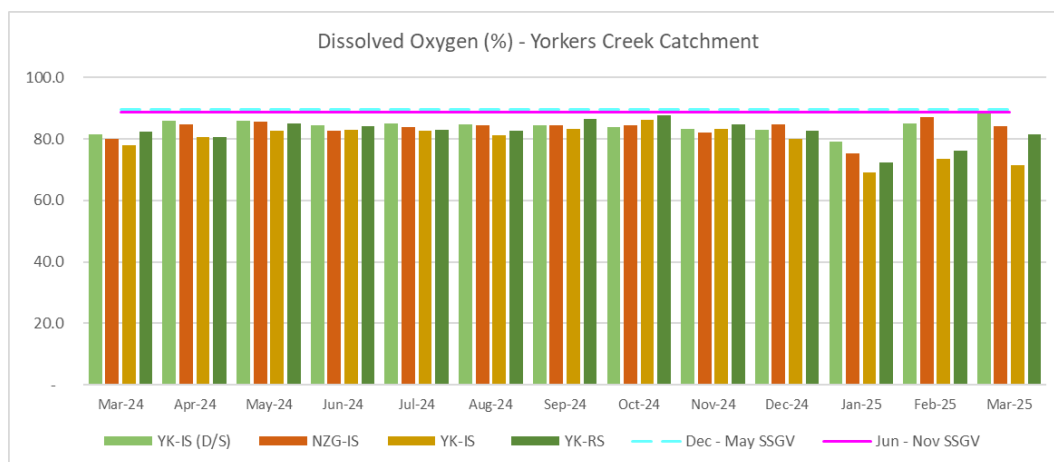
FIGURE 10: DO FOR YARRANGOBILLY RIVER CATCHMENT

March 2025 DO (%) levels in Yarrangobilly River catchment were below the December to May SSGV of 96.2%, except for YR1-IS and YR2-IS which were both greater than the SSGV, refer to Figure 10. All sites within the Yorkers Creek catchment and Talbingo Reservoir were below their respective SSGVs of 91.3% and 89.6%, refer Figure 11 and Figure 12.

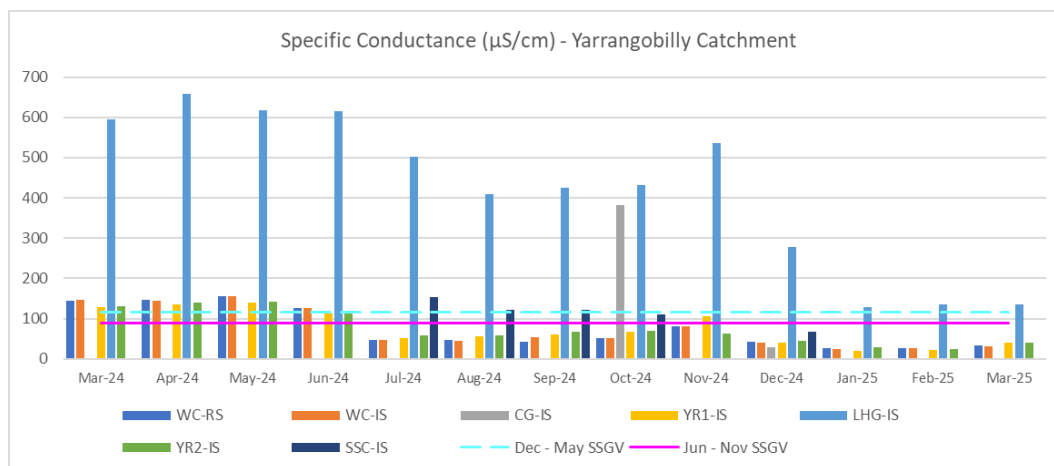
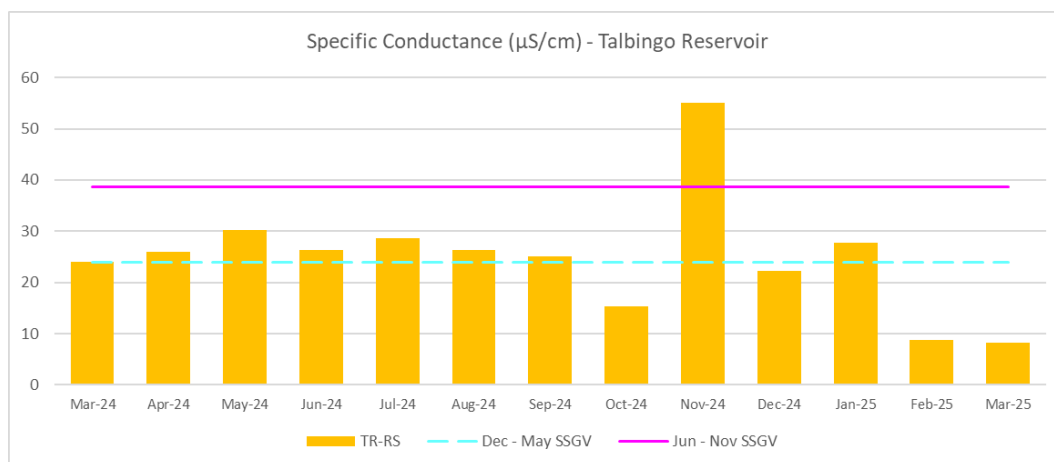
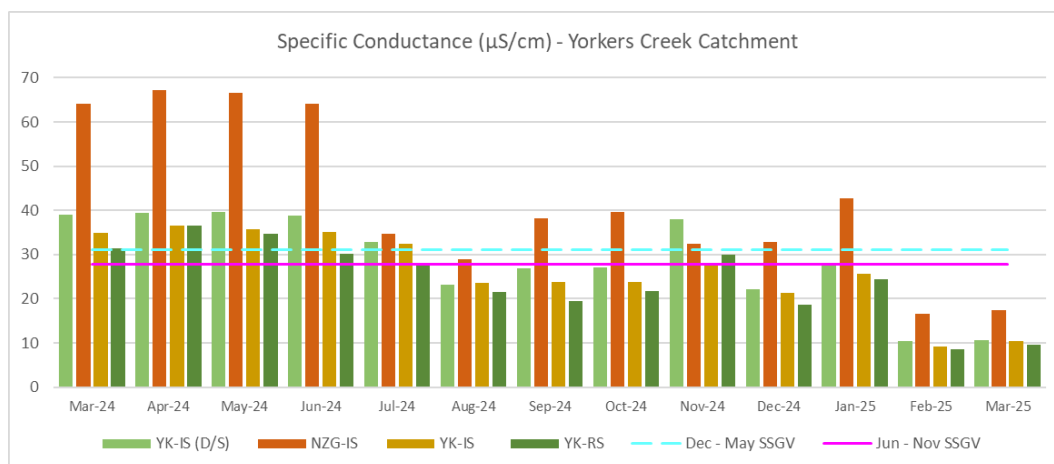
FIGURE 13: SPC FOR YARRANGOBILLY RIVER CATCHMENT

SPC ($\mu\text{S}/\text{cm}$) levels in the Yarrangobilly River catchment were predominantly within the December to May SSGV (115 $\mu\text{S}/\text{cm}$) except for LHG-IS which has always exceeded the SSGV, refer Figure 13. SPC levels were also within the respective SSGV for Talbingo Reservoir and Yorkers Creek catchment, refer Figure 14 and Figure 15.

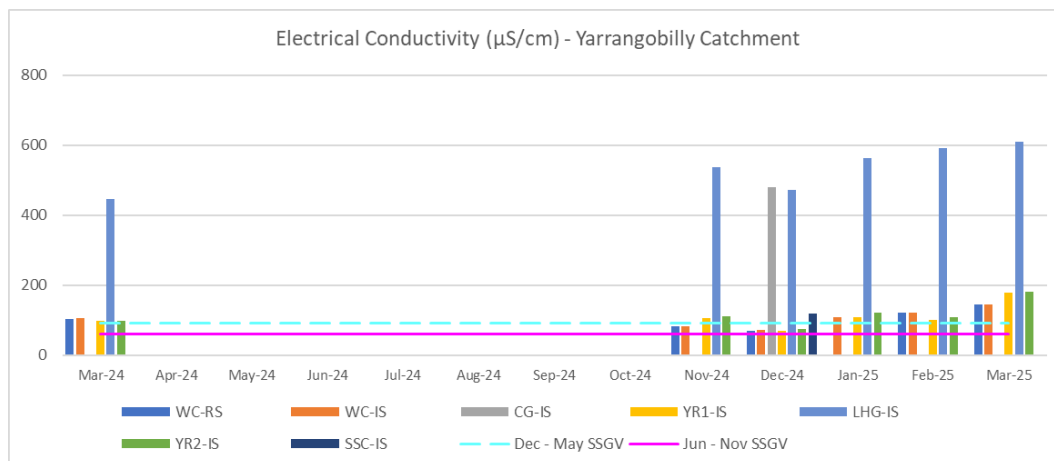
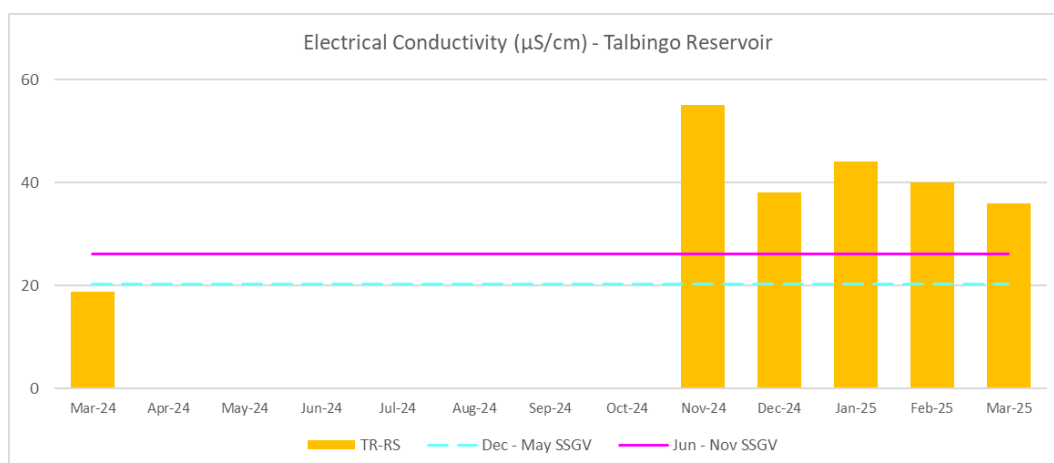
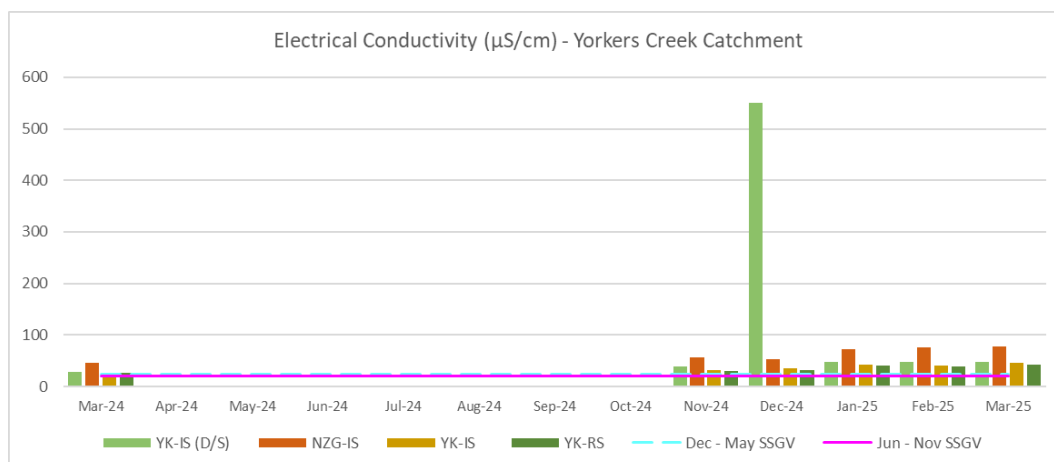
FIGURE 16: EC FOR YARRANGOBILLY RIVER CATCHMENT

Similar to previous monitoring periods, EC ($\mu\text{S}/\text{cm}$) values all exceeded the December to May SSGV of each catchment in March 2025, refer to Figure 16 to Figure 18.

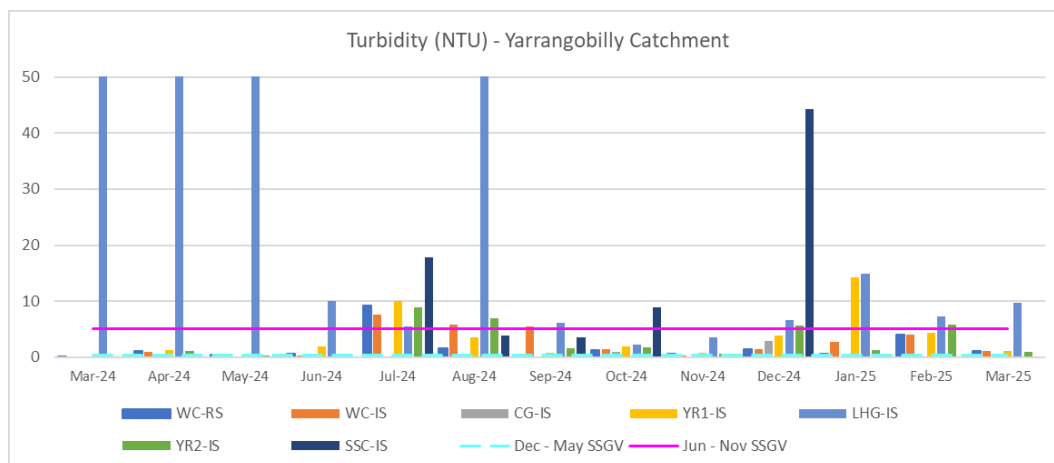
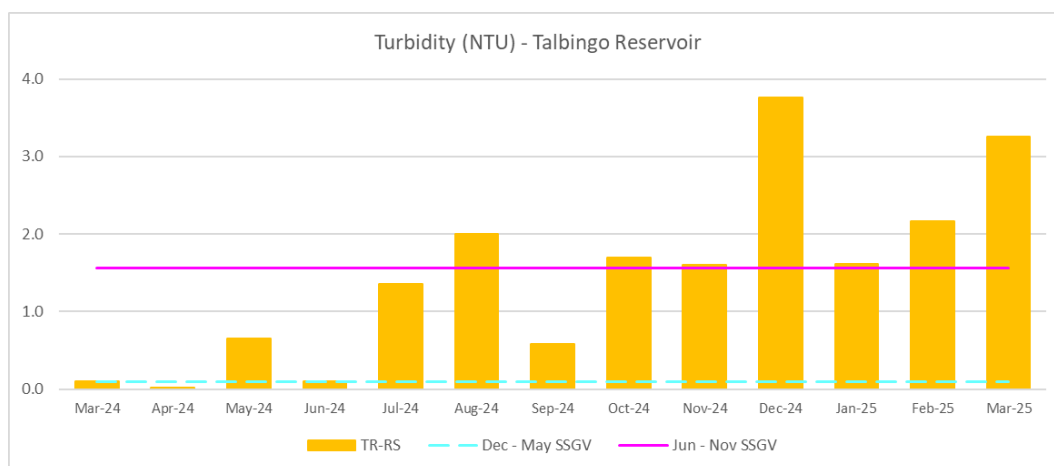
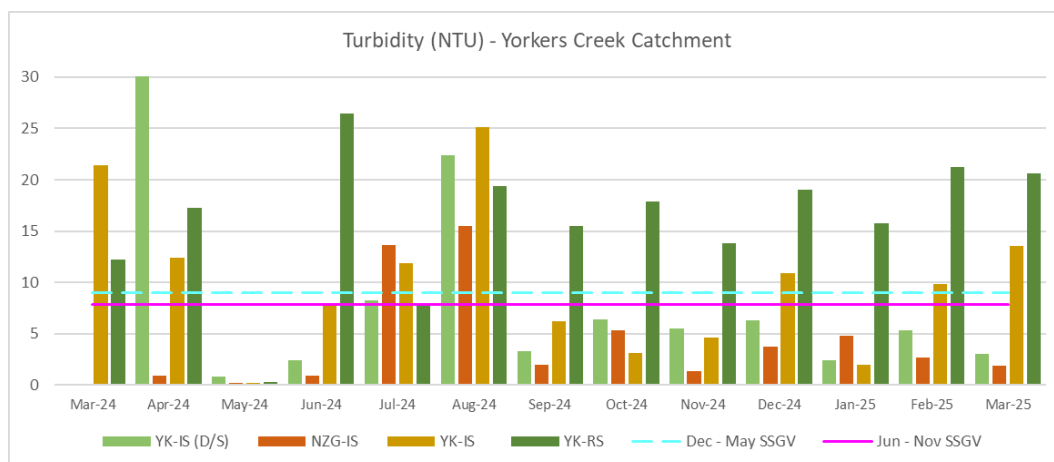
FIGURE 19: TURBIDITY FOR YARRANGOBILLY RIVER CATCHMENT

Turbidity (NTU) levels exceeded the December to May SSGV at all reference sites and majority of the impact sites across all three catchments, refer Figure 19 to Figure 21. The only sites within the SSGV were YK-IS (D/S) and NZG-IS of the Yorkers Creek catchment which had a December to May SSGV of 9 NTU.

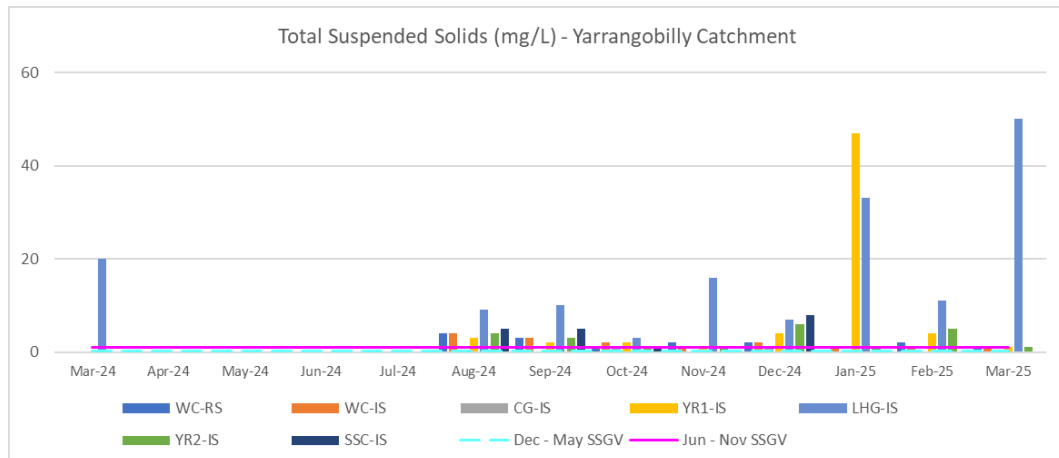
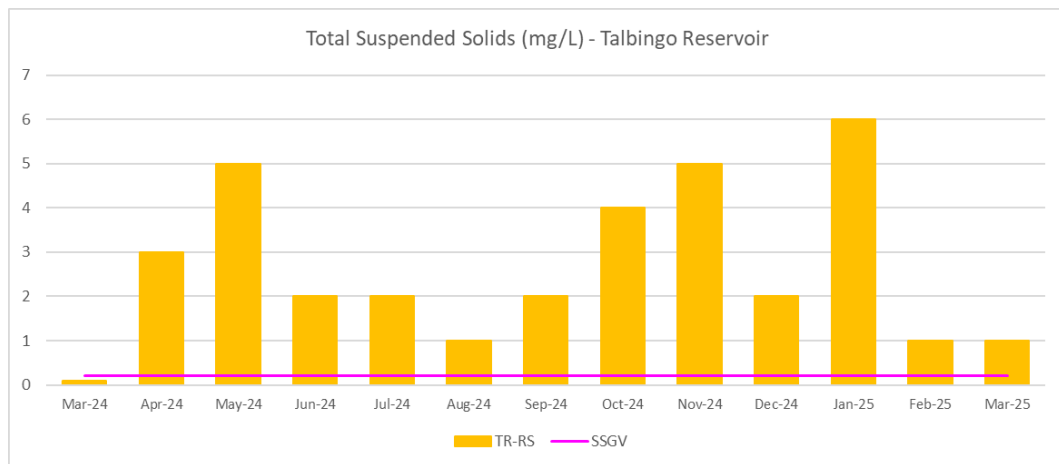
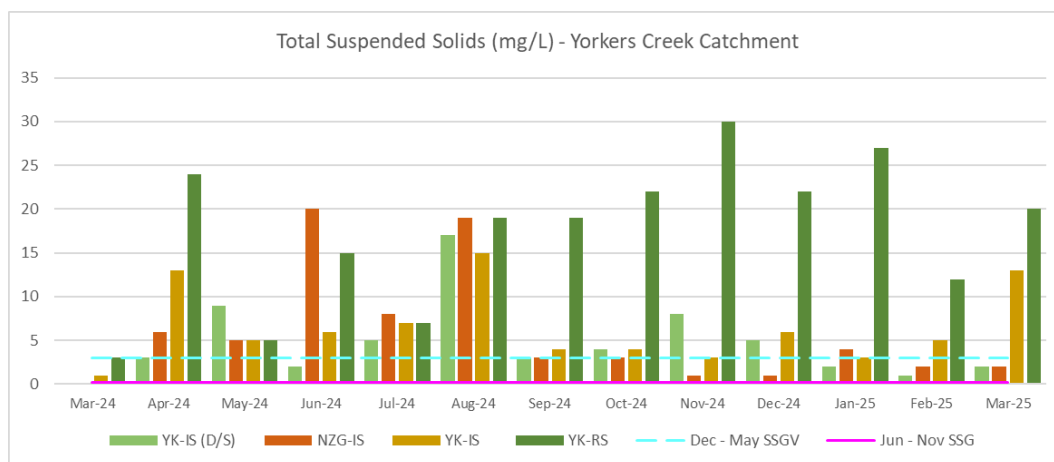
FIGURE 22: TSS FOR YARRANGOBILLY RIVER CATCHMENT

In the Yarrangobilly River catchment, all sites were below the LOR, except for LGH-IS which exceeded the December to May SSGV (0.2 mg/L), refer to Figure 22. Talbingo Reservoir was also below the LOR, refer to Figure 23. In Yorkers Creek catchment, YK-RS and YK-IS both exceeded the December to May SSGV (3 mg/L) and NZG-IS and YK-IS(D/S) were below the LOR, refer to Figure 24.

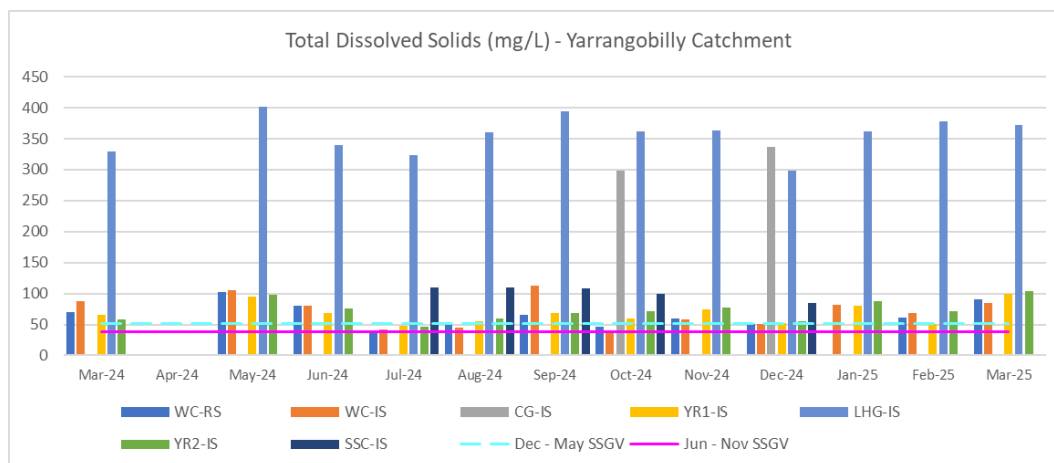
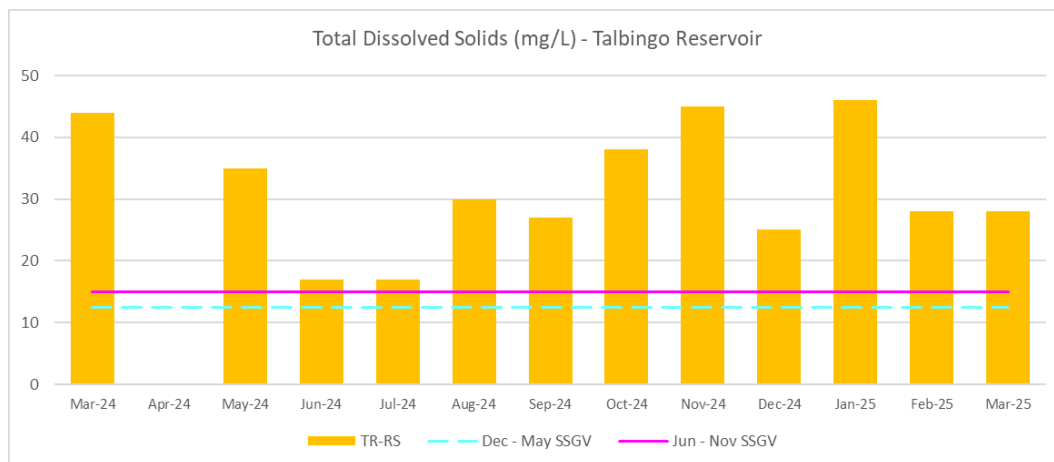
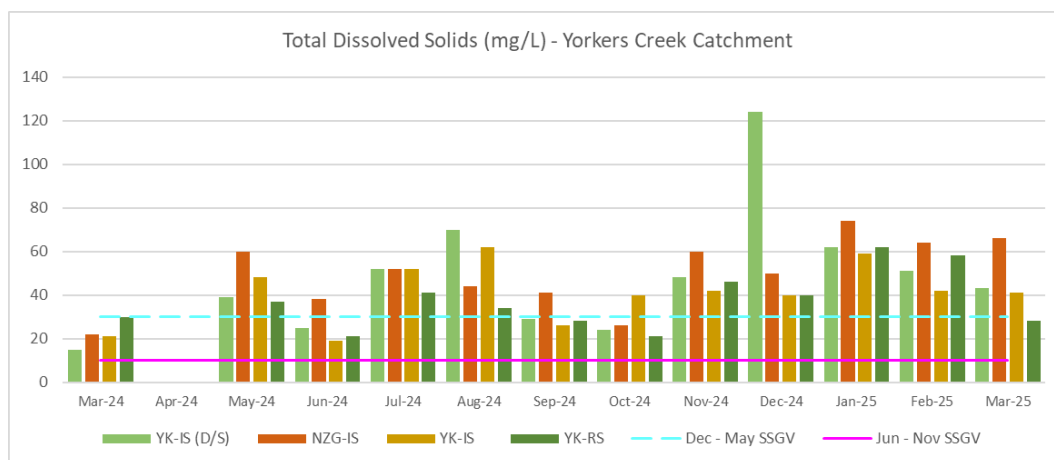
FIGURE 25 TDS FOR YARRANGOBILLY RIVER CATCHMENT

LHG-IS in Yarrangobilly River catchment measured significantly higher than its December to May SSGV at 372 mg/L, refer to Figure 25. YR-RS in Yorkers Creek catchment was the only site to fall within its December to May SSGV (30 mg/L). Figure 26

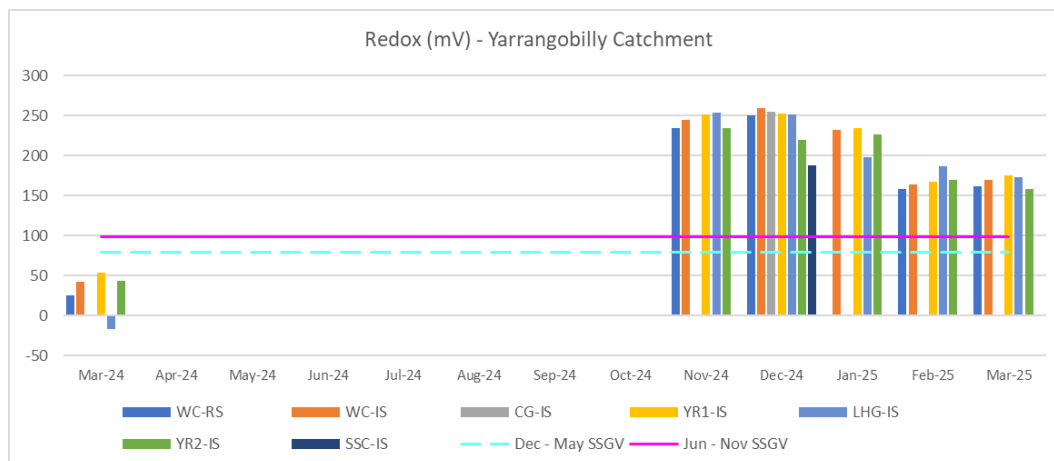
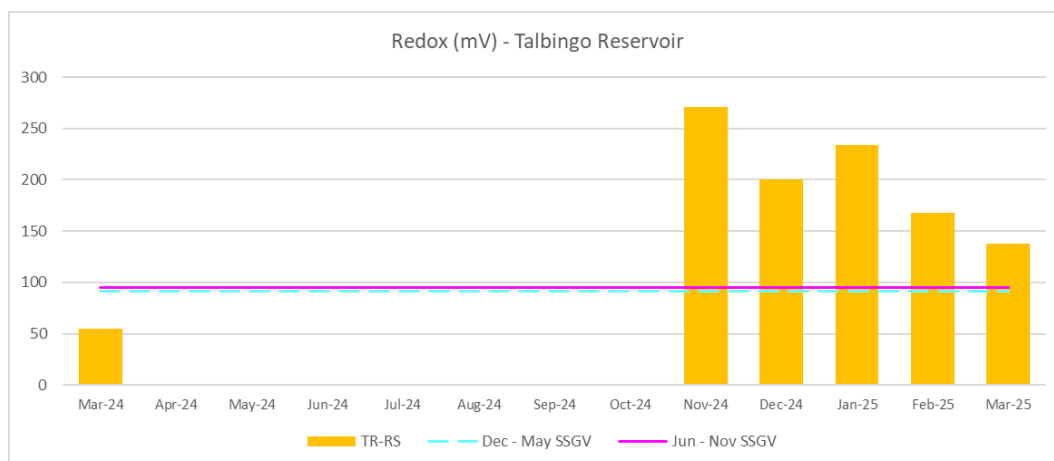
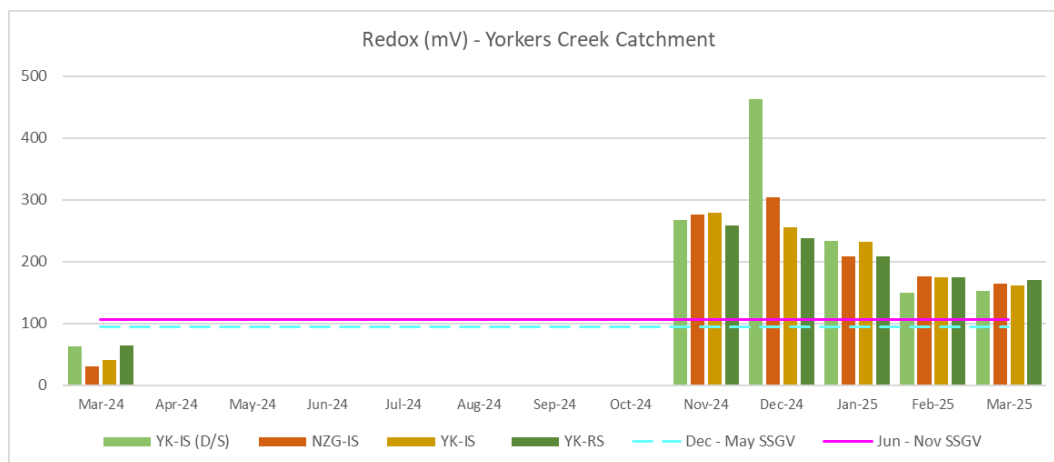
FIGURE 28: REDOX FOR YARRANGOBILLY RIVER CATCHMENT

The December to May SSGV for redox (mV) was exceeded at all sites across all three catchments, refer to Figure 28 to Figure 30.

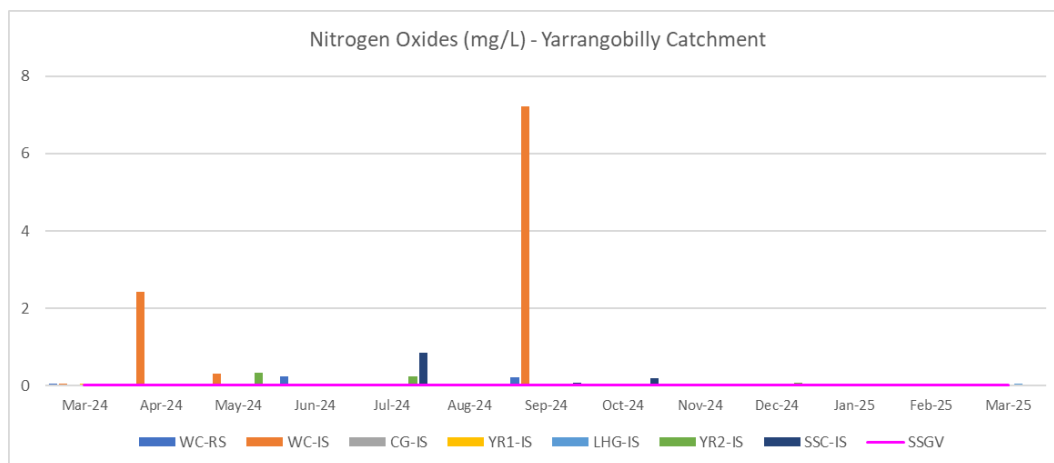
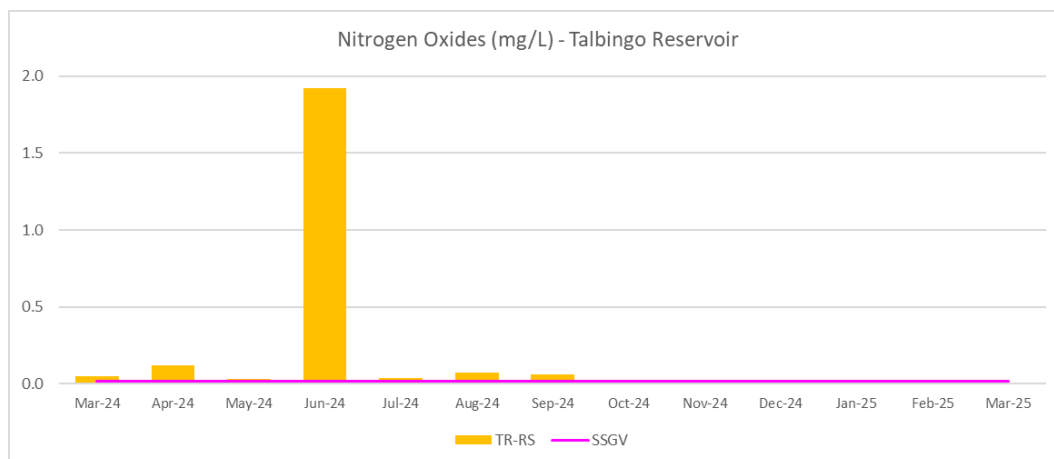
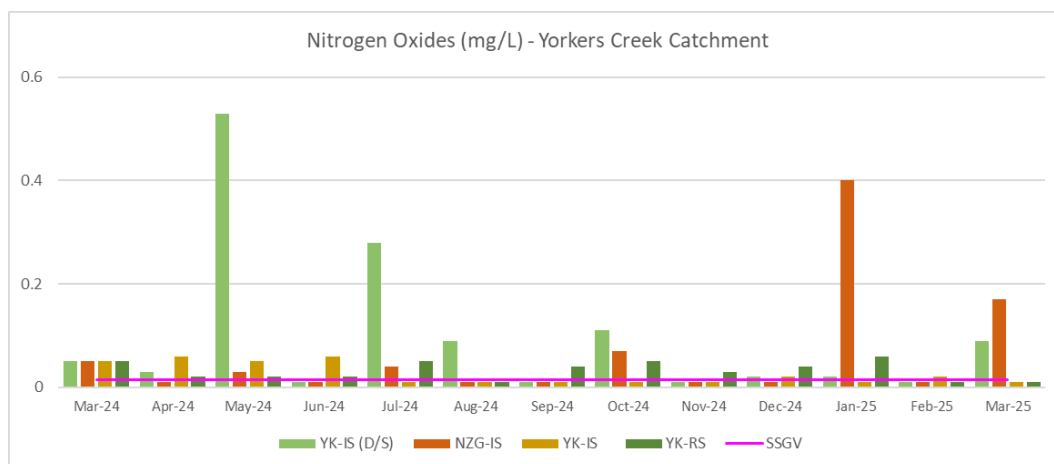
FIGURE 31: NITROGEN OXIDES FOR YARRANGOBILLY RIVER CATCHMENT

Nitrogen oxides (mg/L) levels were within the December to May SSGV (0.015 mg/L) at LGH-IS in Yarrangobilly River catchment and at YK-IS(D/S) and NZG-IS in Yorkers Creek catchment. All other sites were below the LOR, refer to Figure 31 to Figure 33.

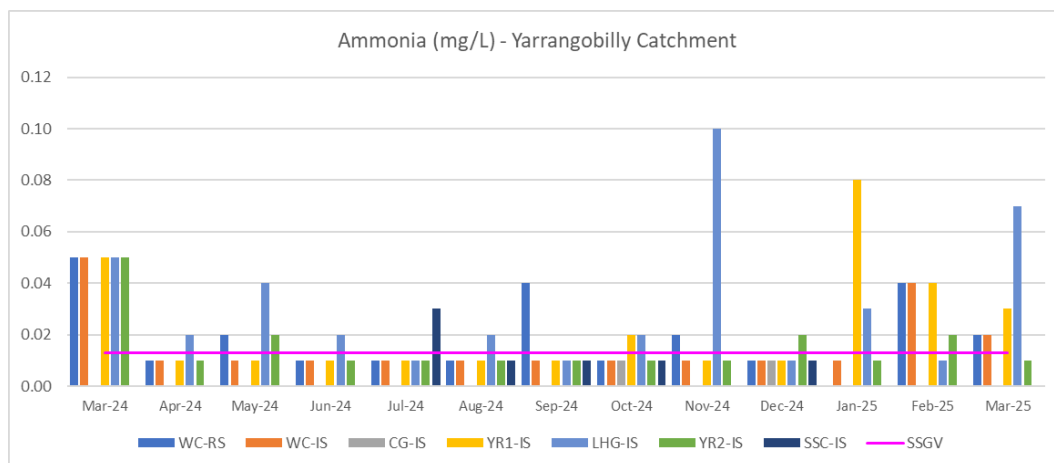
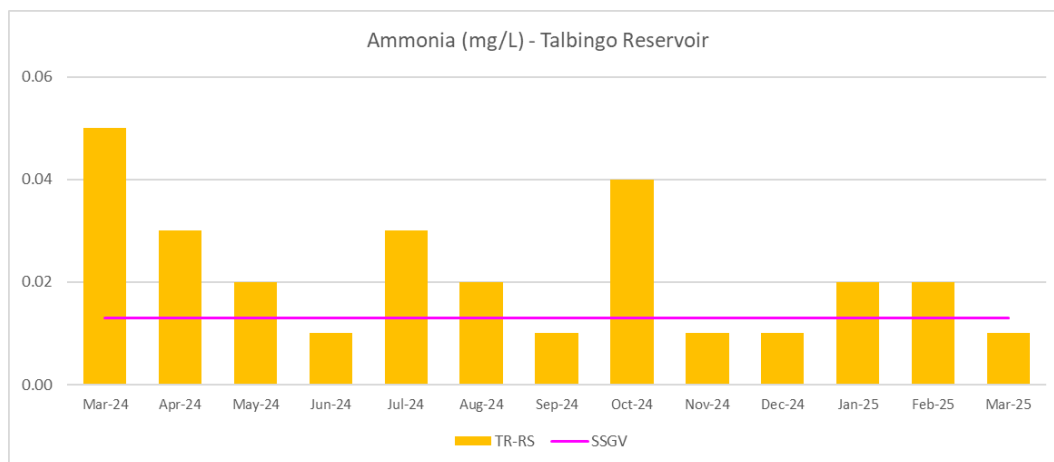
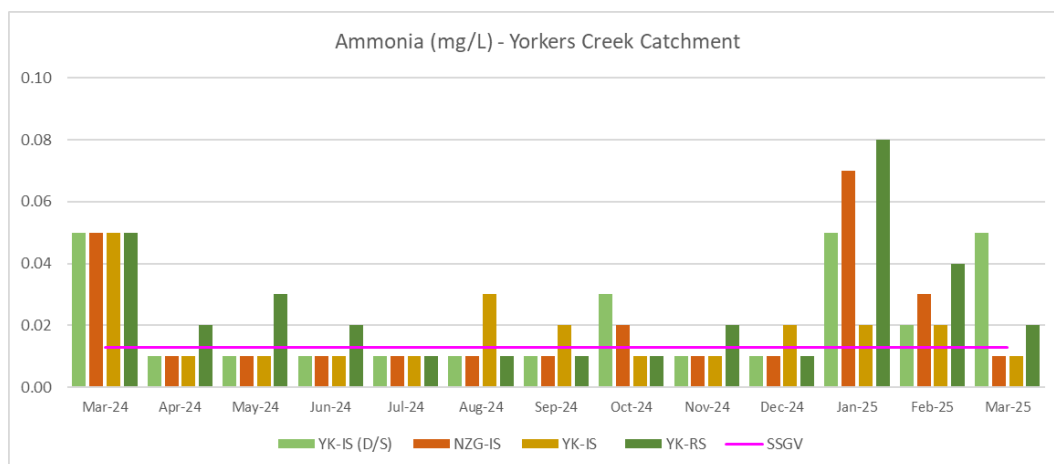
FIGURE 34: AMMONIA FOR YARRANGOBILLY RIVER CATCHMENT

Ammonia (mg/L) levels exceeded the December to May SSGV (0.013 mg/L) at all sites across the three catchments except for YR2-IS in the Yarrangobilly River catchment, TR-RS in Talbingo Reservoir and NZG-IS and YK-IS in Yorkers Creek catchment, which were below the LOR, refer to Figure 34 to Figure 36.

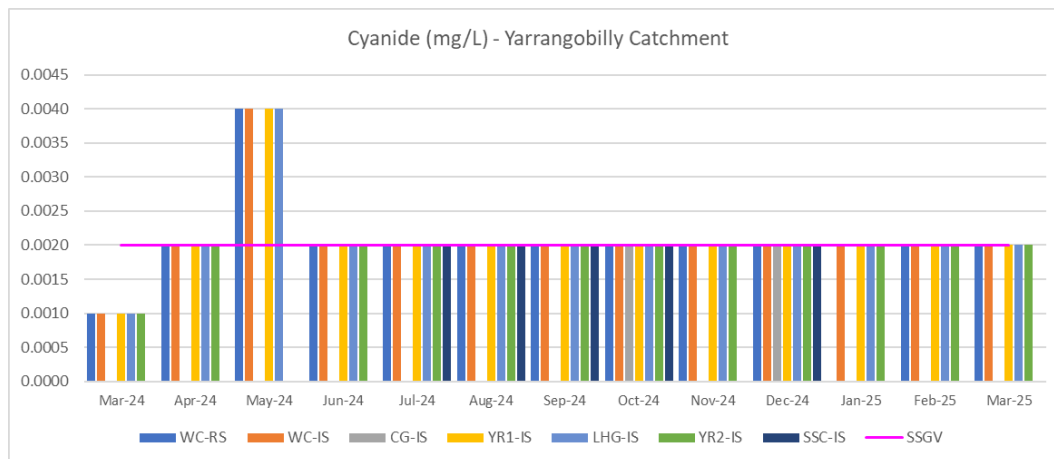
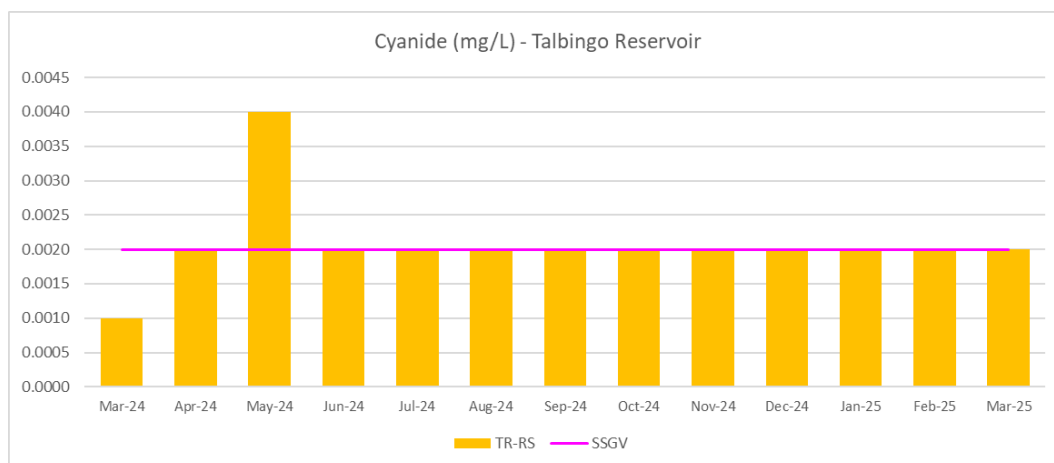
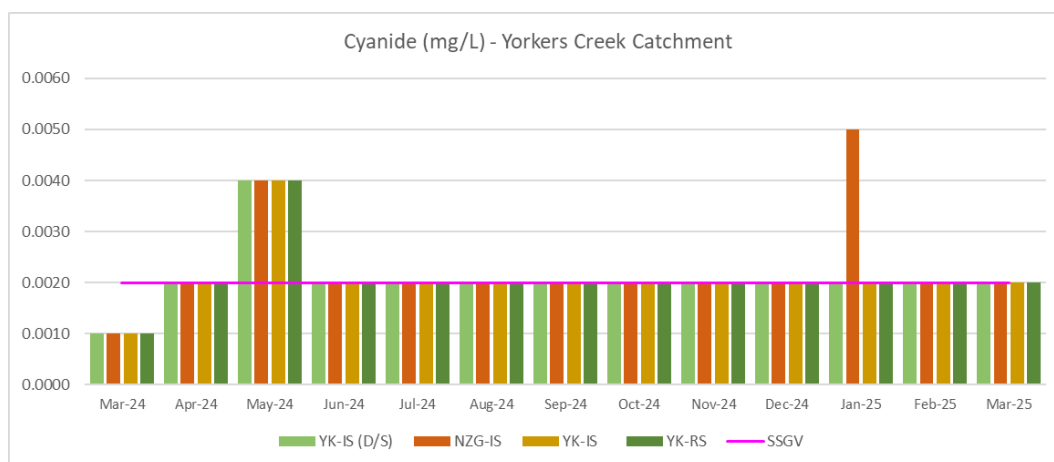
FIGURE 37: CYANIDE FOR YARRANGOBILLY RIVER CATCHMENT

Cyanide (mg/L) was below the LOR at all sites across all three catchments, refer Figure 37 to Figure 39.

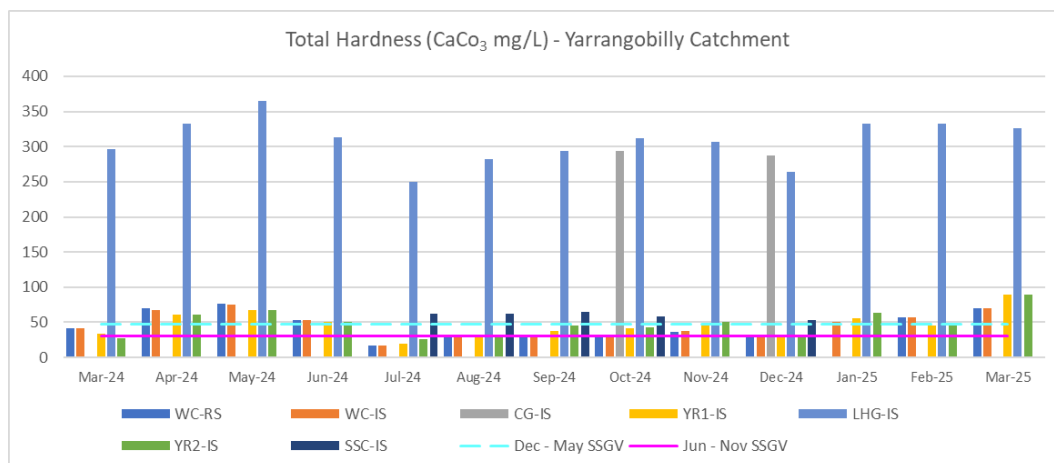
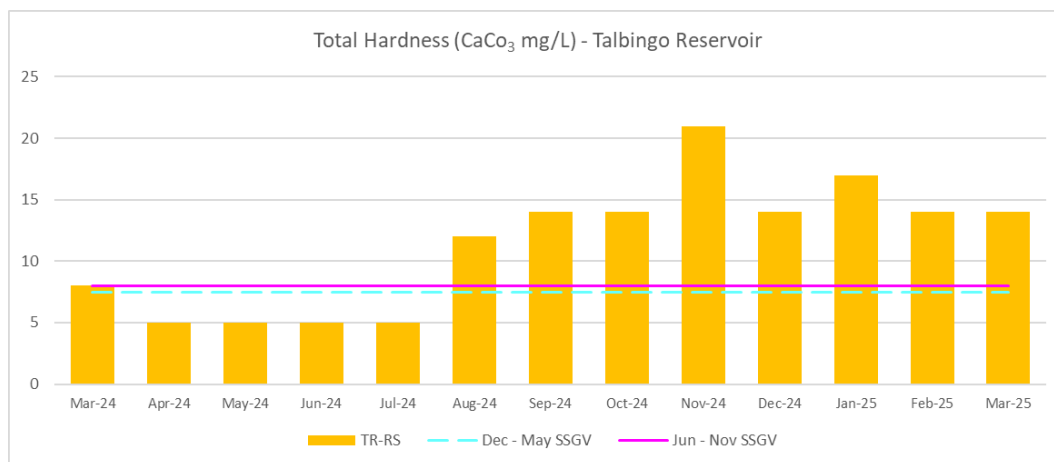
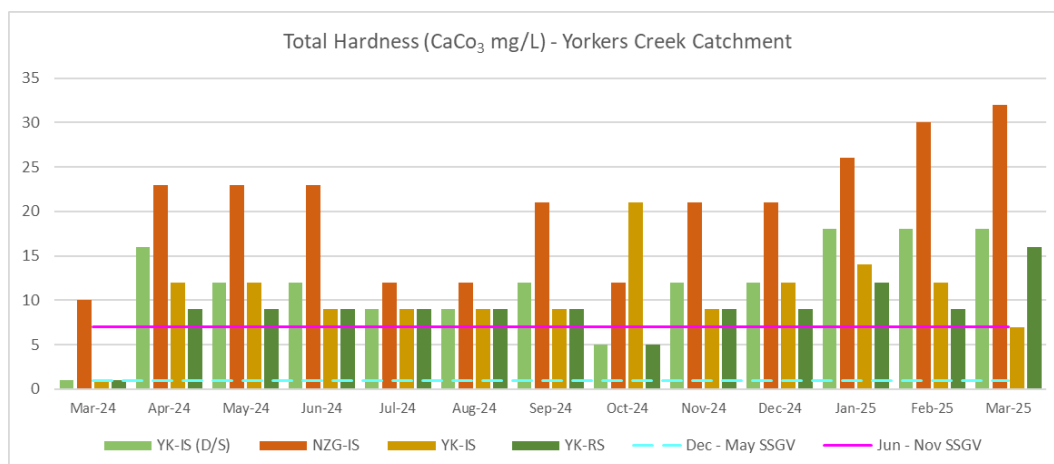
FIGURE 40: CaCO₃ FOR YARRANGOBILLY RIVER CATCHMENT

CaCO₃ (mg/L) levels at all sites in Yarrangobilly River catchment, Talbingo Reservoir and Yorkers Creek catchment exceeded the December to May SSGV of 47 mg/L, 7.5 mg/L and 1 mg/L respectively, refer to Figure 40 to Figure 42. Following previous trends, LHG-IS recorded a significantly elevated value of 326 mg/L in March 2025.
