MONTHLY CONSTRUCTION WATER QUALITY MONITORING REPORT

Project No.: 3200-0645

Project: Transgrid Maragle 500/330 kV Substation

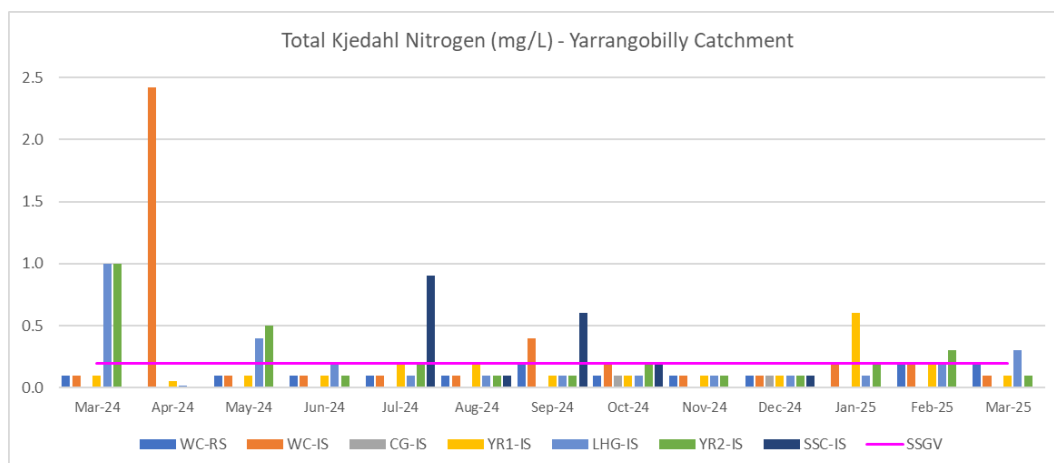
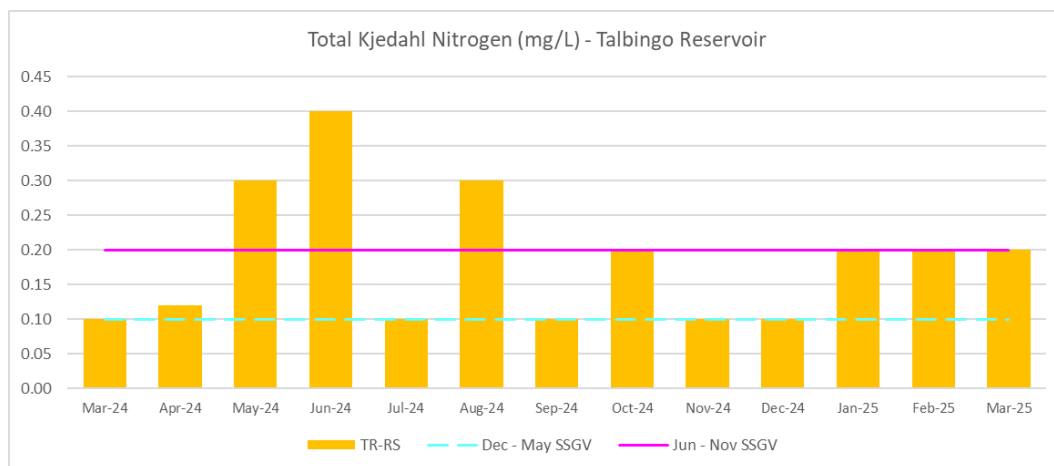
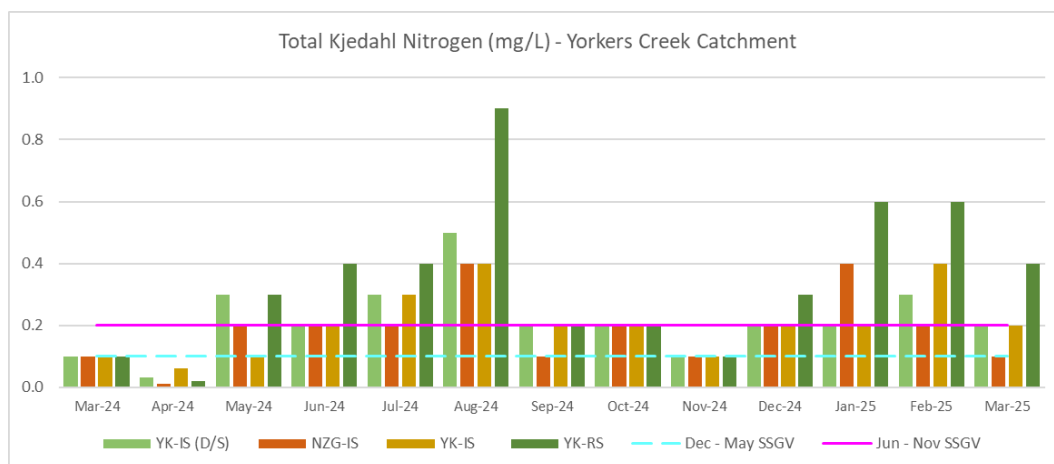
FIGURE 43: TKN FOR YARRANGOBILLY RIVER CATCHMENT

TKN (mg/L) values exceeded the SSGV (0.2 mg/L) at LGH-IS. All other sites within Yarrangobilly River catchment were below the LOR, except for WC-RS which was on-par with the SSGV, refer to Figure 43. All remaining sites at Talbingo Reservoir and Yorkers Creek catchment were above the December to May SSGV (0.1 mg/L) except for NZG-IS, which was below the LOR, refer to Figure 44 and Figure 45.

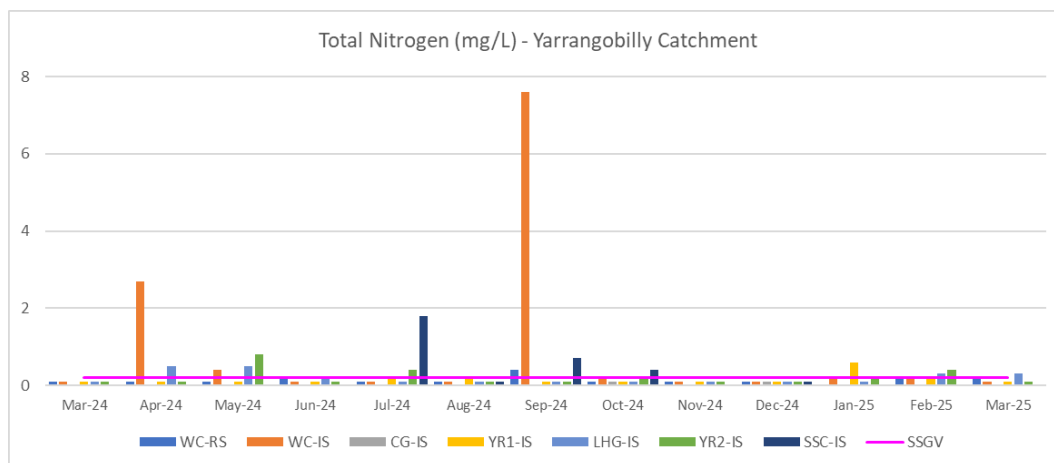
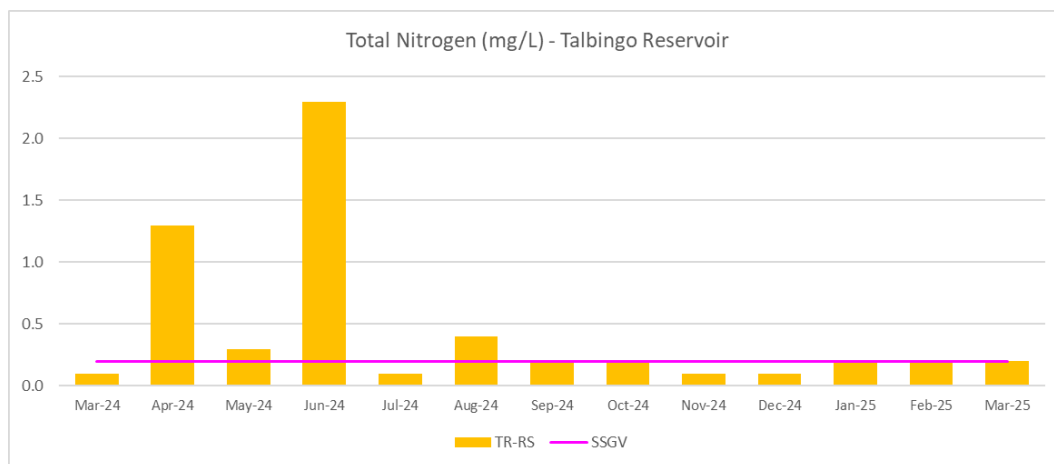
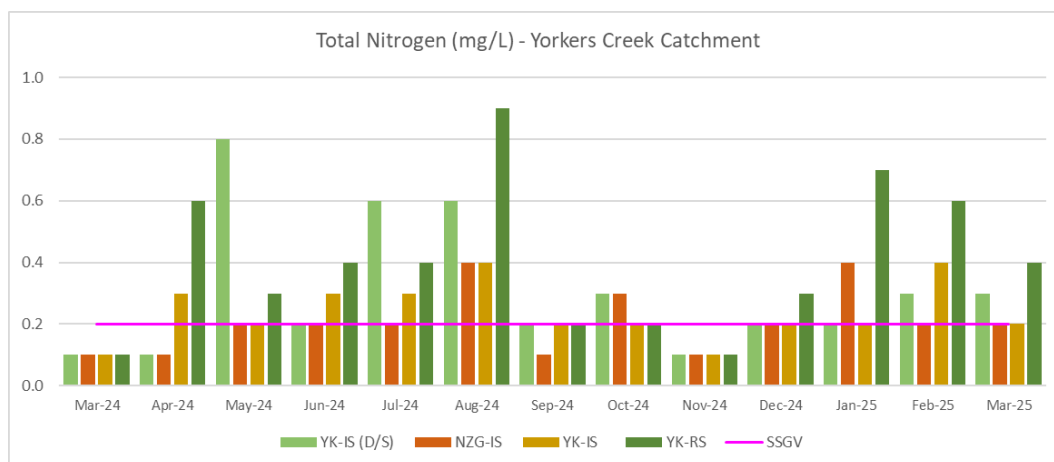
FIGURE 46: TN FOR YARRANGOBILLY RIVER CATCHMENT

TN (mg/L) marginally exceeded the SSGV (0.2 mg/L) at LHG-IS within Yarrangobilly River catchment site, refer to Figure 46. No exceedance was recorded at Talbingo Reservoir, refer to Figure 47. At the Yorkers Creek catchment, NZG-IS and YK-IS were within the SSGV while the other impact sites exceeded the SSGV, refer to Figure 48.

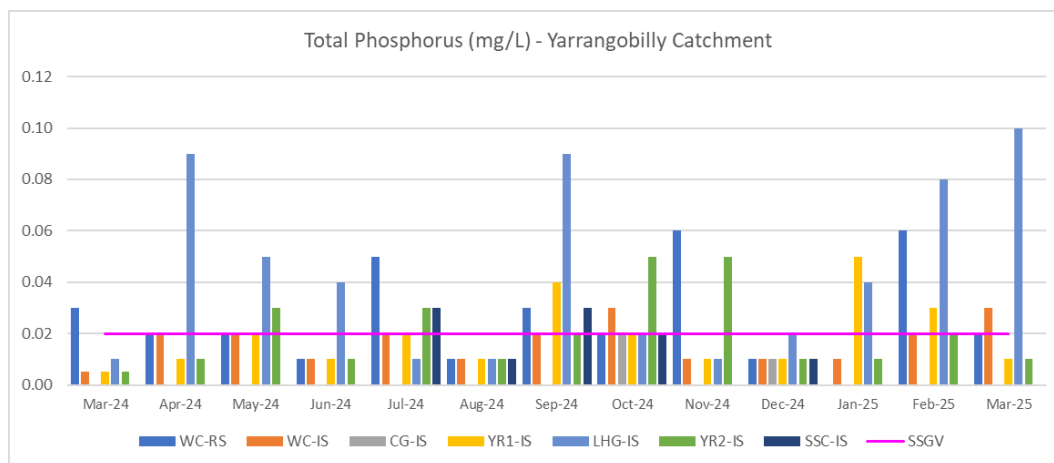
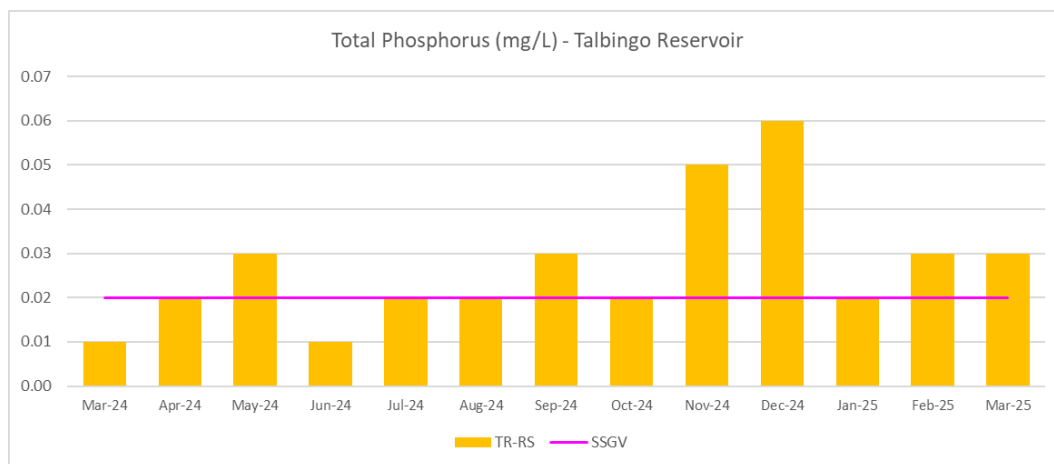
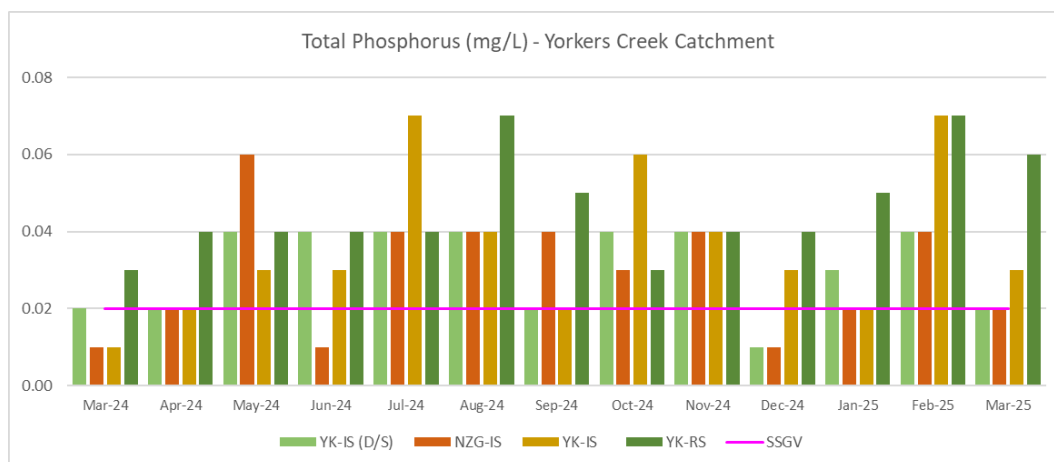
FIGURE 49: TP FOR YARRANGOBILLY RIVER CATCHMENT

Exceedances of the TP (mg/L) SSGV were seen at WC-RS and LHG-IS within Yarrangobilly River catchment, refer to Figure 49. Talbingo Reservoir also marginally exceeded the SSGV by 0.01 mg/L, refer to Figure 50. With the Yorkers Creek catchment, YK-IS(D/S) and NZG-IS were both within the SSGV, refer to Figure 51.

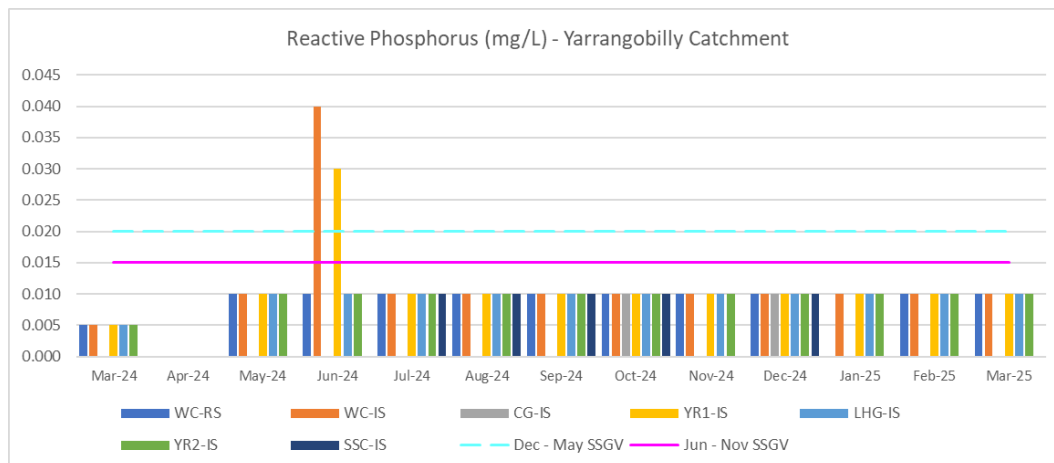
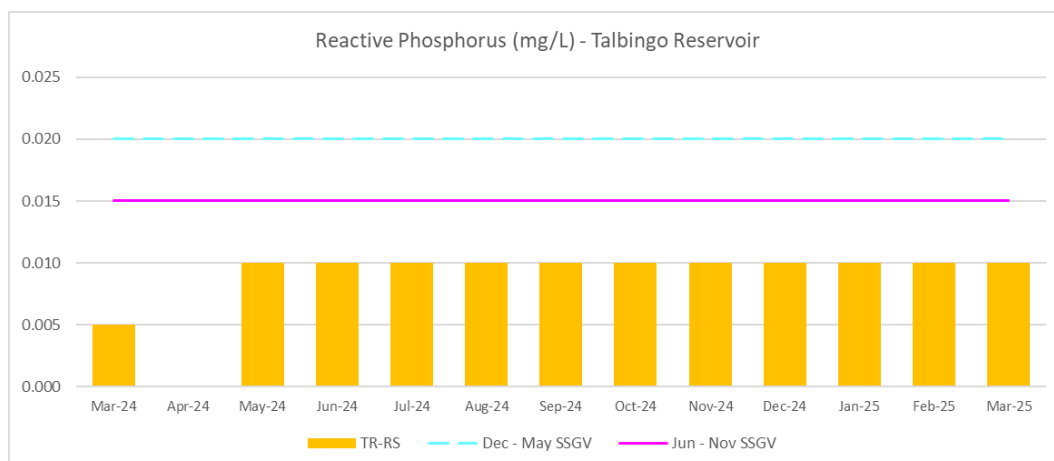
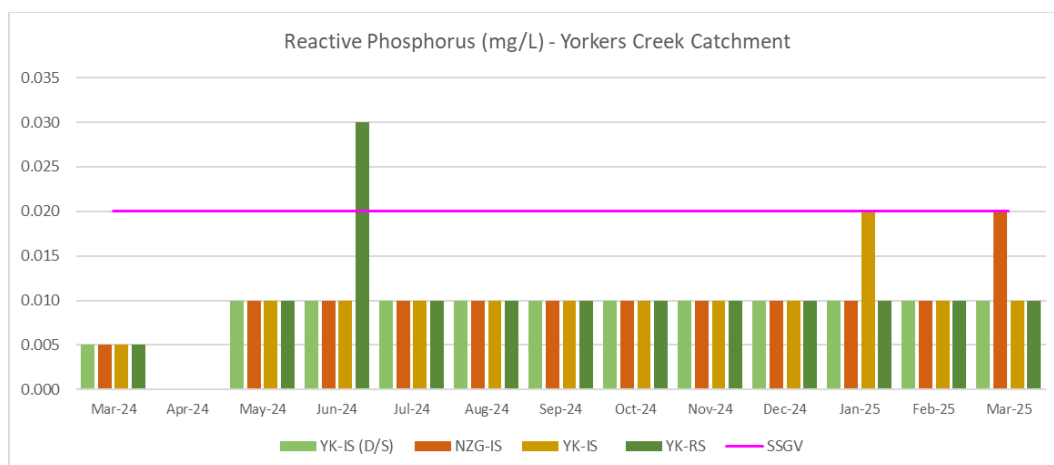
FIGURE 52: RP FOR YARRANGOBILLY RIVER CATCHMENT

All sites measured below the LOR for RP (mg/L), refer to Figure 52 to Figure 54.
