MONTHLY CONSTRUCTION WATER QUALITY MONITORING REPORT

December 2025
Project No.: 3200-0645
Project: Transgrid Maragle 500/330 kV Substation
Private & Confidential

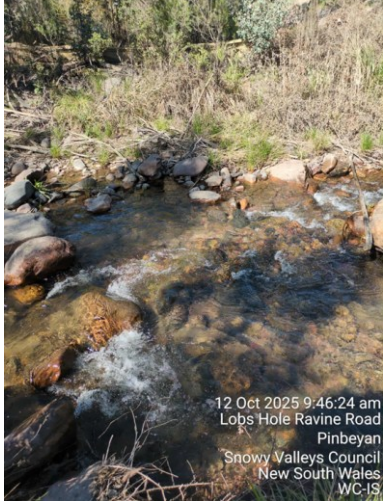
ID	Observations	Photo
WC-IS	<ul style="list-style-type: none"> • Low volume and flow rate. • Water clear with no visible discolouration. • Presence of aquatic vegetation in water channel. • Presence of vegetative detritus in waterbody. • Rocky and undercut banks present. • Riparian vegetation, comprised of trees and grass. • High weed density, including blackberry (<i>Rubus fruticosus</i>). • Monitoring location is situated adjacent to bridge and Mine Trail Road which is frequently used by snowy 2.0 vehicles, plant and machinery. • Foam visible in back eddies

<p>12 Oct 2025 9:46:24 am Lobs Hole Ravine Road Pinbeyan Snowy Valleys Council New South Wales WC-IS</p>
CG-IS	<ul style="list-style-type: none"> • Dry, no flow

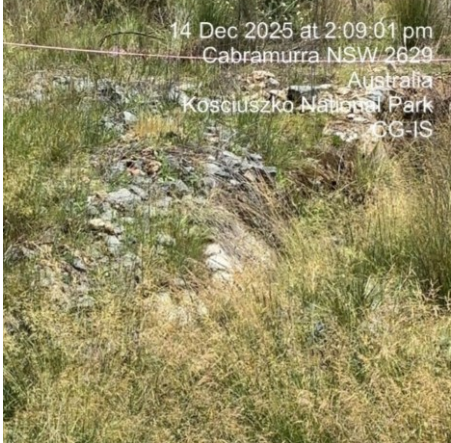
<p>14 Dec 2025 at 2:09:01 pm Cabramurra NSW 2629 Australia Kosciuszko National Park CG-IS</p>

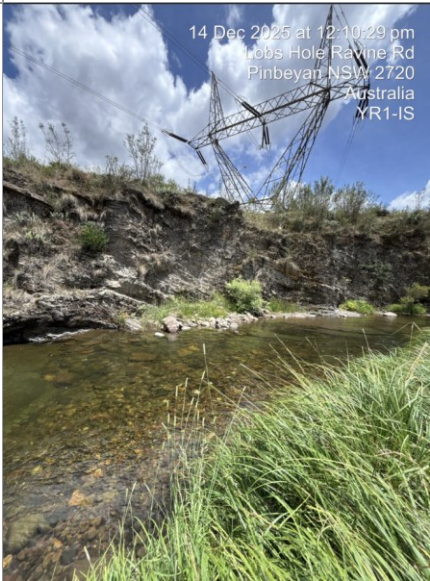
ID	Observations	Photo
YR1-IS	<ul style="list-style-type: none"> • Moderate water volume and flow rate. • Clear visibility. • Rocky and pebbly bed visible. • Riparian vegetation comprised of groundcover species, shrubs and trees. • Moderate weed density including thistle (<i>Cirsium spp.</i>) and blackberry (<i>Rubus fruticosus</i>) • Monitoring location is situated adjacent to bridge and electrical transmission tower on top of rocky cliff and Snowy 2.0 laydown area

<p>14 Dec 2025 at 12:10:29 pm Robs Hole Ravine Rd Pinbeyan NSW 2720 Australia YR1-IS</p>
LHG-IS	<ul style="list-style-type: none"> • Low water volume and flow rate. • Slight discolouration in water – yellow tinge. • Presence of aquatic vegetation within channel. • Vegetation of vegetative detritus in waterbody. • Presence of silt and grass seed husks on stream bed. • Slight sulphur smell to water. • Overgrown vegetation, predominantly groundcover species. • Monitoring location is adjacent to Mine Trail Road which is frequently used by Snowy 2.0 vehicles, plant and machinery.

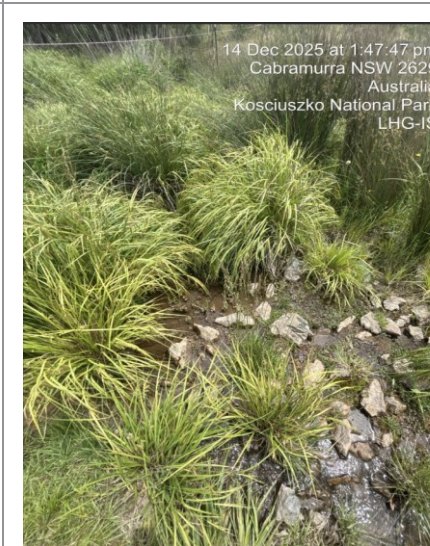
<p>14 Dec 2025 at 1:47:47 pm Cabramurra NSW 2629 Australia Kosciuszko National Park LHG-IS</p>

- » Vegetation cover along the riparian zone can influence the stability of the banks and groundwater which in turn may influence the waterways
 - » A sheen from organic decomposition observed on the surface of the water at LHG-IS may impact WQ parameters

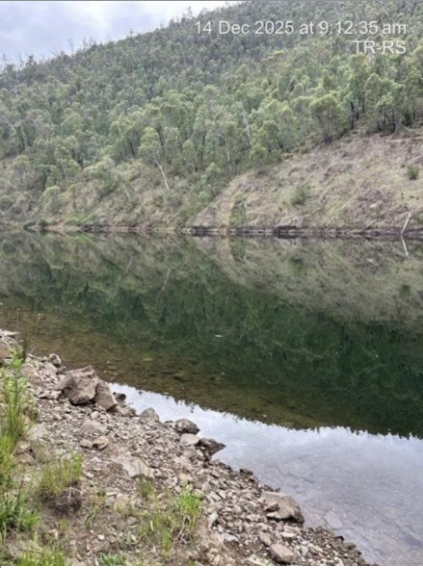
ID	Observations	Photo
TR-RS	<ul style="list-style-type: none"> • Moderate water volume and flow rate. • Clear visibility. • Presence of aquatic invertebrates and vegetation in water channel. • Presence of vegetative detritus in waterbody. • Sandy bed and rocky banks. • Riparian vegetation comprised of groundcover and trees. • Presence of landslips. • Monitoring location is situated adjacent to publicly accessible O'Hares Campground and Talbingo Reservoir ancillary infrastructure.

<p>14 Dec 2025 at 9:12:35 am TR-RS</p>
YK-RS	<ul style="list-style-type: none"> • Very low water volume and flow rate. • Turbid water. • Muddy banks • Presence of aquatic vegetation (including algae) in water channel. • Presence of vegetative detritus in waterbody. • Eroded and undercut banks. • Ground cover is comprised of shrubs and grasses.

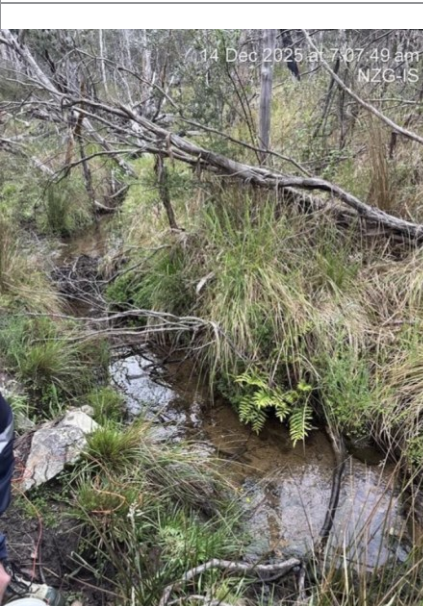
<p>14 Dec 2025 at 7:07:49 am NZG-IS</p>

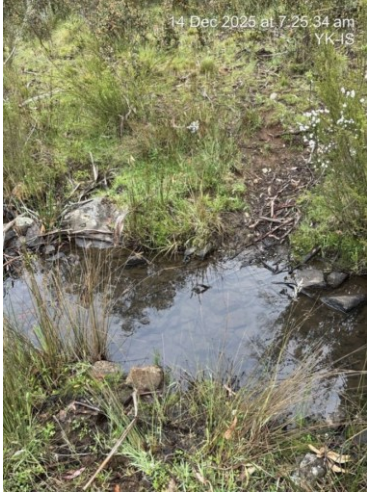
ID	Observations	Photo
YK-IS (D/S)	<ul style="list-style-type: none"> • Low water volume and flow rate. • Yellow and brown tinge observed in water. • Presence of aquatic vegetation (including algae) in water channel. • Presence of vegetative detritus observed in waterbody. • Evidence of undermined banks • Rocky and sandy stream bed • Riparian vegetation consisted of groundcover species and trees. • Overhanging and overgrown vegetation. • Foam forming on surface of water • Monitoring location is situated adjacent to publicly accessible 4WD track.

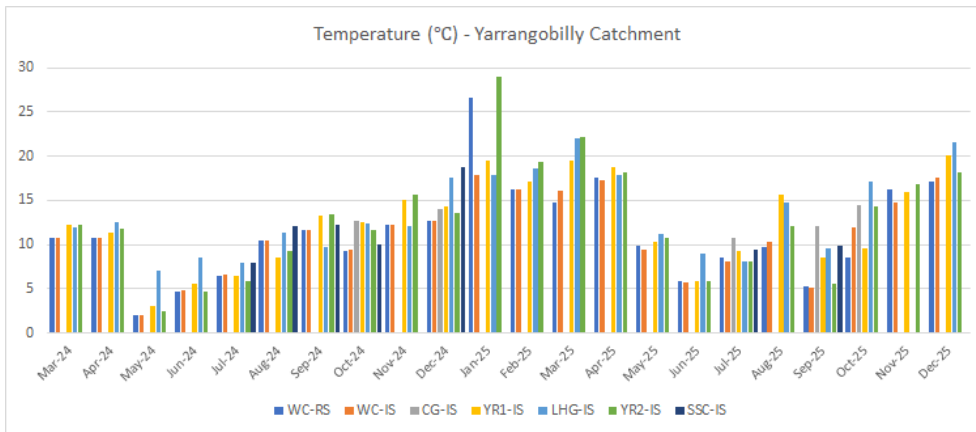
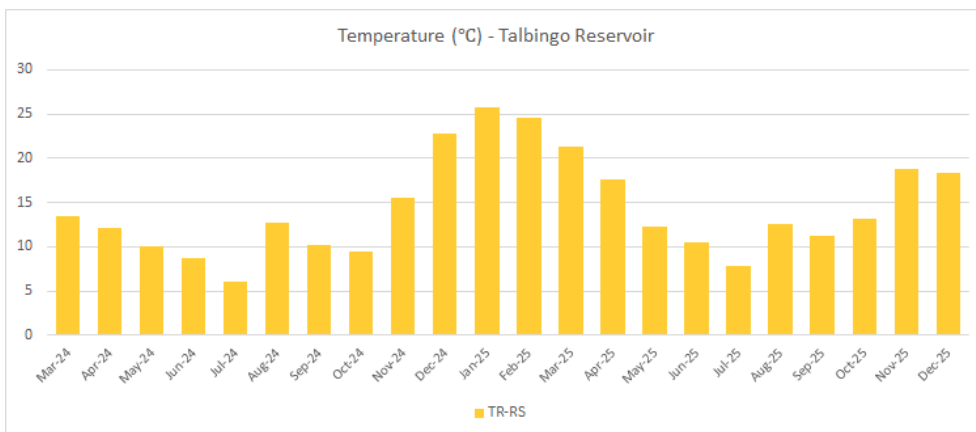
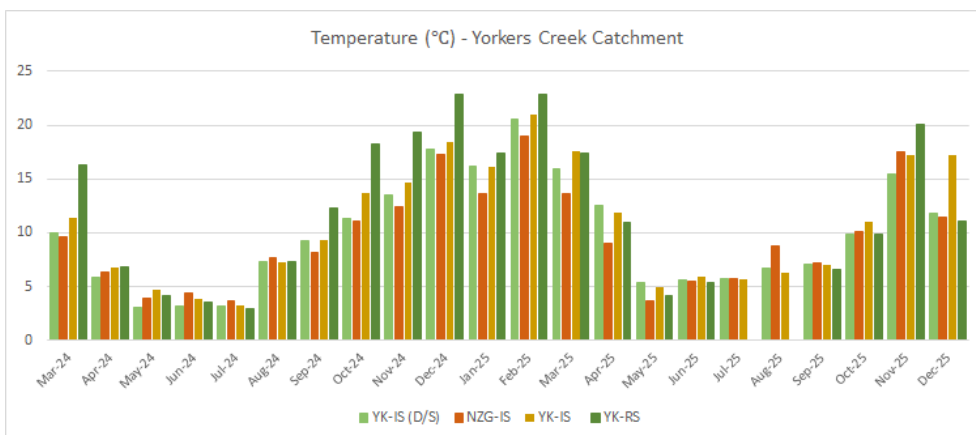
In December 2025, Yarrangobilly River Catchment exhibited an increase in mean temperature (°C) by $\approx 3^{\circ}\text{C}$ to $\approx 19^{\circ}\text{C}$ (Figure 4). In contrast, the temperature at Talbingo Reservoir in December 2025 remained on-par with November 2025 (Figure 5). A notable temperature change during the December 2025 sampling period was exhibited at Yorkers Creek Catchment, where the mean temperature reduced by $\approx 5^{\circ}\text{C}$ to $\approx 13^{\circ}\text{C}$ (Figure 6).

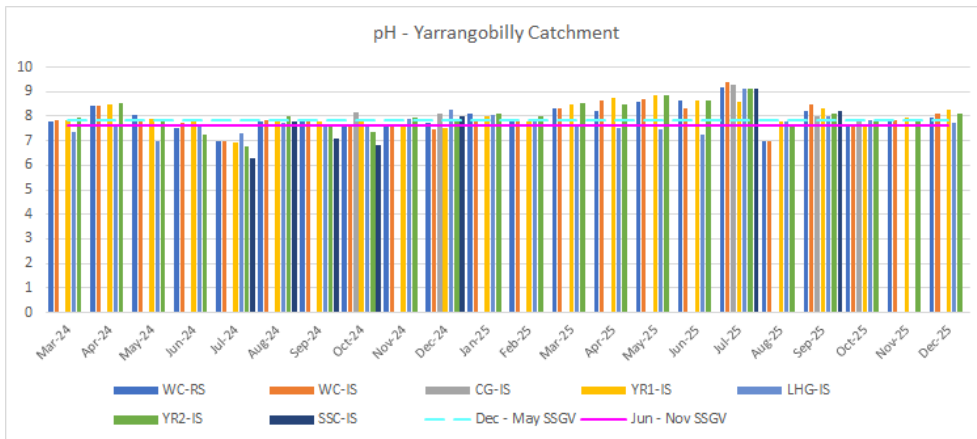
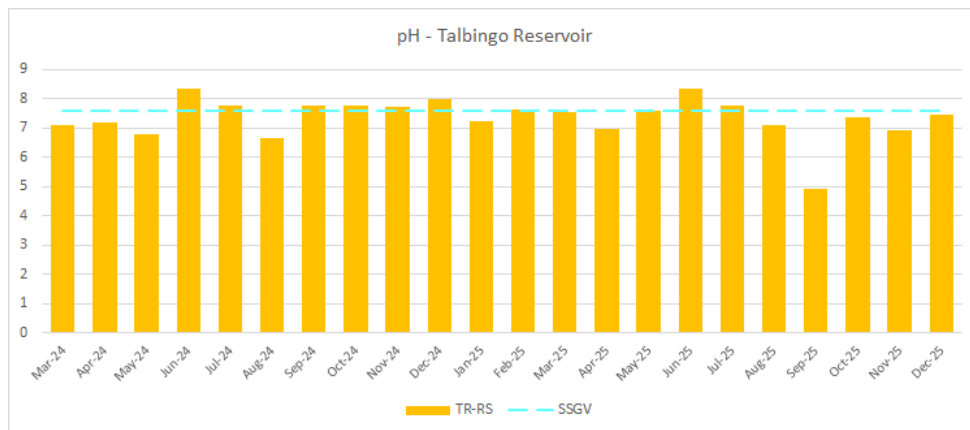
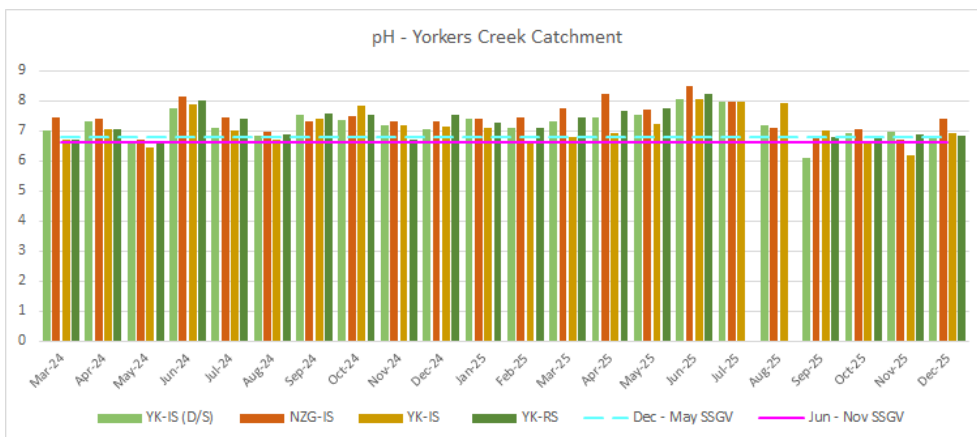
During the December 2025 sampling period, pH values at most sites across the catchments (Yarrangobilly River Catchment, Talbingo Reservoir, Yorkers Creek Catchment) exhibited an increase compared to November 2025 (Figure 7 – Figure 9). All sites exceeded the December-May SSGV, except LHG-IS and TR-RS, which recorded values below the SSGV.

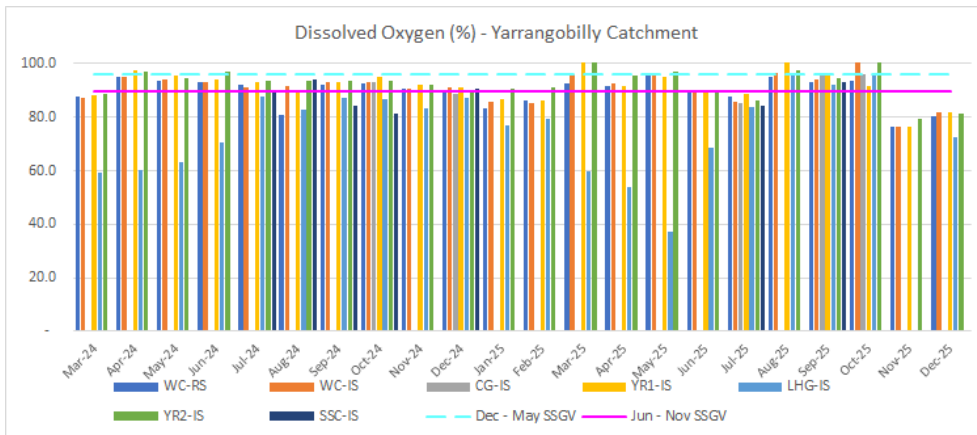
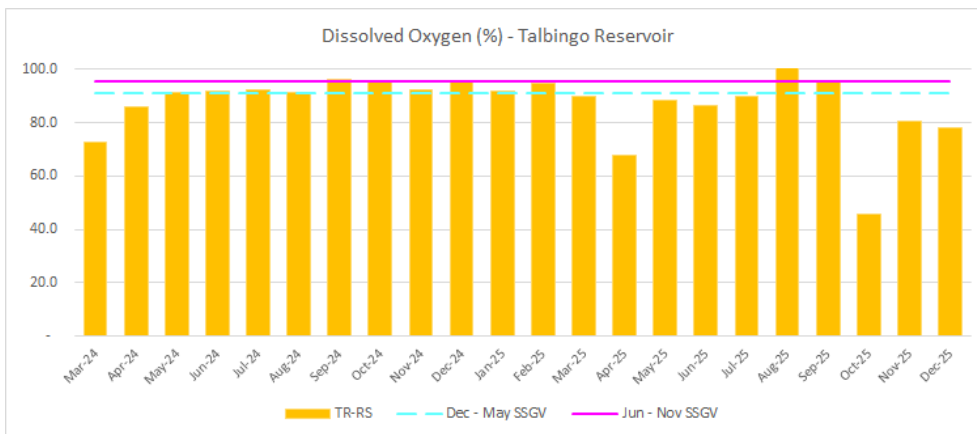
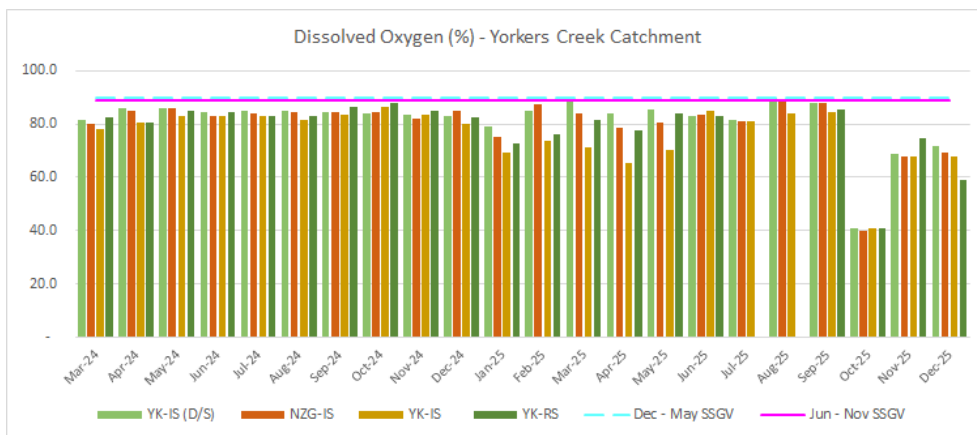
During the December 2025 sampling period, DO (%) values generally improved across Yarrangobilly River Catchment and Yorkers Creek Catchment compared to November 2025. Talbingo Reservoir pH values were marginally lower. All sites were below the December-May SSGV (Figure 10–12).

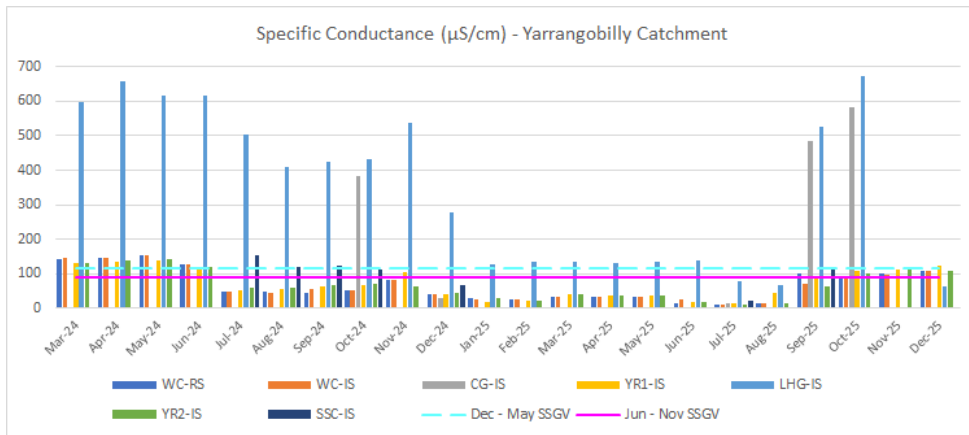
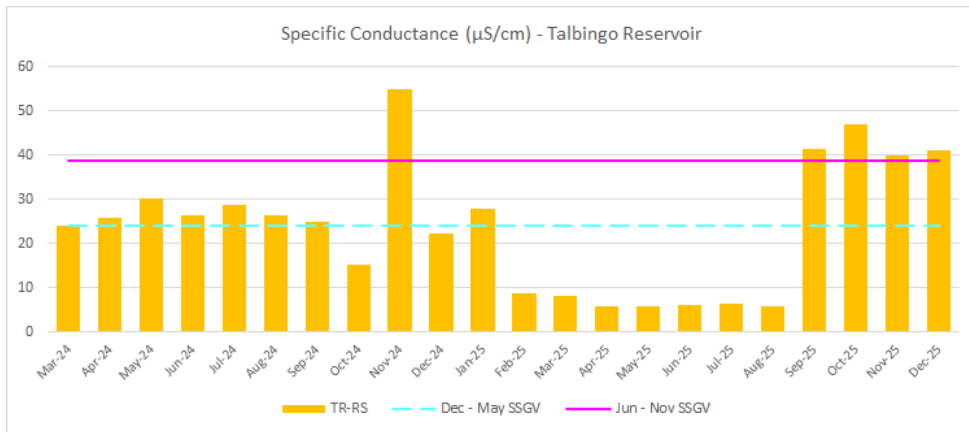
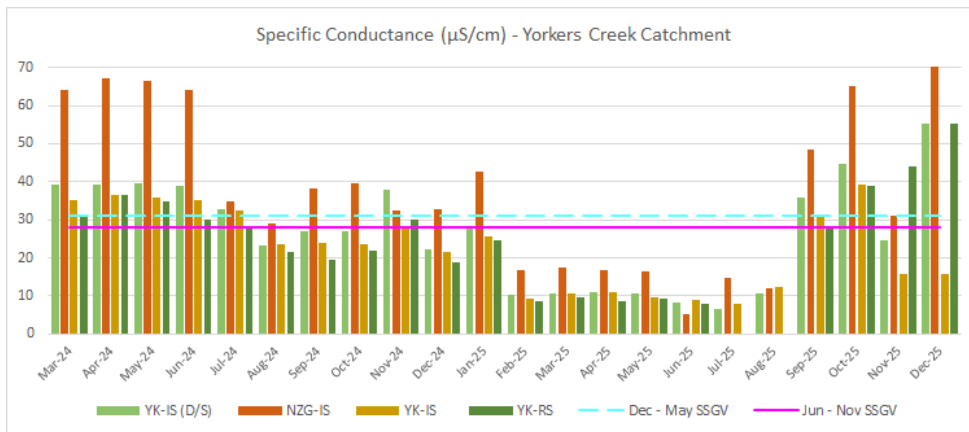
December 2025 specific conductance ($\mu\text{S}/\text{cm}$) results varied across all sampling locations. Exceedance of the December-May SSGV was recorded in Yarrangobilly River Catchment at YR1-IS (Figure 13). Exceedance of the SSGV was recorded at Talbingo Reservoir (Figure 14) and all sites across Yorkers Creek Catchment, except YK-IS which was within the SSGV (Figure 15).

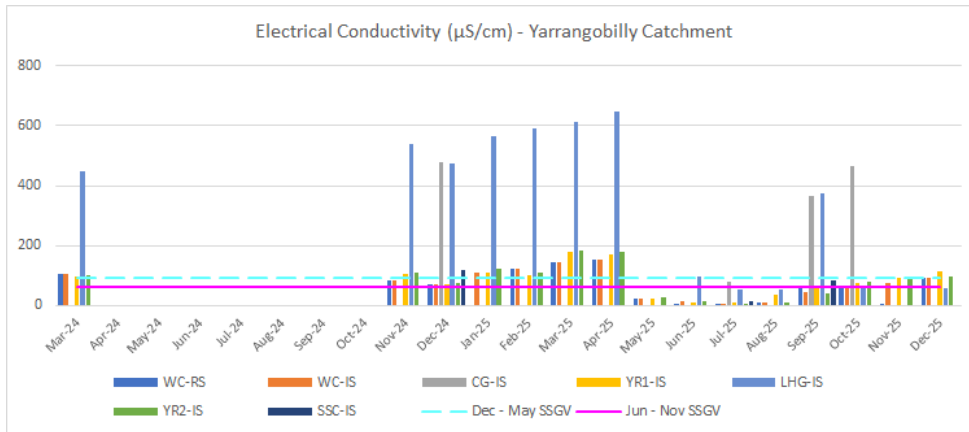
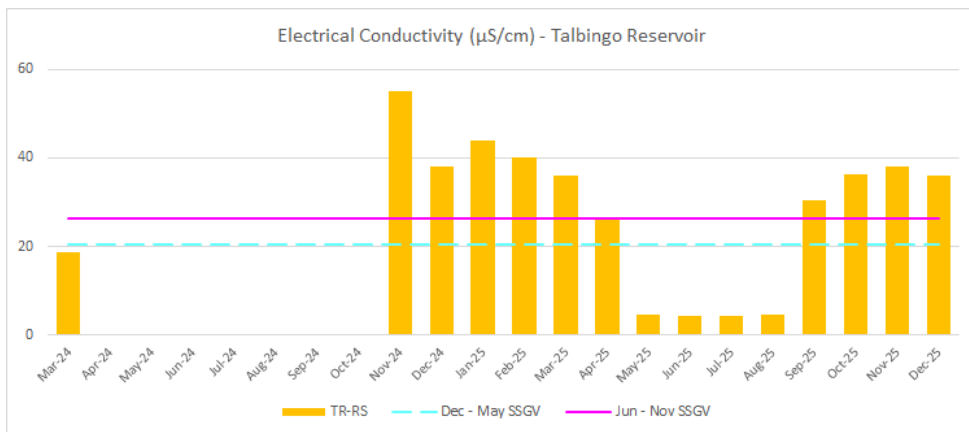
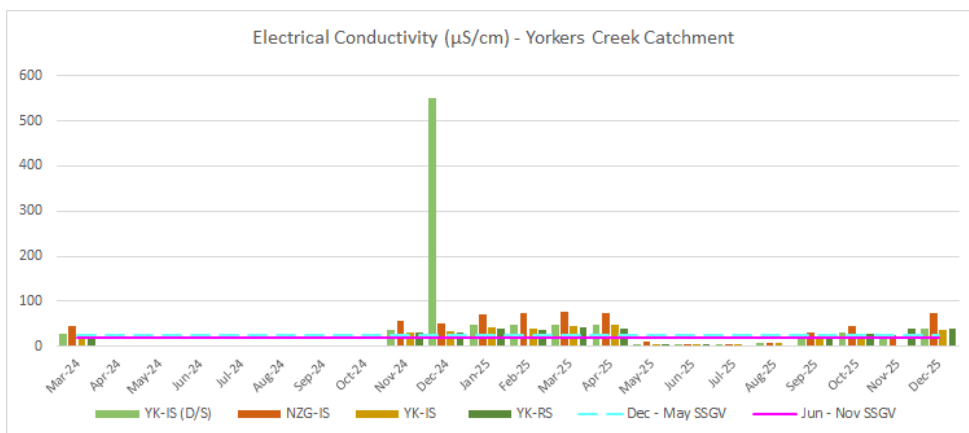
In December 2025, Electrical Conductivity (EC, $\mu\text{S}/\text{cm}$) exceeded SSGV values across all three catchments (Yarrangobilly River Catchment, Talbingo Reservoir and Yorkers Creek Catchment), except at LHG-IS which was below the SSGV (Figure 16—18).

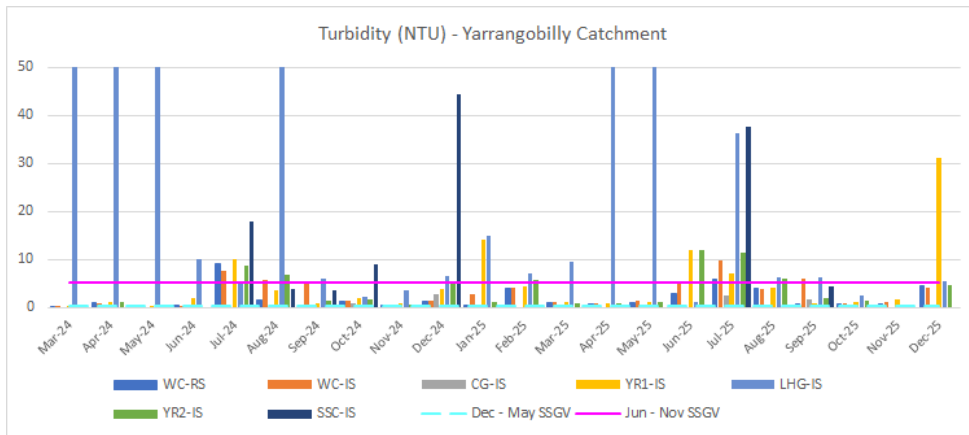
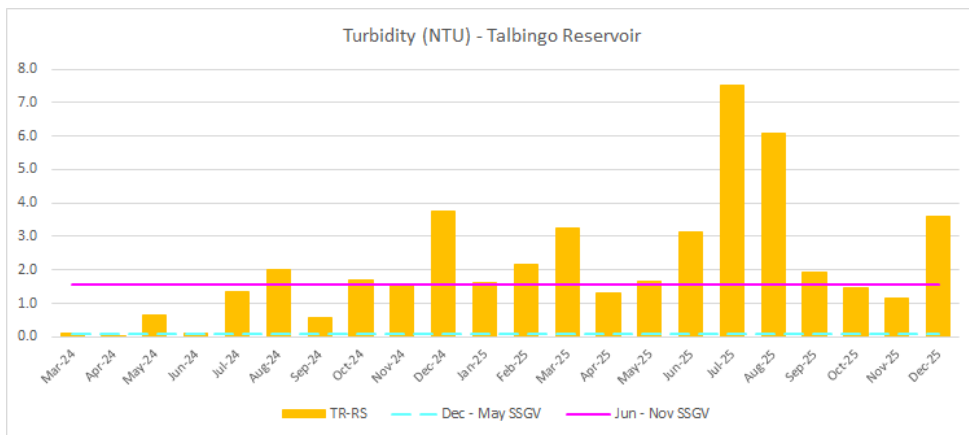
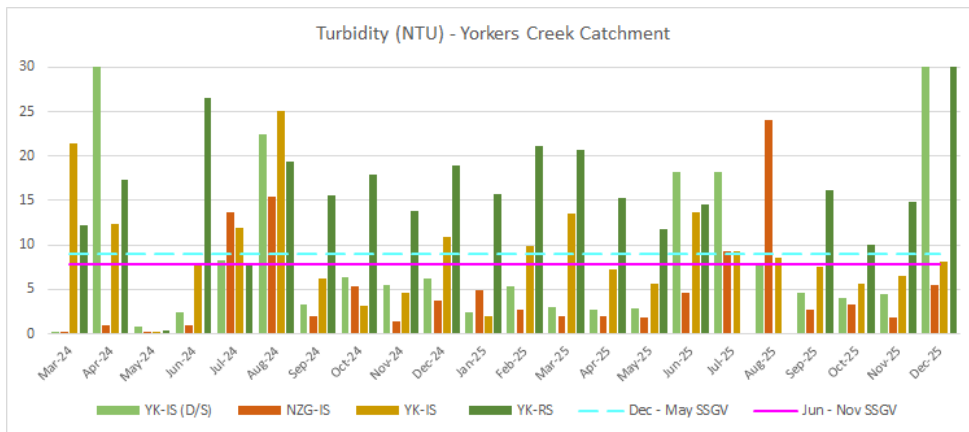
In December 2025, results generally exceeded the December – May SSGV (Figure 19–21). A marked increase in turbidity was recorded at YR1-IS in Yarrangobilly River Catchment (31.04 NTU). Two sites (NZG-IS and YK-IS) in Yorkers Creek catchment were below the SSGV (Figure 21).

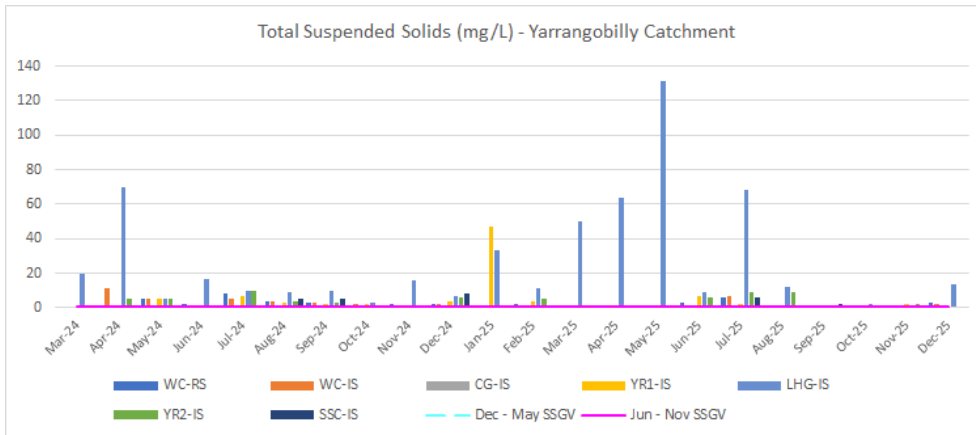
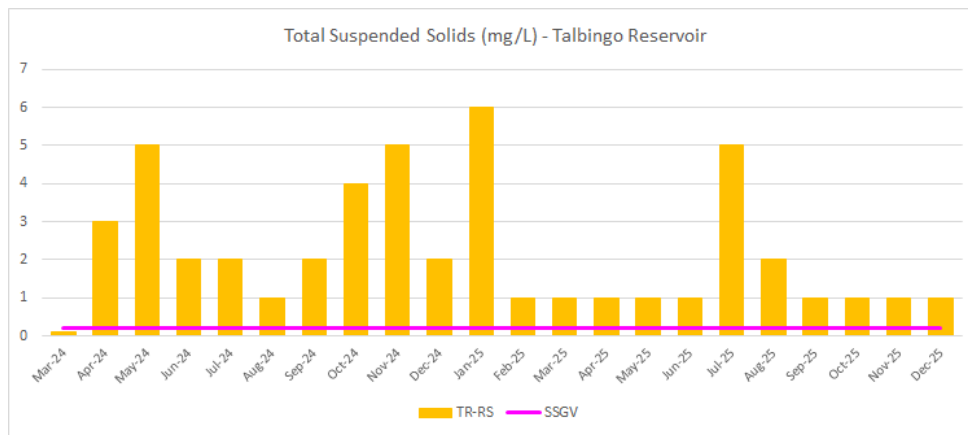
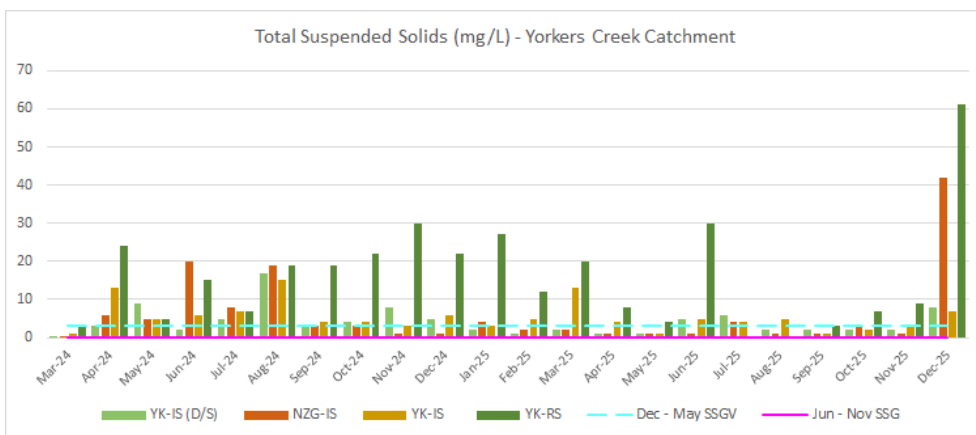
Total Suspended Solids (mg/L) exceeded the December-May SSGV at all sites except YR1-IS and YR2-IS in Yarrangobilly River Catchment and TR-RS at Talbingo Reservoir, which were below the LOR (Figure 22- Figure 24).

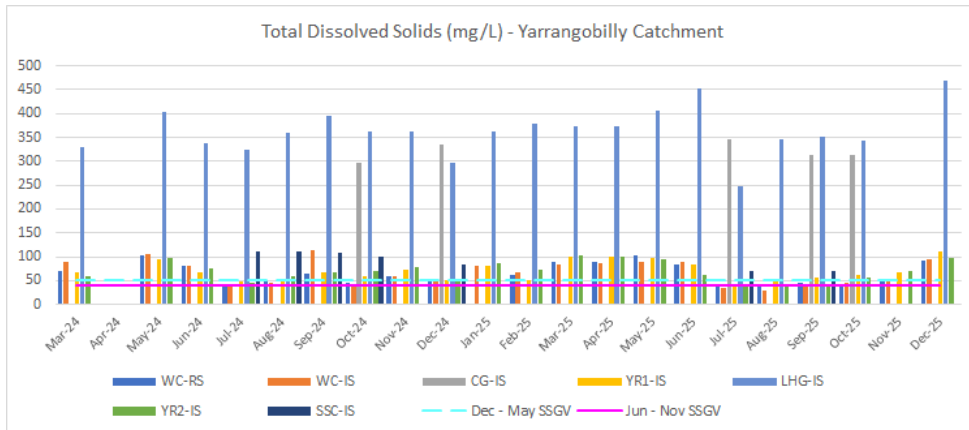
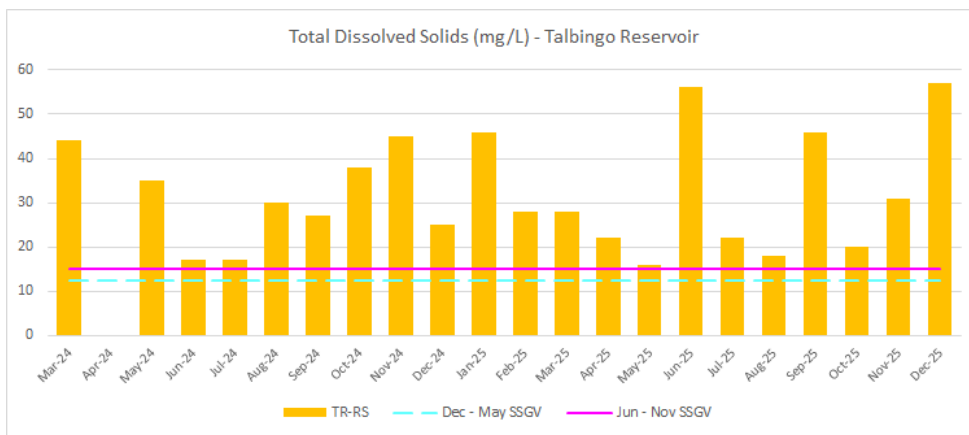
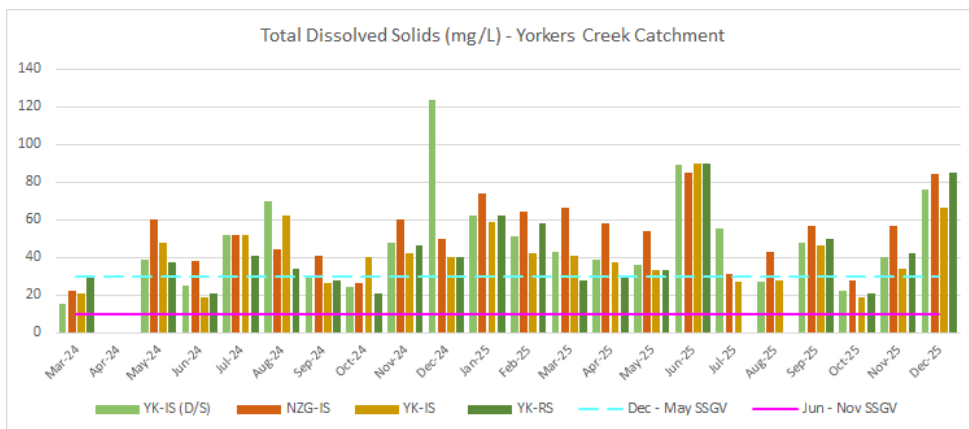
In December 2025, Total Dissolved Solids (mg/L) increased at each site compared with November 2025 values. All sites exceeded the December-May SSGV (Figure 25-Figure 27).

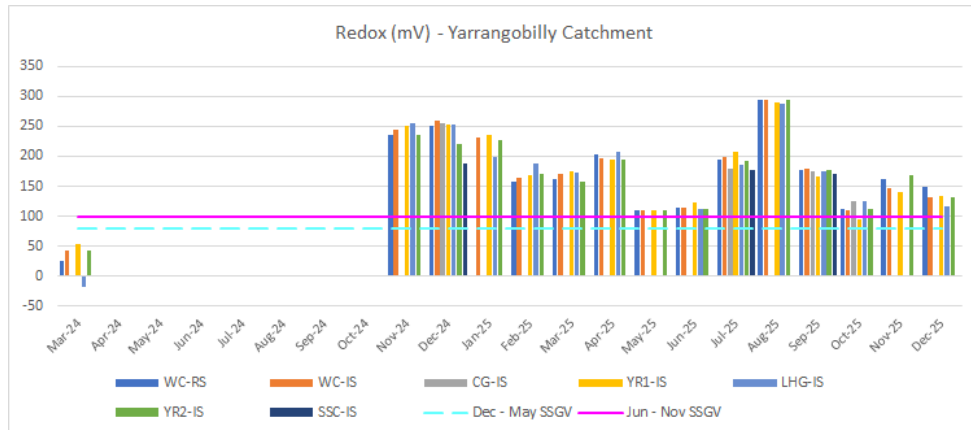
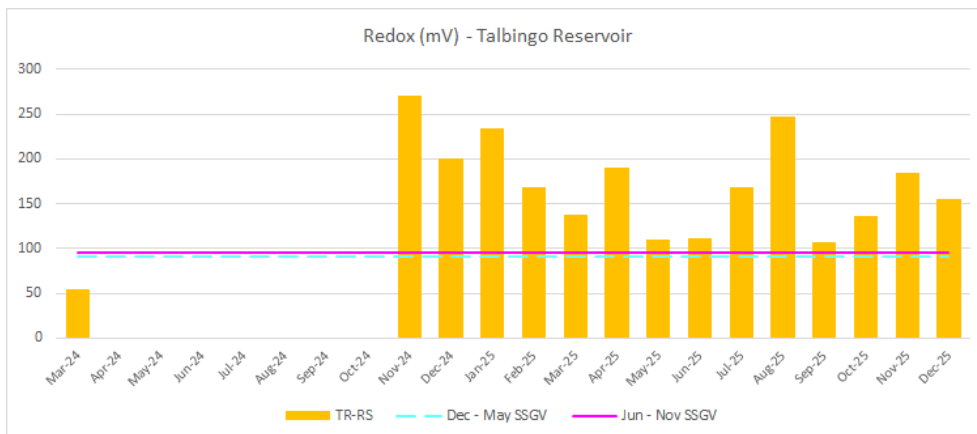
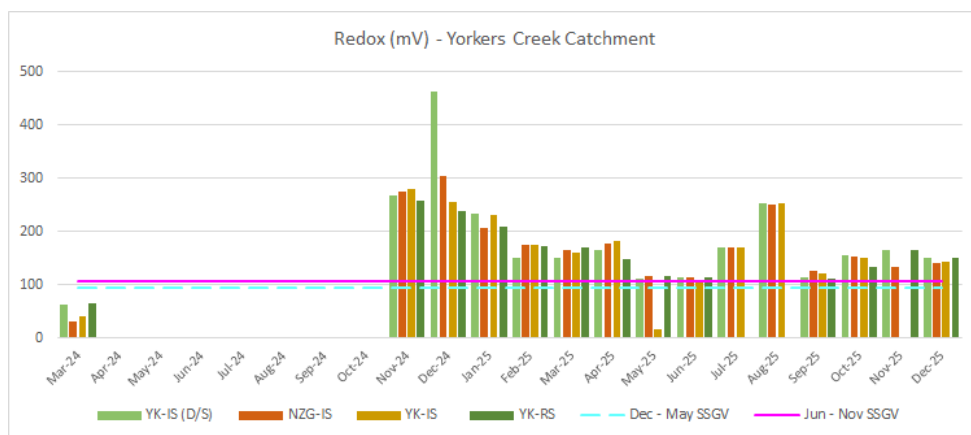
Redox (mV) results exhibited a general decrease during the December 2025 sampling period (Figure 28 – Figure 30). All sites across all catchments recorded values above the December – May SSGV.

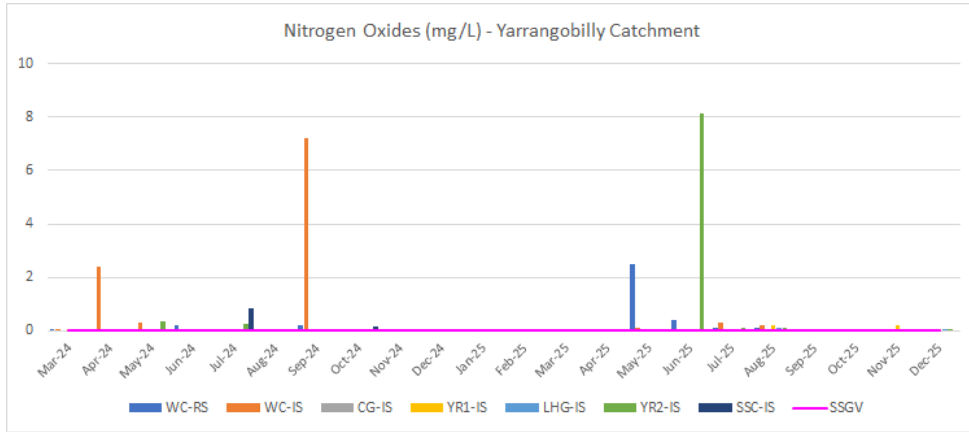
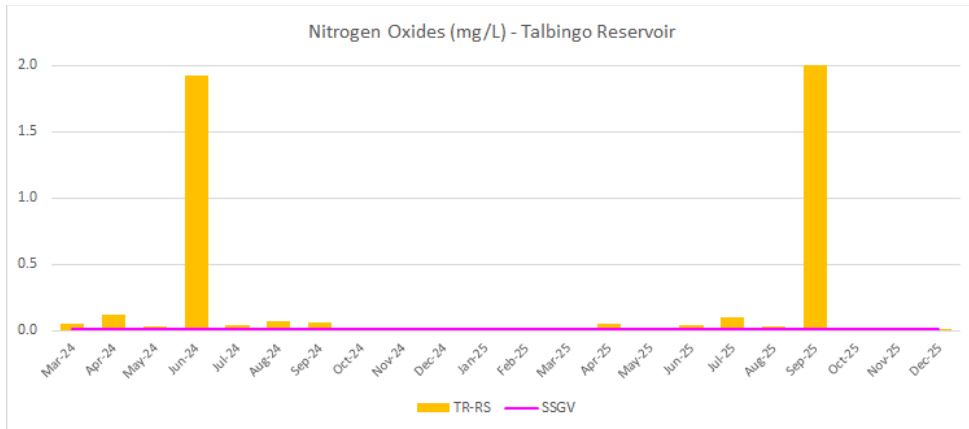
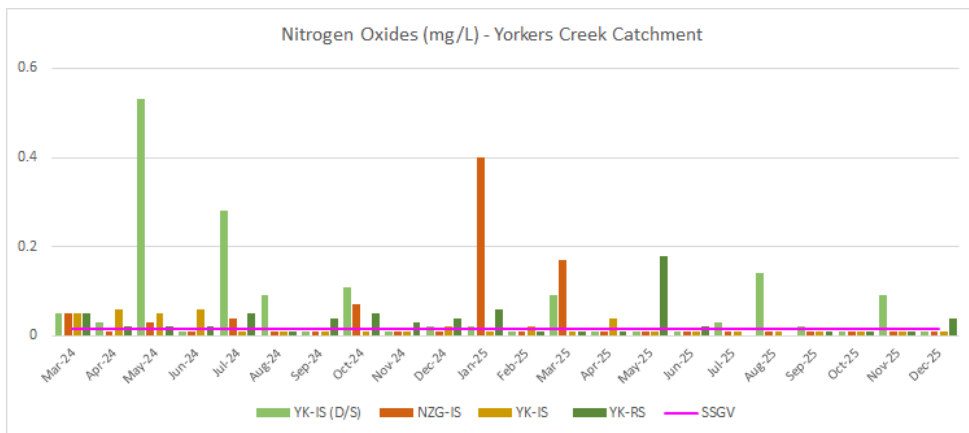
Nitrogen Oxides (mg/L) levels remained below the LOR during the December 2025 sampling period across all sites, except the reference sites at Yarrangobilly River Catchment (WC-RS) and Yorkers Creek Catchment (YK-RS), which were both above the December-May SSGV (Figure 31 – 33)

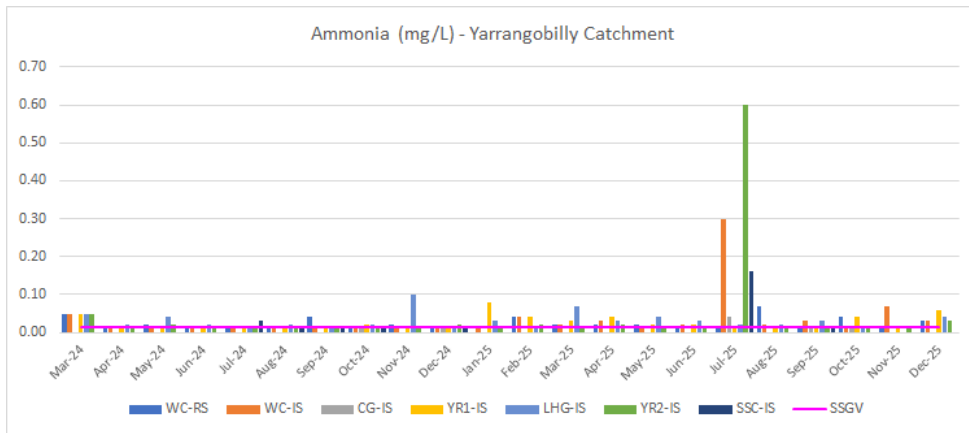
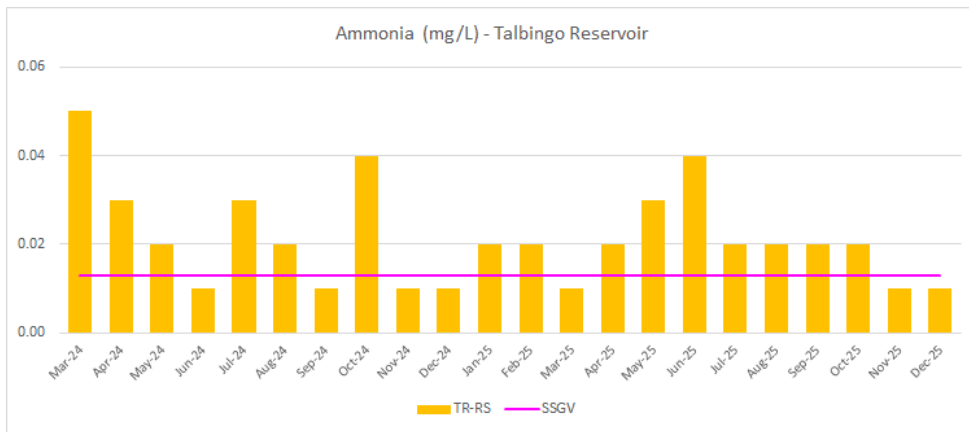
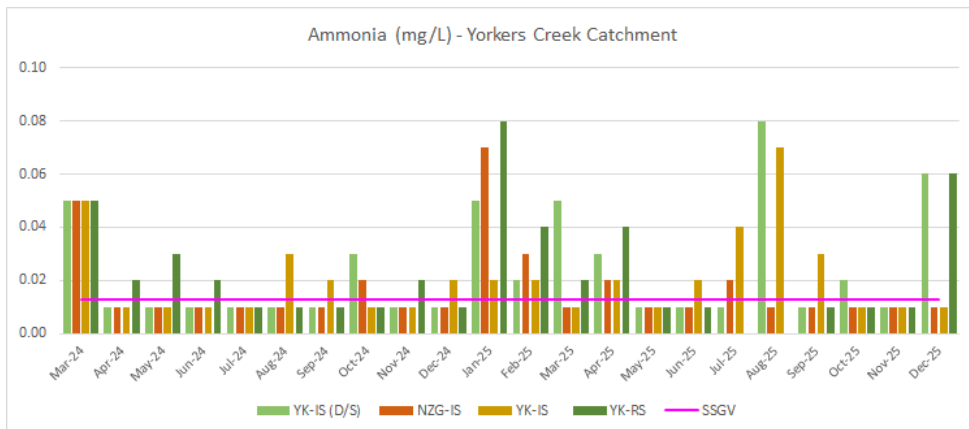
During the December 2025 sampling period, Ammonia (mg/L) concentrations exceeded the SSGV at all sites within Yarrangobilly River Catchment (Figure 34). Talbingo Reservoir recorded values below the LOR (Figure 35). Exceedances were identified at YK-RS and YK-IS(D/S) in Yorkers Creek Catchment, with the remaining sites below the LOR (Figure 36).

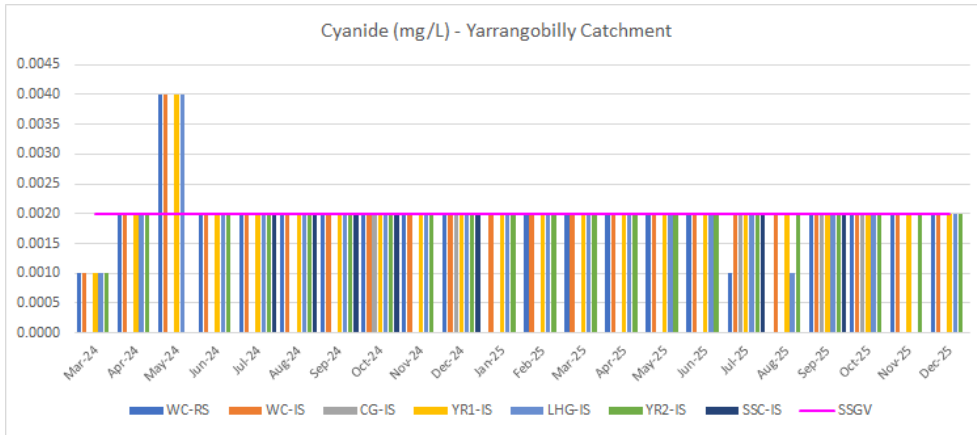
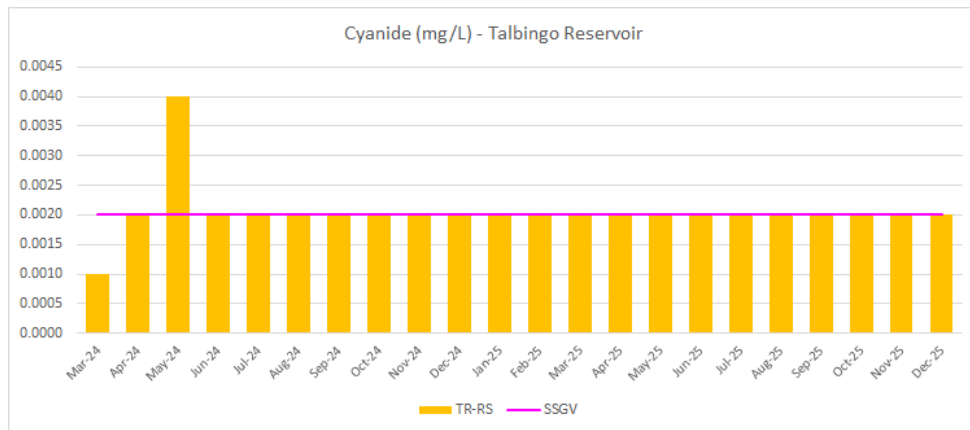
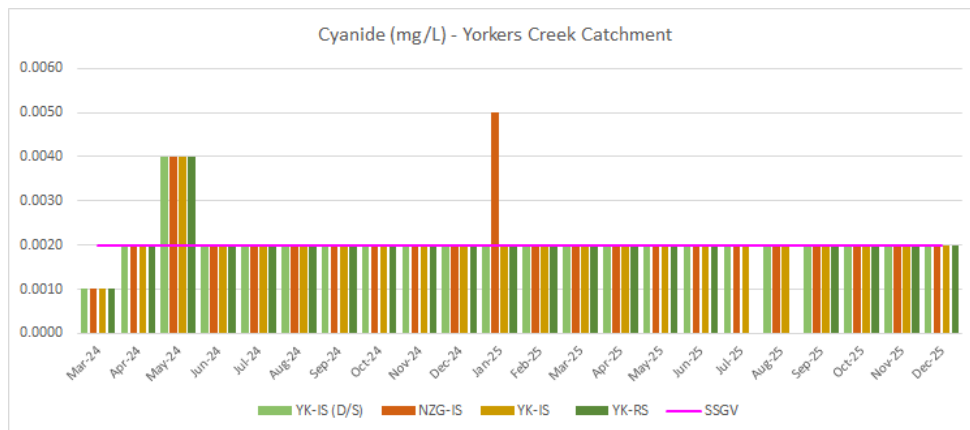
Cyanide (mg/L) concentration was below the LOR at all sites across all three catchments, refer Figure 37 to Figure 38.

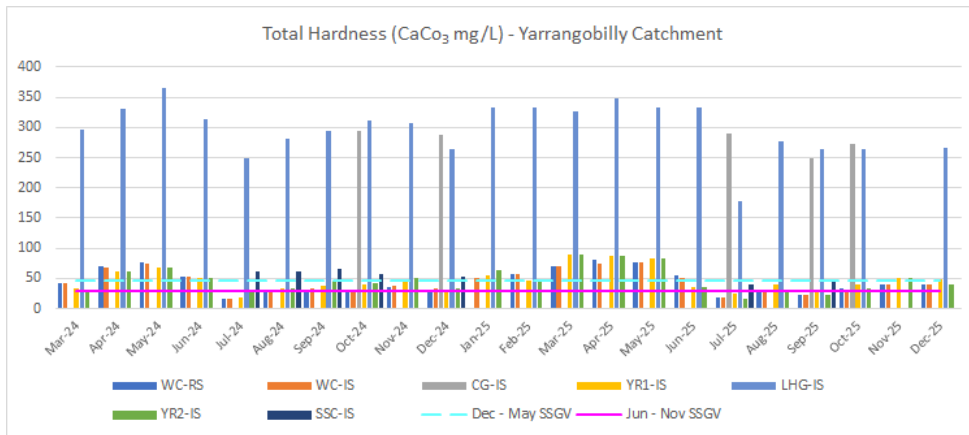
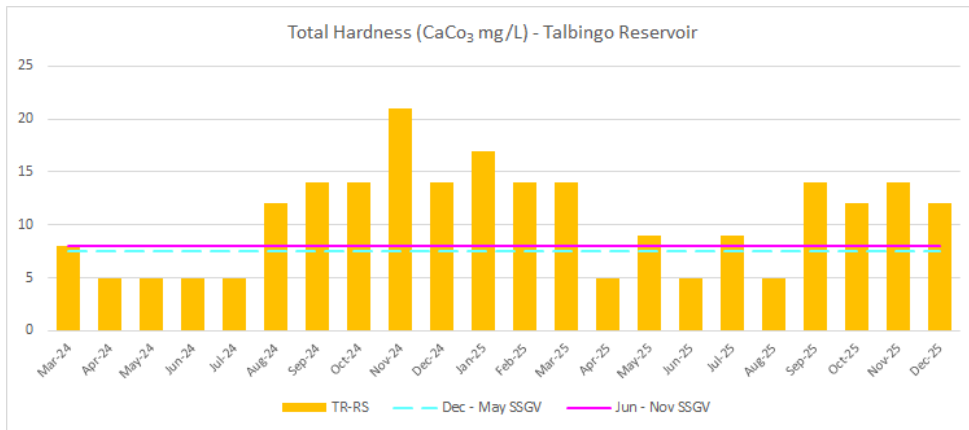
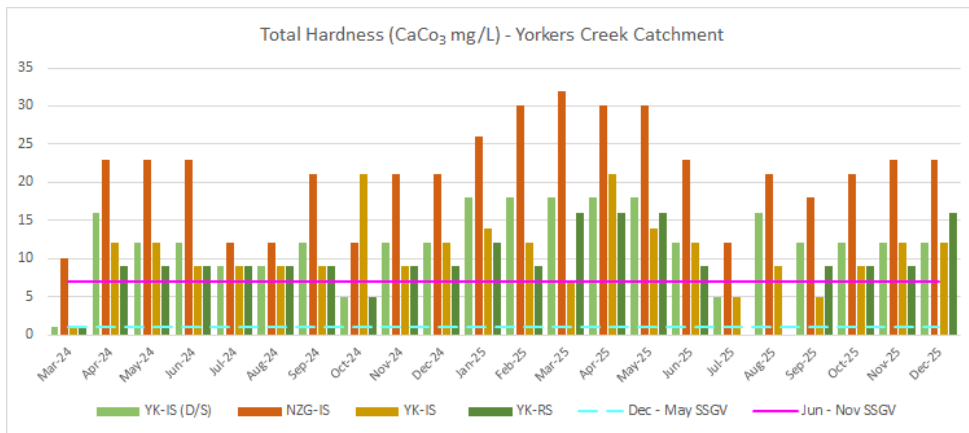
December 2025 Total Hardness results were below the December-May SSGV in Yarrangobilly River Catchment, except for LHG-IS and YR1-IS, which exceeded the SSGV (Figure 40). Similar to previous reporting periods, LGH-IS values were markedly high. All sites at Talbingo Reservoir and Yorkers Creek Catchment exceeded the December-May SSGV (Figure 41—42).

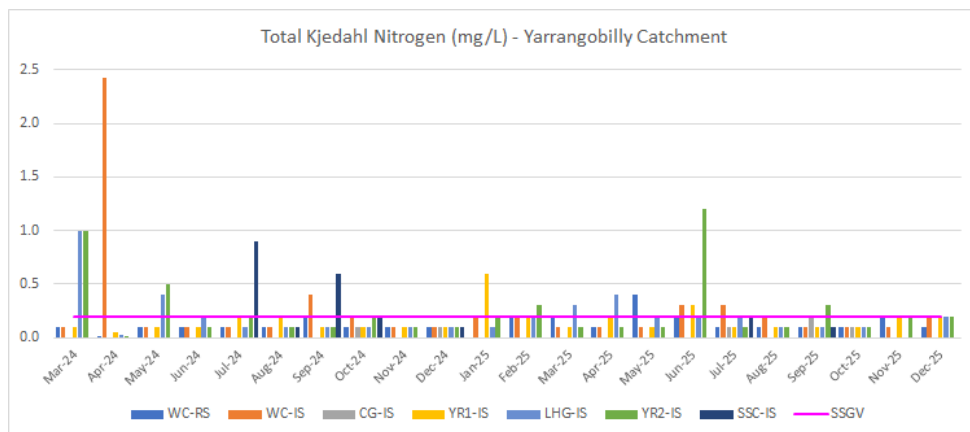
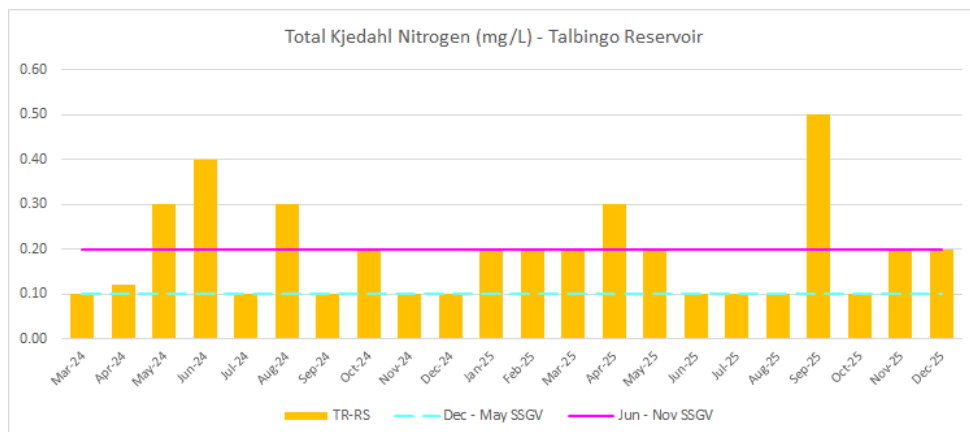
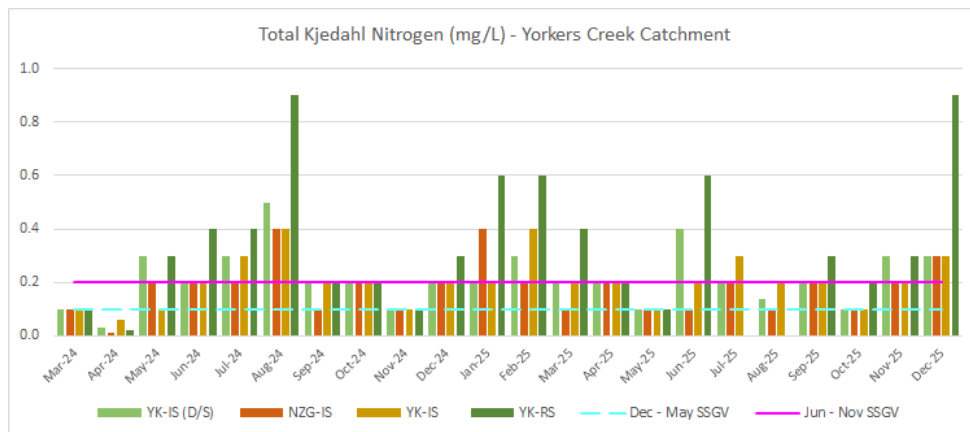
During the December 2025 sampling period, all sites within Yarrangobilly River Catchment recorded values for Total Kjeldahl Nitrogen (mg/L) on-par with the SSGV or below the LOR (Figure 43). In contrast, sites at Talbingo Reservoir and Yorkers Creek Catchment exceeded the SSGV, with a notable increase at the Yorkers Creek Catchment reference site (YK-RS), refer Figure 44—45.

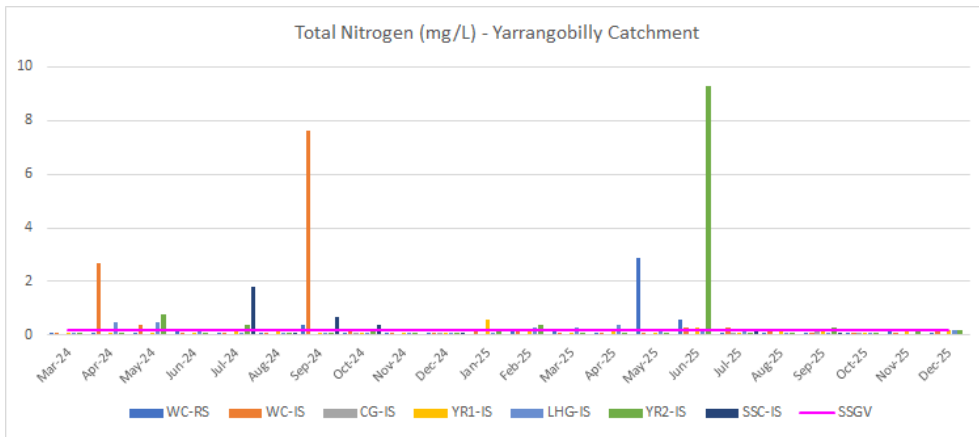
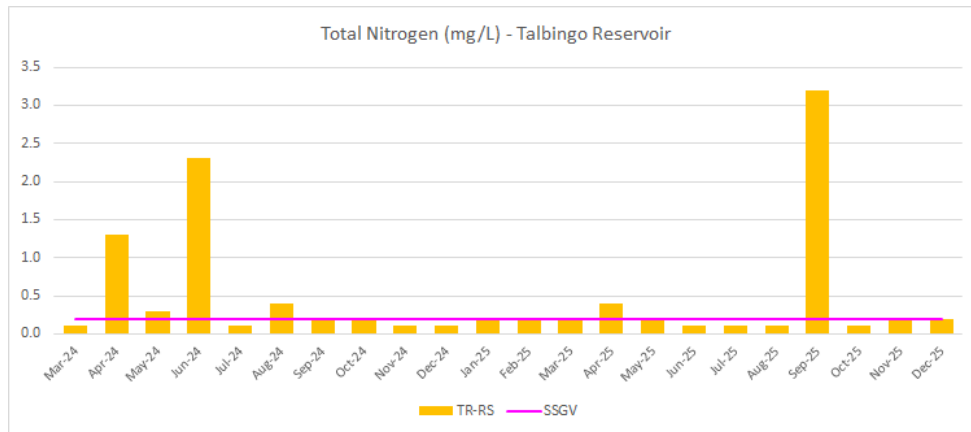
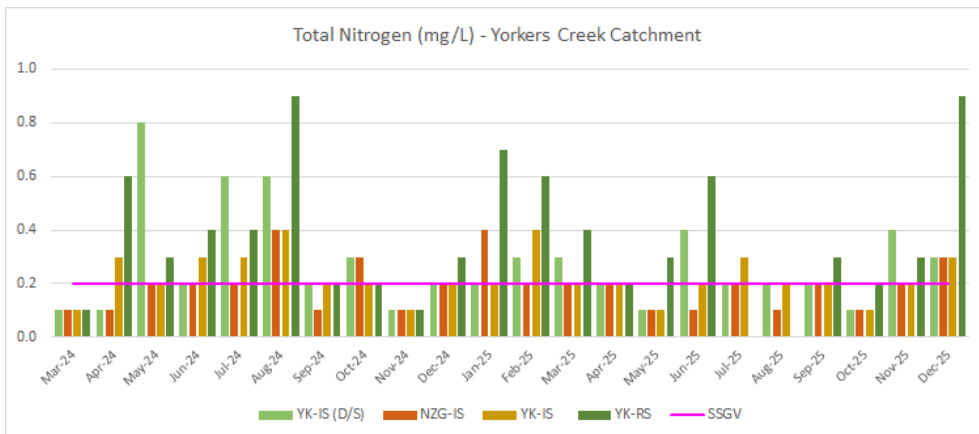
TN (mg/L) results for the December 2025 sampling period were on-par with the SSGV or below the LOR at all sites across Yarrangobilly River Catchment and Talbingo Reservoir (Figure 46-Figure 47). A marked increase in TN was exhibited at YK-RS, which increased from 0.3mg/L to 0.9mg/L (Figure 48).
