MONTHLY CONSTRUCTION WATER QUALITY MONITORING REPORT

December 2025
Project No.: 3200-0645
Project: Transgrid Maragle 500/330 kV Substation
Private & Confidential

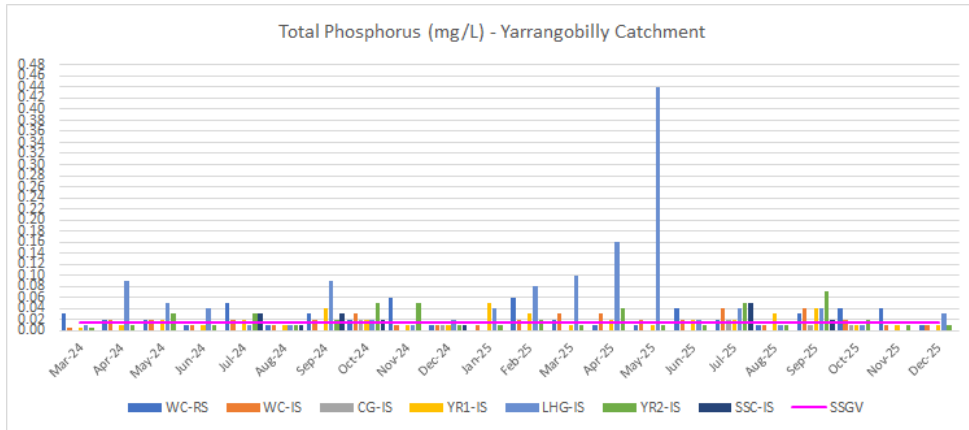
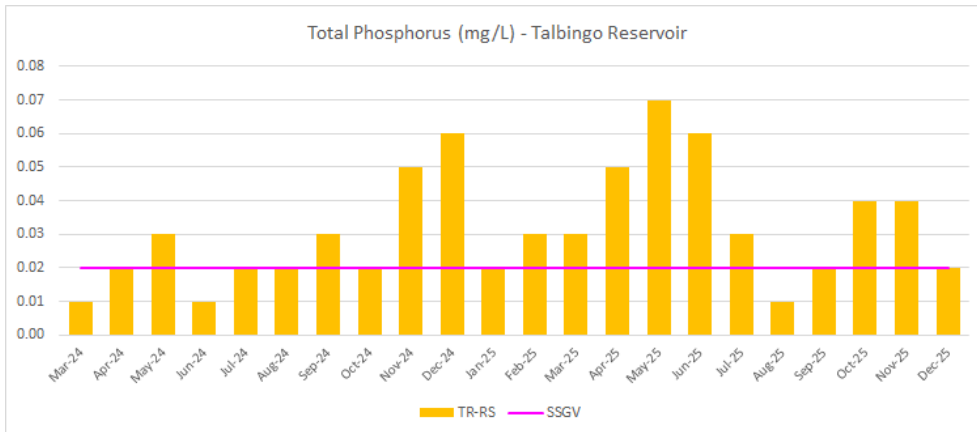
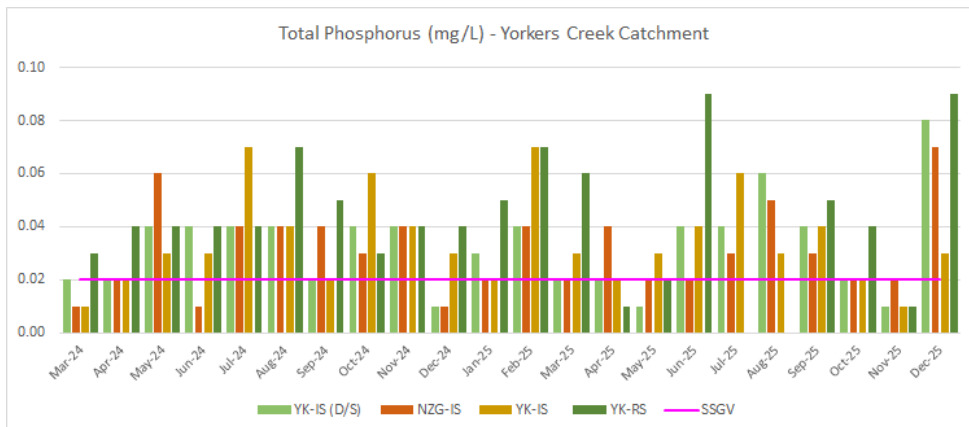
During the December 2025 sampling period, a marginal Total Phosphorus (TP, mg/L) SSGV exceedance was recorded at LHG-IS in Yarrangobilly River Catchment (Figure 49). Talbingo Reservoir (TR-RS) recorded a TP value on-par with the SSGV (Figure 50). All sites across Yorkers Creek Catchment exceeded the SSGV and exhibited a marked increase compared to November 2025 values (Figure 51).

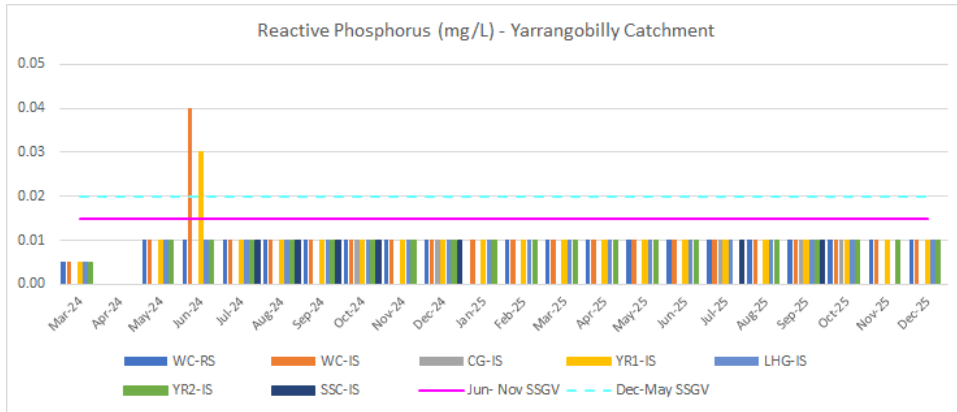
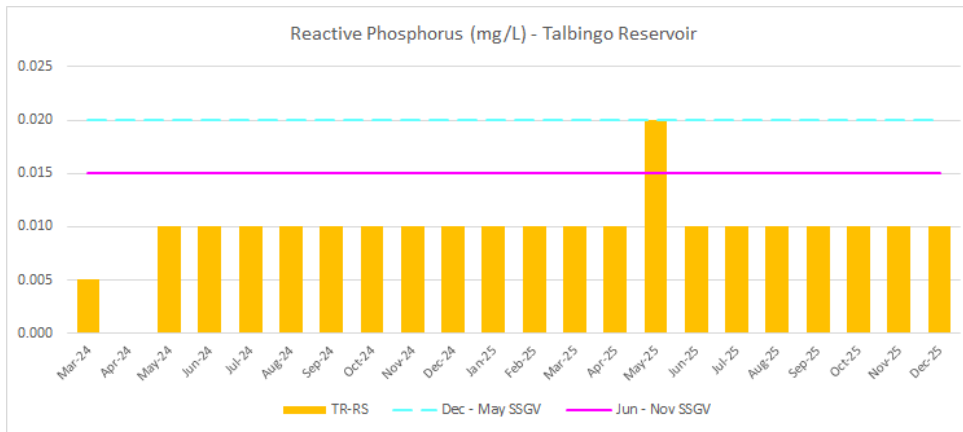
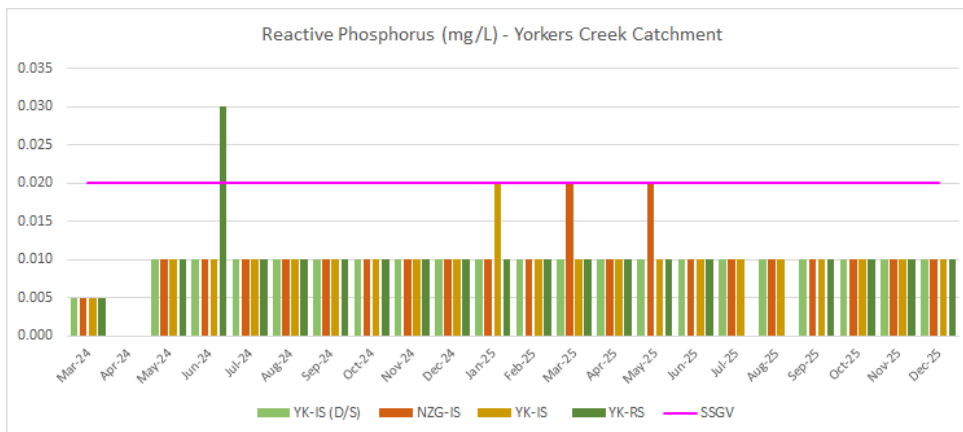
All sites measured below the LOR for RP (mg/L), refer to Figure 51 to Figure 53.
