# MONTHLY CONSTRUCTION WATER QUALITY MONITORING REPORT

November 2025  
Project No.: 3200-0645  
Project: Transgrid Maragle 500/330 kV Substation  
Private & Confidential

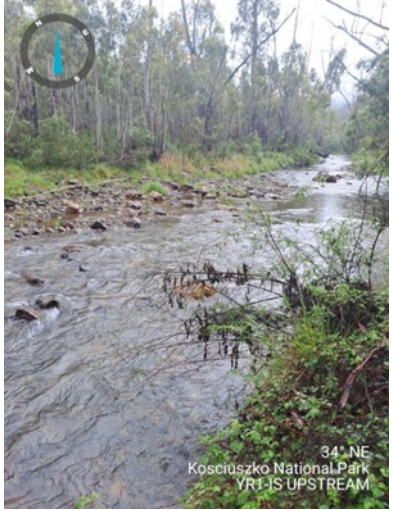
ID	Observations	Photo
YR1-IS	<ul style="list-style-type: none"> <li>• Moderate flow</li> <li>• Clear water</li> <li>• Rocky bed and banks</li> <li>• Overhanging vegetation</li> <li>• Riparian vegetation predominantly groundcover</li> <li>• Moderate weed density including Blackberry (<i>Rubus fruticosus</i>)</li> <li>• Monitoring location is adjacent to bridge and electrical transmission tower on top of rocky cliff and Snowy 2.0 laydown area</li> </ul>

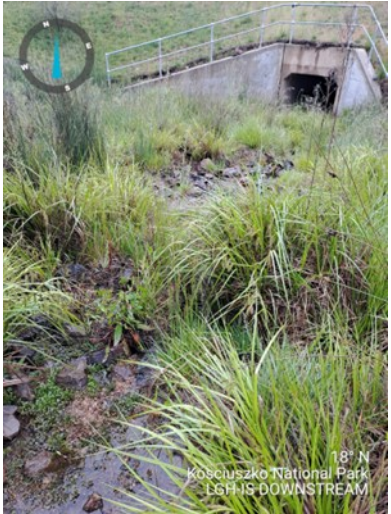
LHG-IS	<ul style="list-style-type: none"> <li>• No flow, dry</li> </ul>

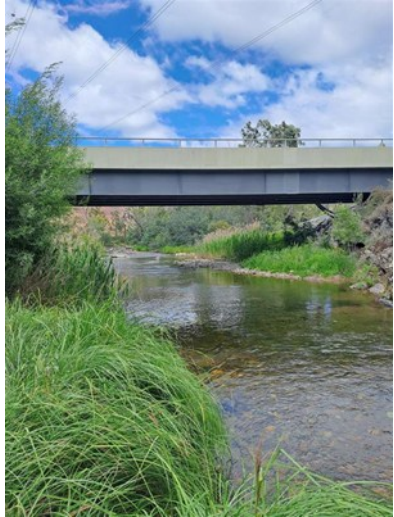
ID	Observations	Photo
YR2-IS	<ul style="list-style-type: none"> <li>• Low flow</li> <li>• Clear water</li> <li>• Moderate weed density including Thistle and Blackberry (<i>Rubus fruticosus</i>)</li> <li>• Riparian vegetation consisted of groundcover, shrubs and trees</li> <li>• Rocky banks with sections of exposed soil higher up the bank</li> <li>• Presence of aquatic vegetation</li> </ul>

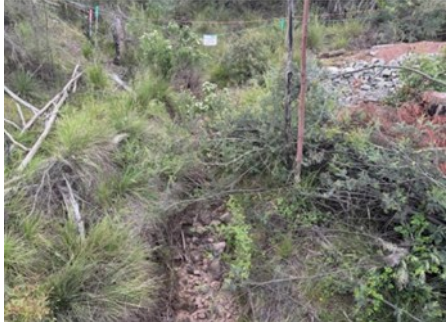
SSC-IS	<ul style="list-style-type: none"> <li>• No flow, dry</li> </ul>

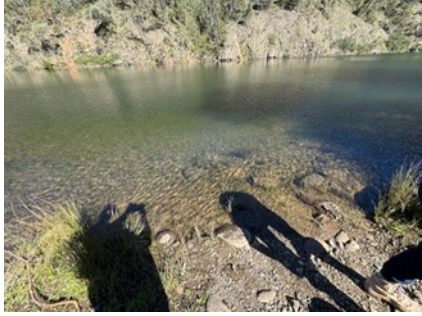
ID	Observations	Photo
TR-RS	<ul style="list-style-type: none"> <li>• Rocky banks and sandy bed</li> <li>• Monitoring location is adjacent to publicly accessible O'Hares Campground and Talbingo Reservoir ancillary infrastructure</li> <li>• Presence of aquatic vegetation and vertebrates</li> <li>• Clear water</li> <li>• High low water volume</li> <li>• Riparian vegetation consisted of groundcover and trees</li> <li>• Presence of organic detritus</li> <li>• Low weed density</li> </ul>

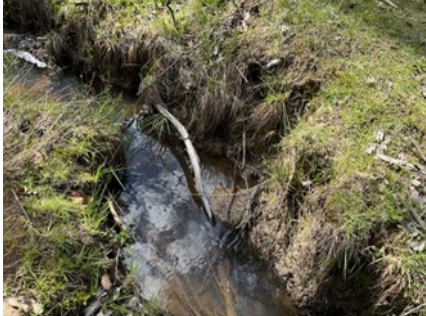
YK-RS	<ul style="list-style-type: none"> <li>• Low flow</li> <li>• Low weed density including Blackberry (<i>Rubus fruticosus</i>)</li> <li>• Undercut bed with eroded banks and sandy bed</li> <li>• Riparian vegetation consisted of groundcover, overhanging vegetation and trees</li> <li>• Slightly murky water</li> <li>• Monitoring location is adjacent to publicly accessible four-wheel drive (4WD) track</li> <li>• Presence of horse scats</li> <li>• Vegetative detritus in water</li> <li>• Presence of vegetative detritus</li> </ul>

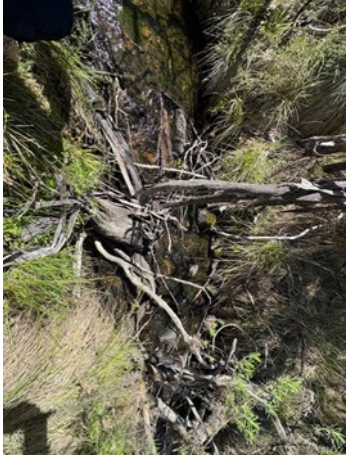
ID	Observations	Photo
YK-IS (D/S)	<ul style="list-style-type: none"> <li>• Low flow</li> <li>• Presence of aquatic vegetation including algae</li> <li>• Clear water</li> <li>• Vegetative detritus in water</li> <li>• Riparian vegetation consisted of groundcover, overhanging vegetation and trees</li> <li>• Low weed density including Blackberry (<i>Rubus fruticosus</i>)</li> <li>• Undermined banks and eroded banks</li> <li>• Monitoring location is adjacent to Elliot Way</li> </ul>

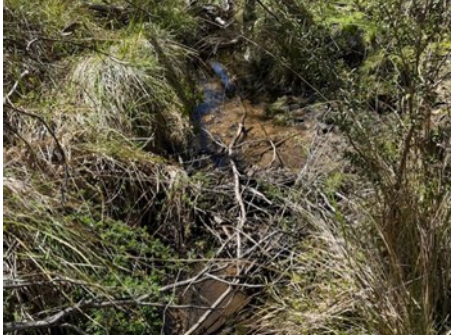
NZG-IS	<ul style="list-style-type: none"> <li>• Low flow</li> <li>• Presence of aquatic vegetation</li> <li>• Presence of organic detritus</li> <li>• Overhanging vegetation</li> <li>• Clear water</li> <li>• Moderate weed density including Blackberry (<i>Rubus fruticosus</i>)</li> <li>• Monitoring location is adjacent to publicly accessible 4WD track</li> <li>• Eroded and undermined banks and pebbly bed</li> <li>• Riparian vegetation consisted of groundcover and trees</li> </ul>

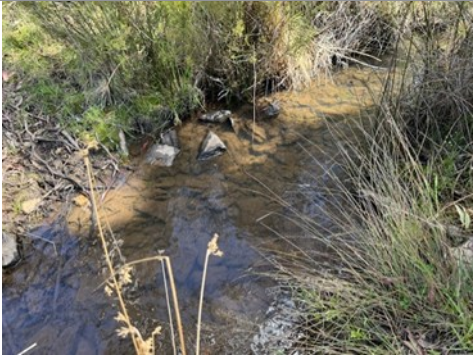
ID	Observations	Photo
YK-IS	<ul style="list-style-type: none"> <li>• Low flow</li> <li>• Clear water with slight milky tinge</li> <li>• Evidence of sediment deposition upstream of the creek</li> <li>• Eroded banks</li> <li>• Overhanging vegetation</li> <li>• Presence of vegetative detritus</li> <li>• HML activity</li> <li>• Riparian vegetation consisted of groundcover, shrubs and trees</li> <li>• Monitoring location is adjacent to Elliott Way, leading towards culvert</li> </ul>

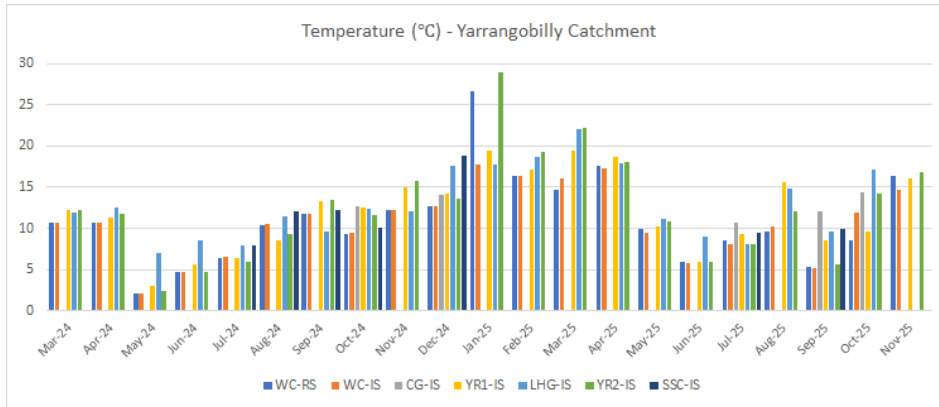
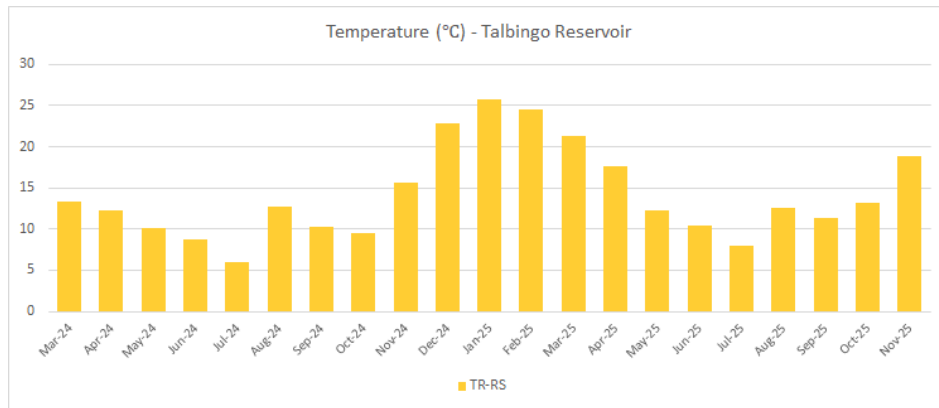
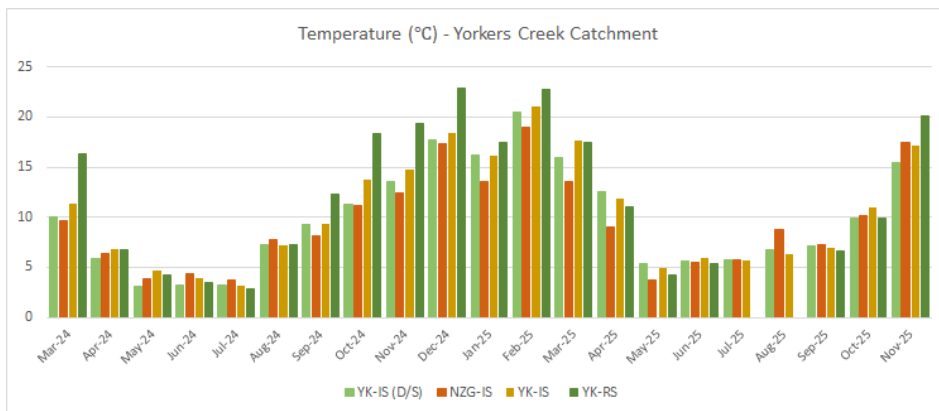
During November 2025, all three sampling locations exhibited an increase in temperature (°C) compared to October 2025. At both the Yarrangobilly River Catchment (Figure 4) and Talbingo Reservoir (Figure 5), the mean temperature increased by  $\approx 3^{\circ}\text{C}$  to  $\approx 16^{\circ}\text{C}$  and  $\approx 19^{\circ}\text{C}$  respectively. The largest temperature increase was evidenced at Yorkers Creek Catchment (Figure 6), where the mean temperature increased by  $\approx 7^{\circ}\text{C}$  to  $\approx 17^{\circ}\text{C}$ .

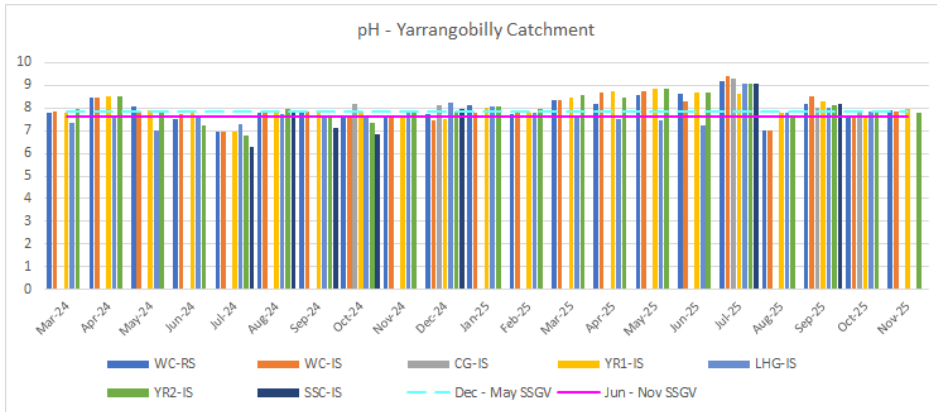
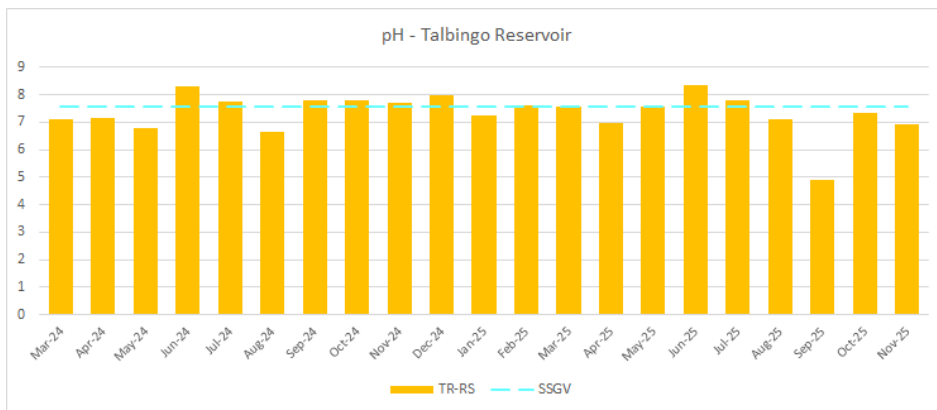
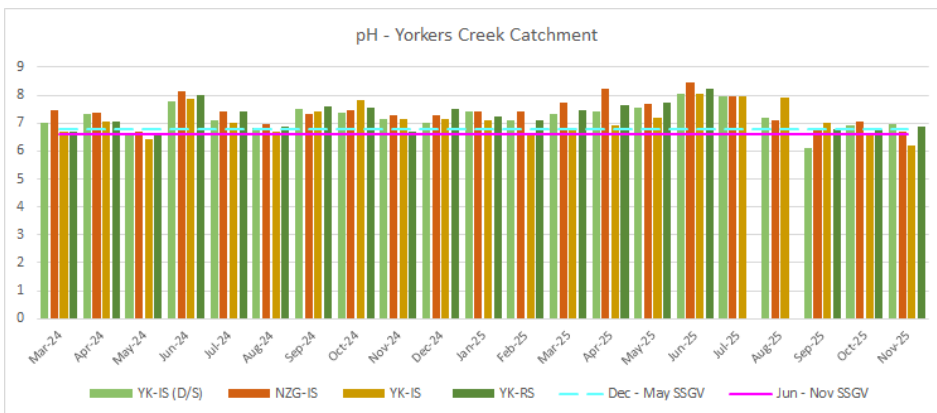
During the November 2025 sampling period, Yarrangobilly River Catchment pH results increased from October values and marginally exceeded the June—November SSGV value (Figure 7). Talbingo Reservoir exhibited a decrease in pH values to ≈6.91pH (Figure 8) and continued to trend below the SSGV for the fourth consecutive month. Yorkers Creek Catchment pH values were above the June – November SSGV at all sites except YK-IS, which recorded ≈6.18pH in November 2025 (Figure 9).

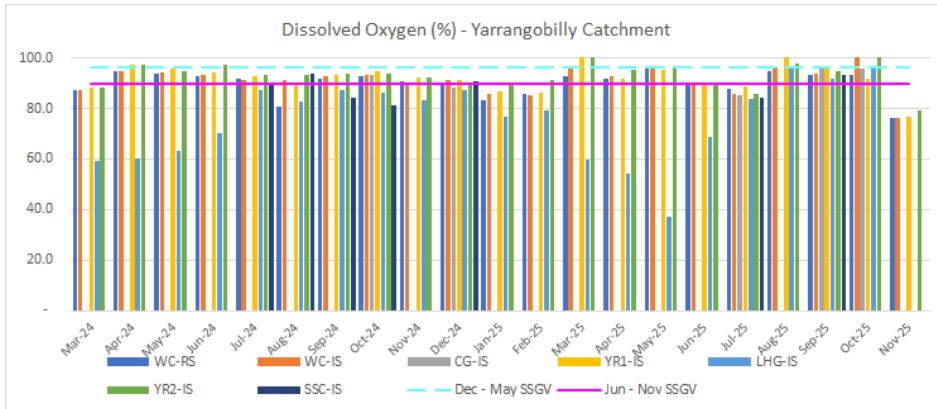
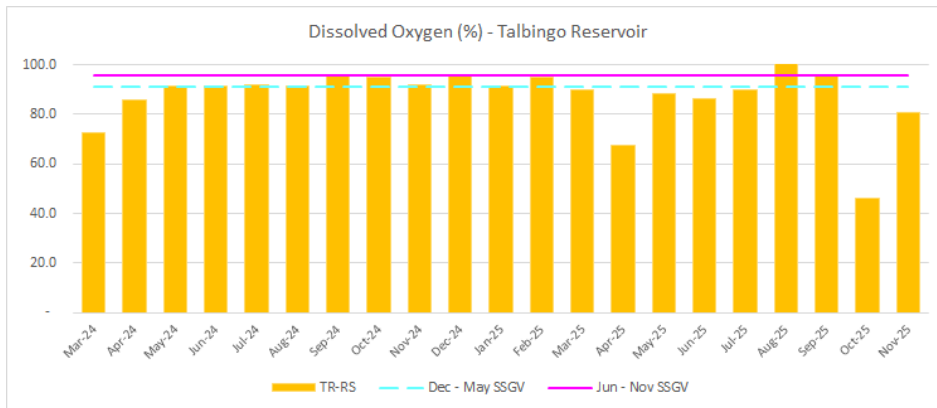
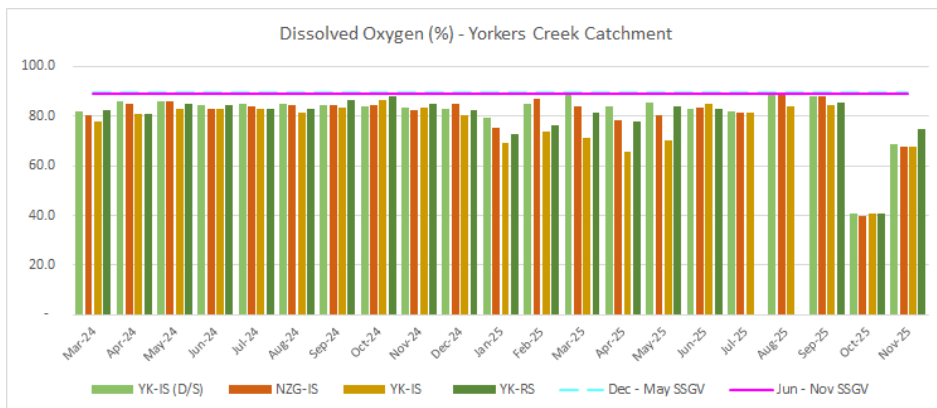
During the November 2025 sampling period, Yarrangobilly River Catchment DO (%) was below October 2025 results and below the June–November SSGV at all sites (Figure 10). DO (%) at Talbingo Reservoir improved markedly in November 2025 to 80.7%, albeit trending below the June–November SSGV (Figure 11). Yorkers Creek Catchment presented similar results to Talbingo Reservoir, with marked improvements in DO (%) levels across all sites (Figure 12).

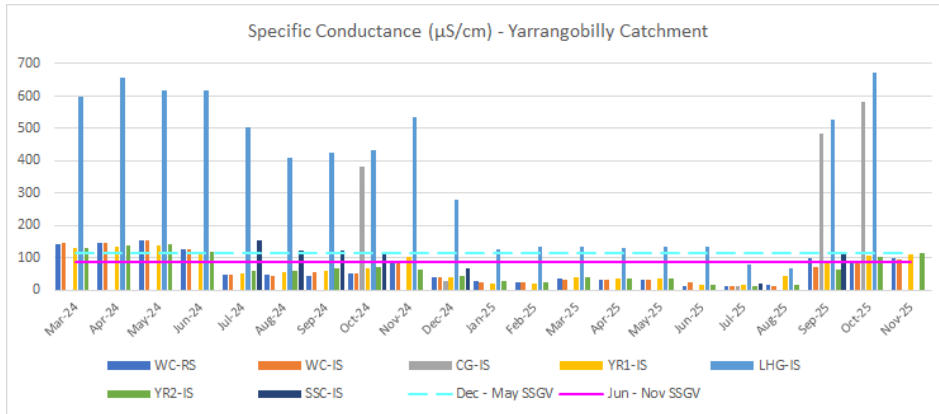
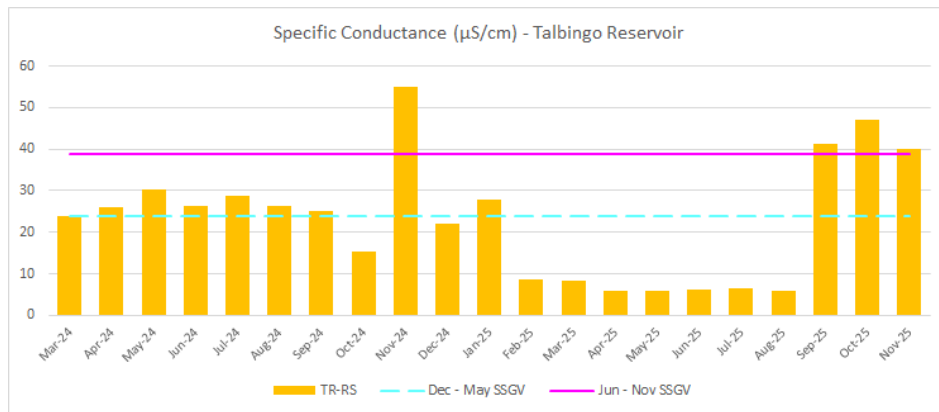
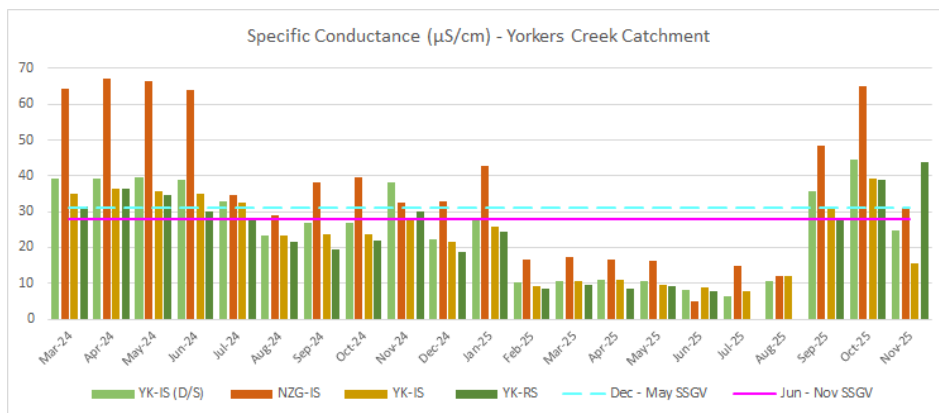
November 2025 specific conductance ( $\mu\text{S}/\text{cm}$ ) values exceeded the June – November SSGV at all sites within the Yarrangobilly River Catchment (Figure 13). Talbingo Reservoir (TR-RS) specific conductance ( $\mu\text{S}/\text{cm}$ ) value marginally exceeded the June – November SSGV (Figure 14). An exceedance was recorded in Yorkers Creek Catchment at YK-RS and NZG-IS (Figure 15).

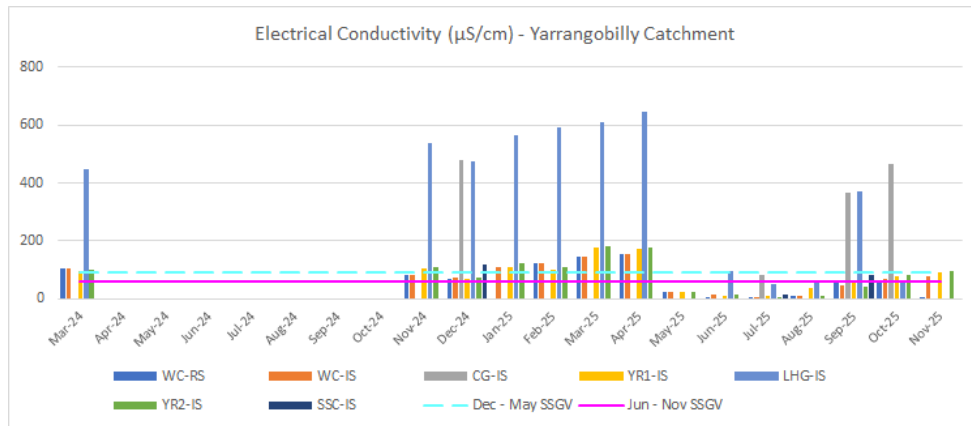
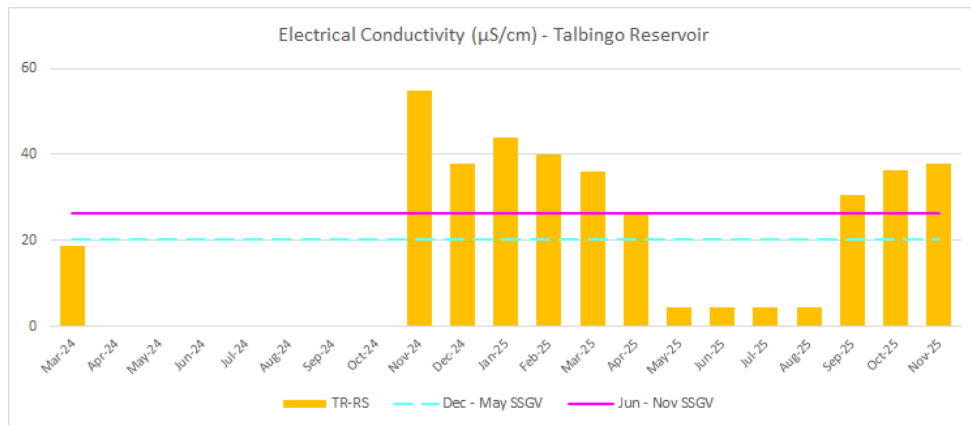
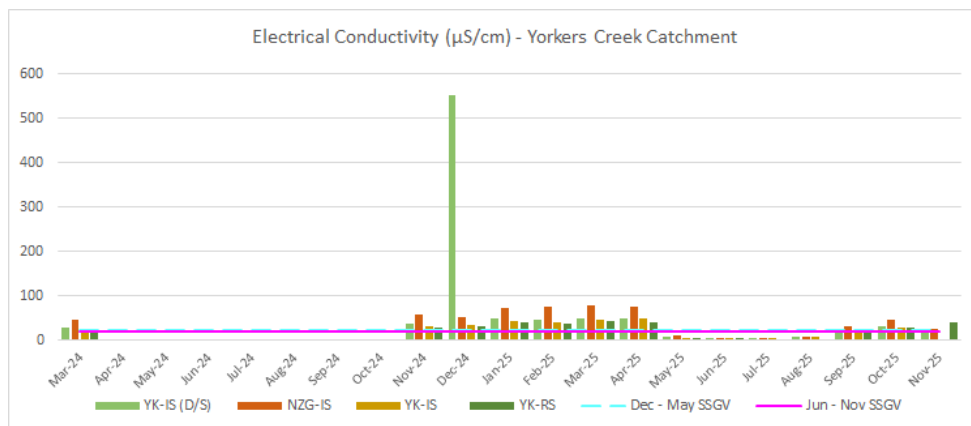
In November 2025, Electrical Conductivity (EC,  $\mu\text{S}/\text{cm}$ ) exceeded June-November SSGV across all three catchments (Yarrangobilly River Catchment in Figure 16, Talbingo Reservoir in Figure 17, Yorkers Creek Catchment in Figure 18), except WC-RS and YK-IS(D/S) which were below October 2025 results and below the June-November SSGV.

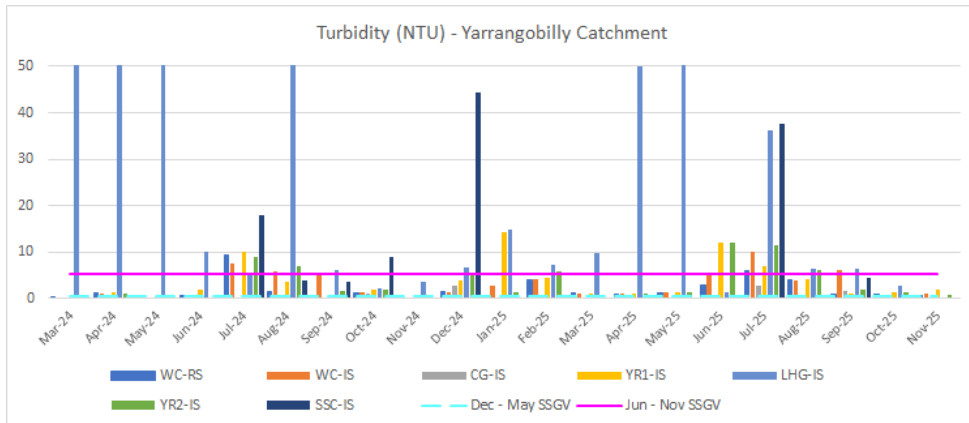
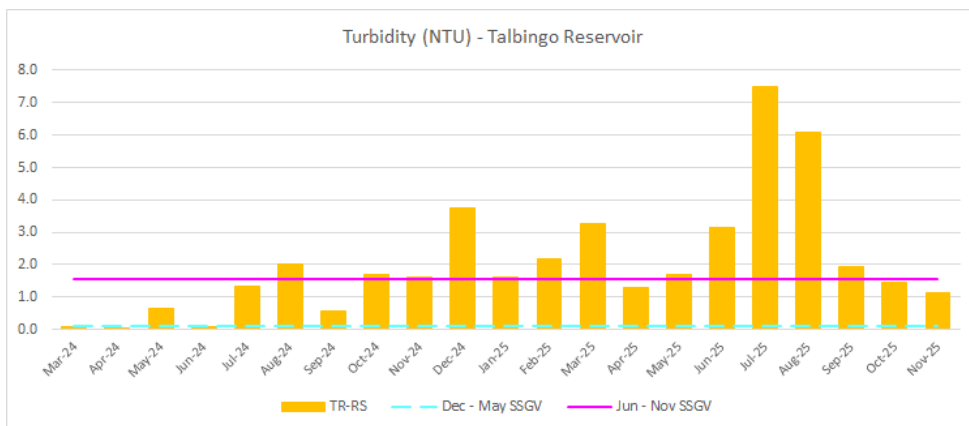
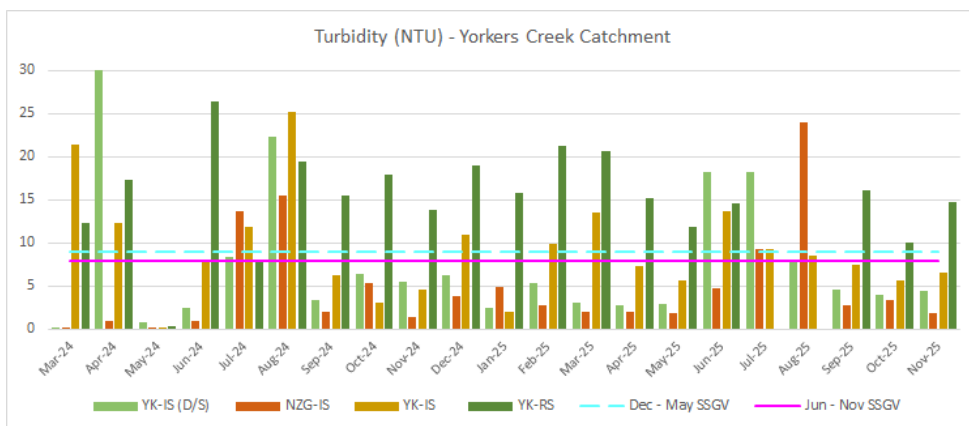
In November 2025, Turbidity (NTU) results were generally below the June—November SSGV (Figure 19—21) with only one exceedance recorded from YK-RS (14.8NTU) in the Yorkers Creek Catchment (Figure 21).

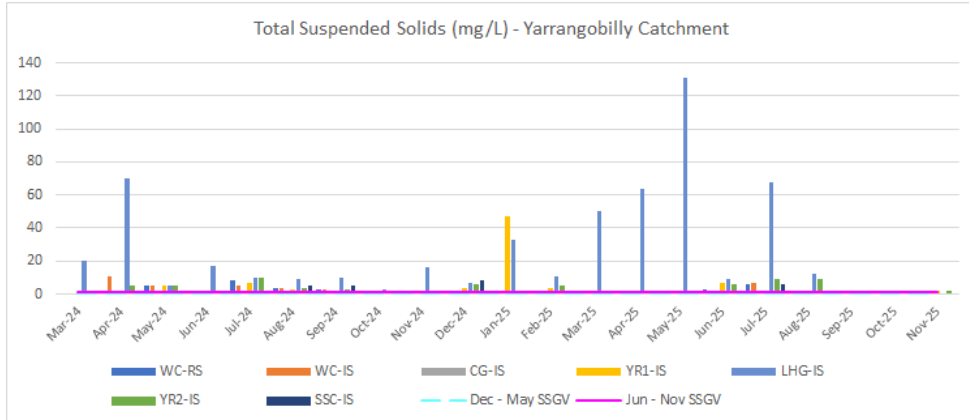
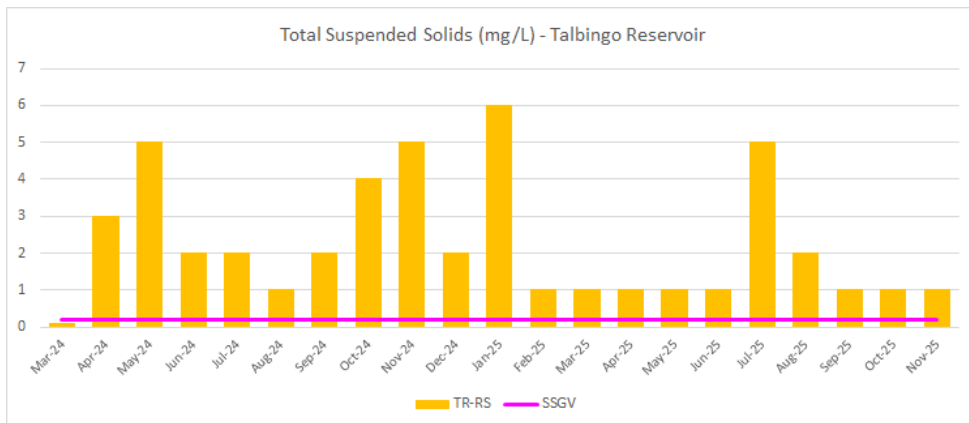
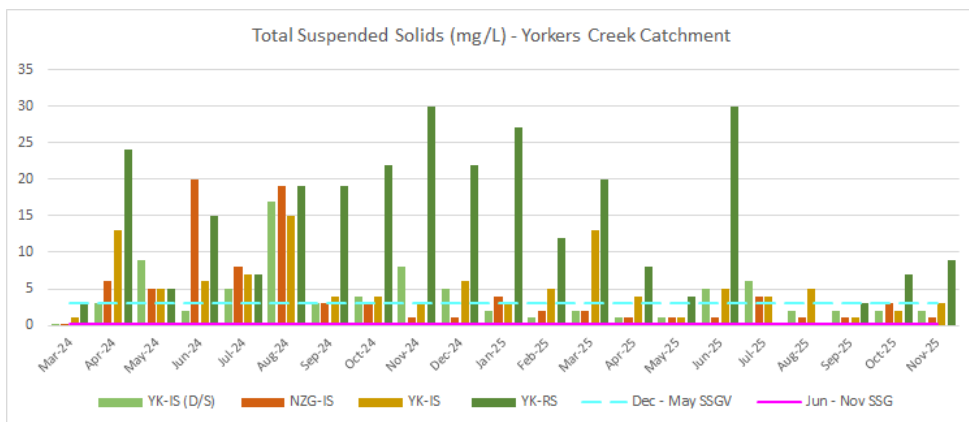
In November 2025, Total Suspended Solids (TSS, mg/L) maintained similar results compared to October 2025 (Figure 22—24). A moderate increase in TSS (mg/L) was recorded at YK-RS in the Yorkers Creek Catchment (Figure 24).

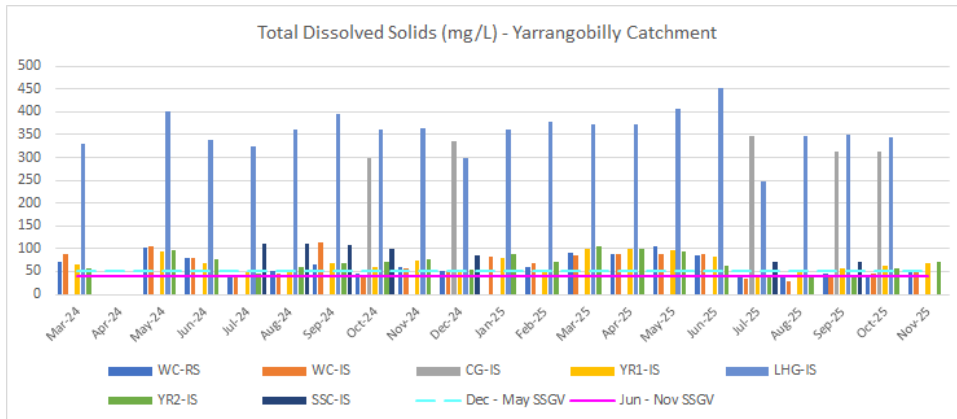
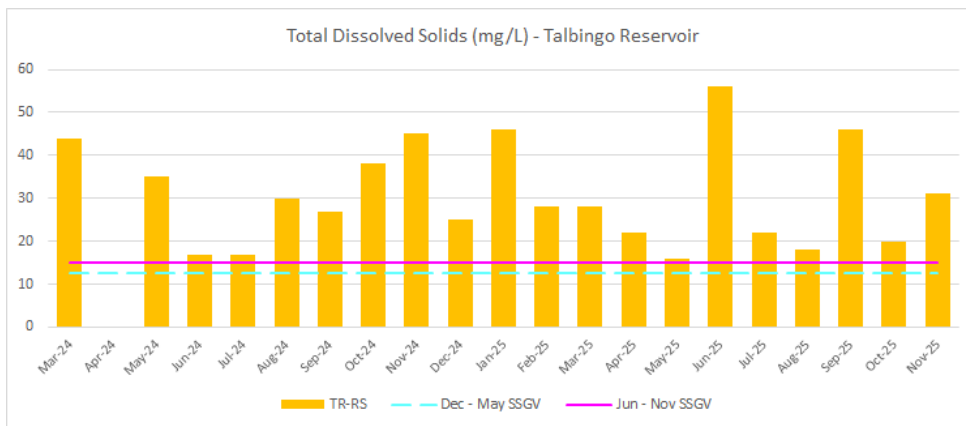
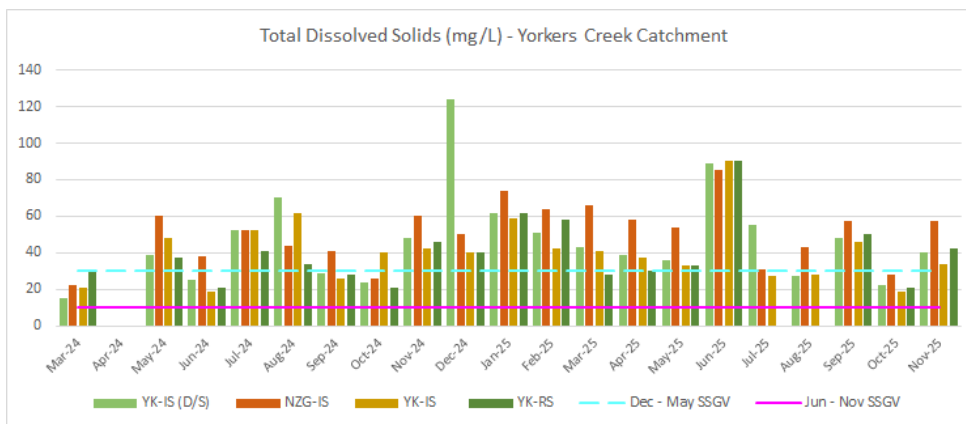
In the November 2025 sampling period, Total Dissolved Solids (mg/L) values exceeded the June-November SSGV at all sites across all catchments (Figure 25 – 27).

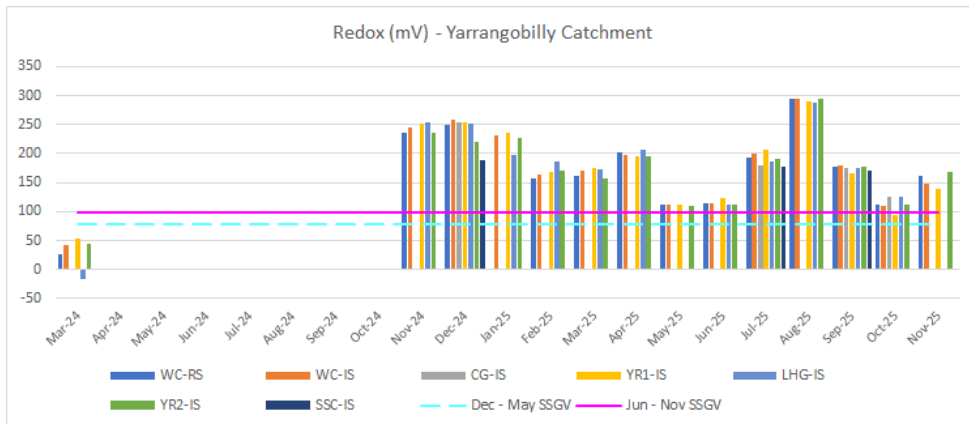
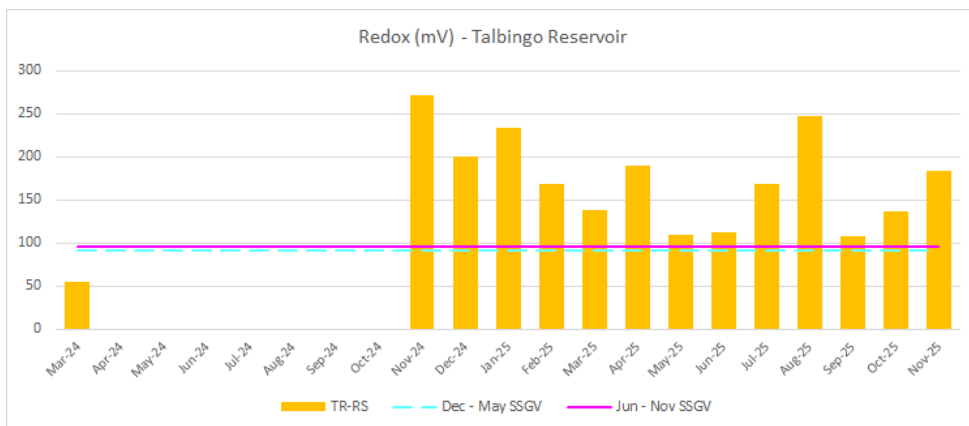
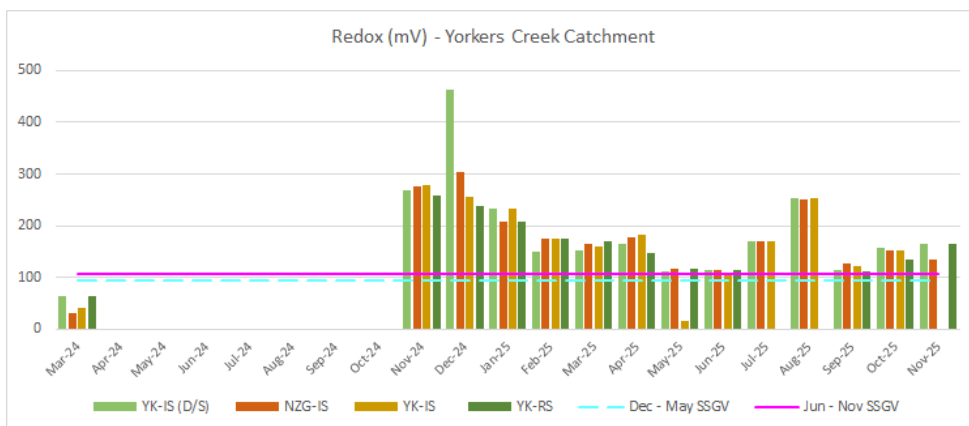
All Redox (mV) results for November 2025 exhibited an increase compared with October 2025 across all catchments (Yarrangobilly River Catchment, Talbingo Reservoir, Yorkers Creek Catchment). All sites exceeded the June-November SSGV (Figure 28-Figure30).

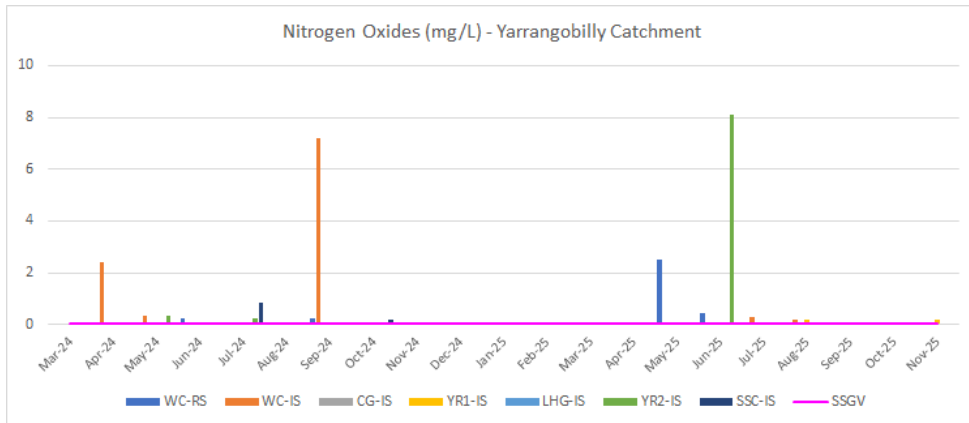
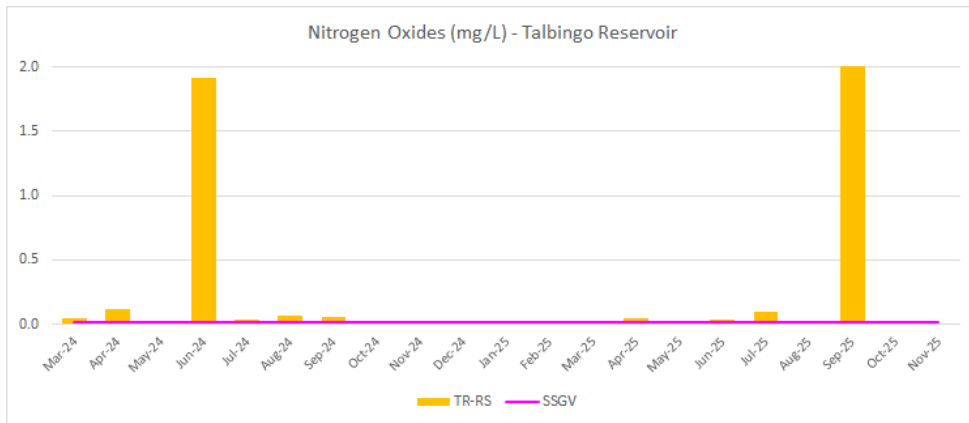
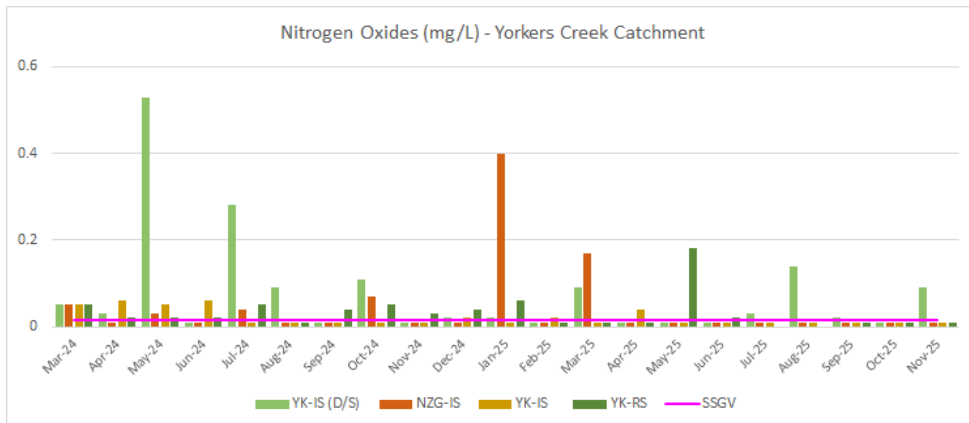
During the November 2025 sampling period, Nitrogen Oxides (mg/L) levels remained below the LOR across all sites in all catchments, except for YR1-IS and YK-IS(D/S), which were above the SSGV (Figure 31 – 33).

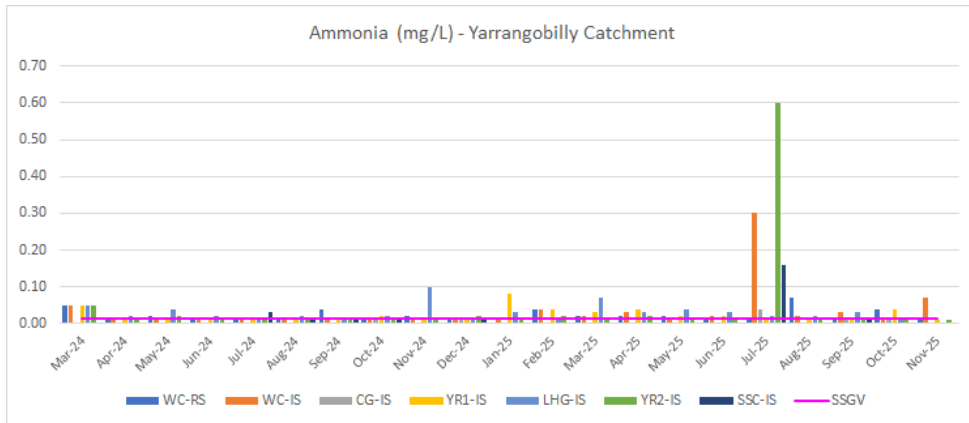
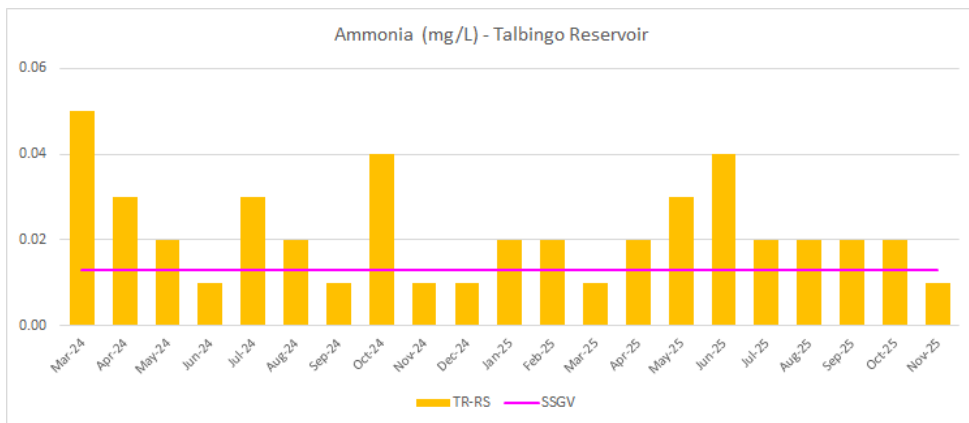
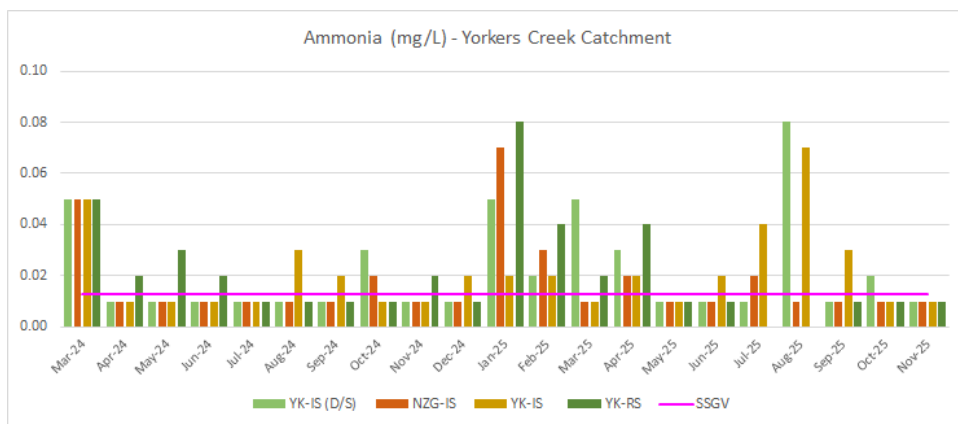
Ammonia (mg/L) concentrations during the November 2025 sampling period were below the LOR across all sites in all catchments (Figure 34—36), except WC-IS in Yarrangobilly River Catchment, which was above the SSGV (Figure 34).

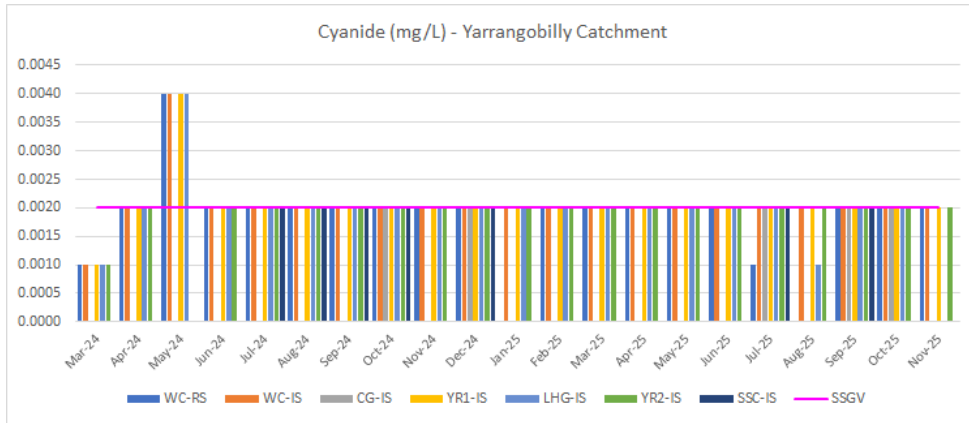
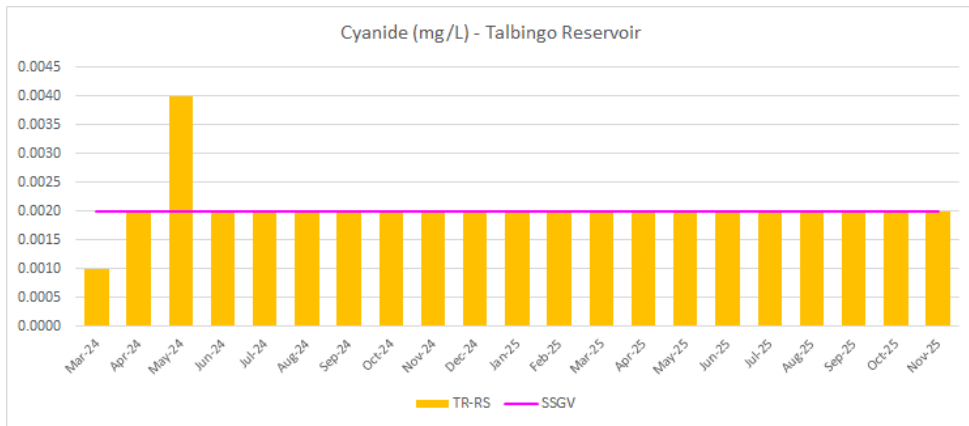
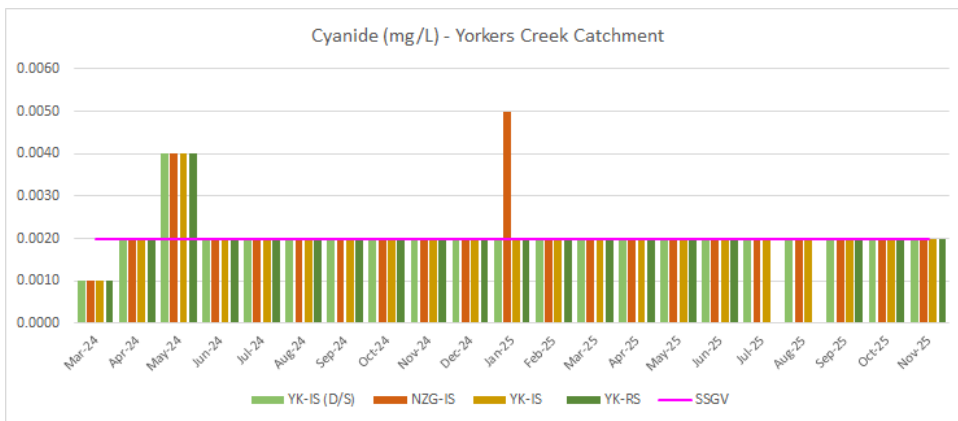
Cyanide (mg/L) concentration was below the LOR at all sites across all three catchments (Figure 37 to Figure 38).

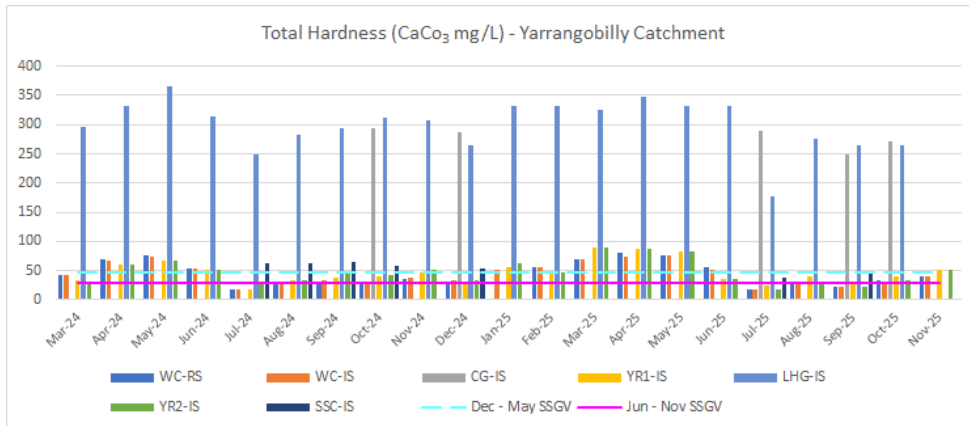
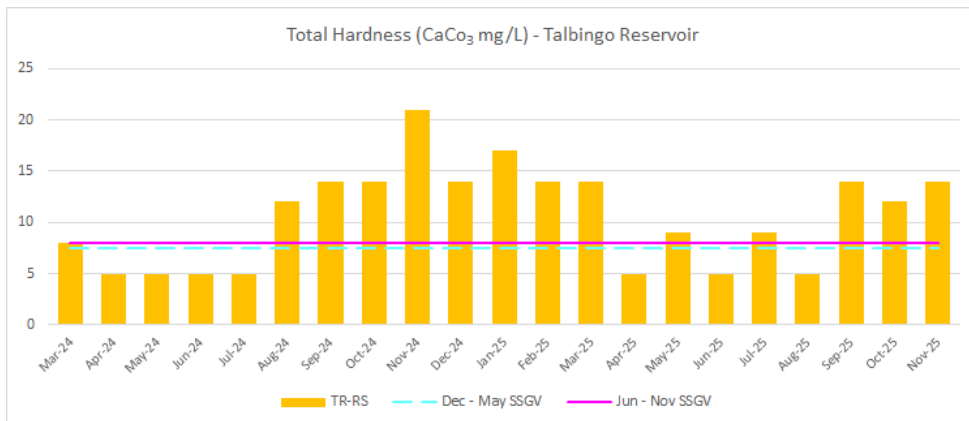
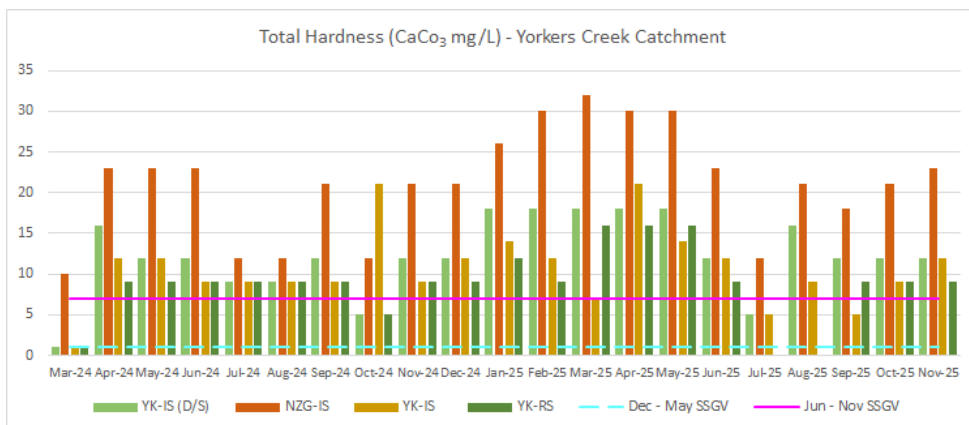
November 2025 sampling of Total Hardness (mg/L) did not record values at CG-IS and LHG-IS in the Yarrangobilly Catchment, which historically have been higher than other sites. All sites exceeded the June-November SSGV (Figure 40—42).

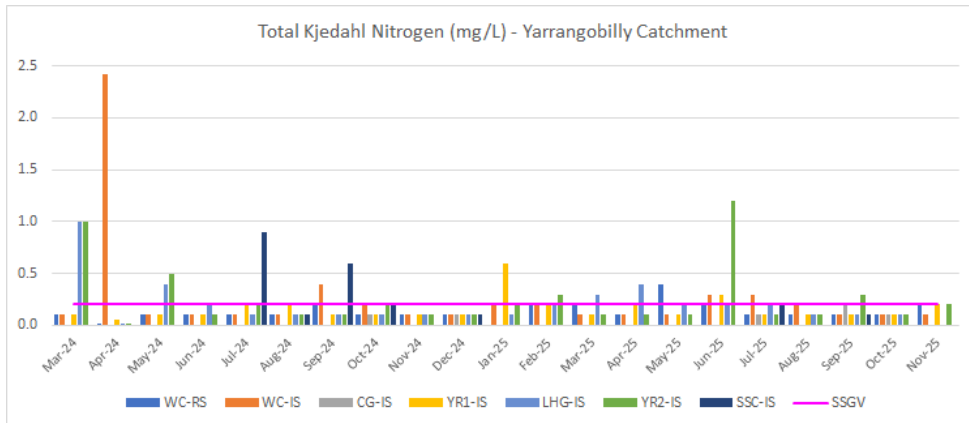
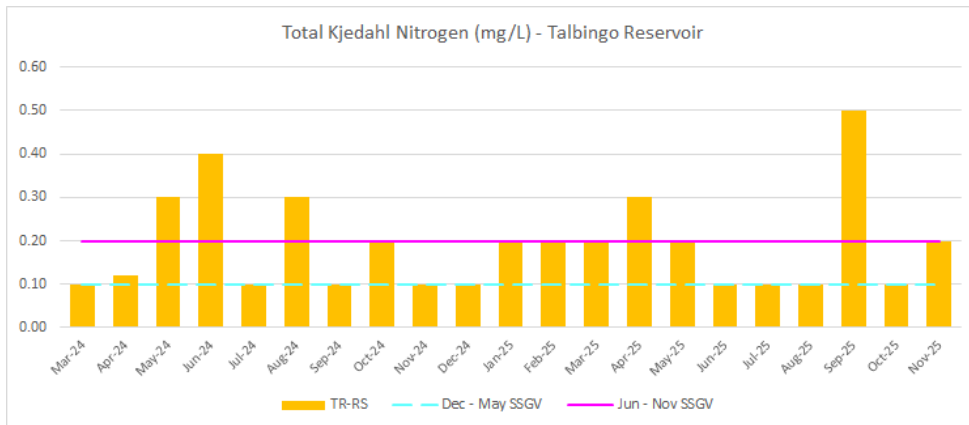
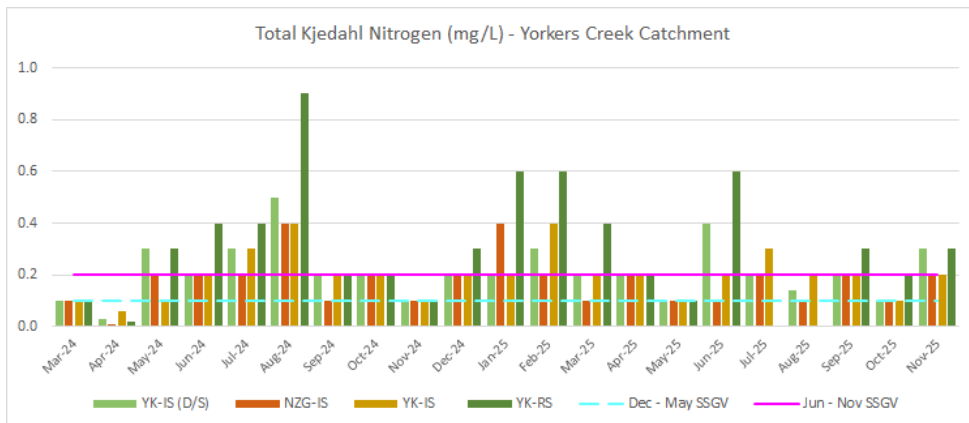
During the November 2025 sampling period, several sites exhibited results that were either below the LOR or on-par with the SSGV (Figure 43-Figure 45). Two sites within Yorkers Creek Catchment (YK-RS, YK-IS(D/S)) exceeded the SSGV (Figure 45).

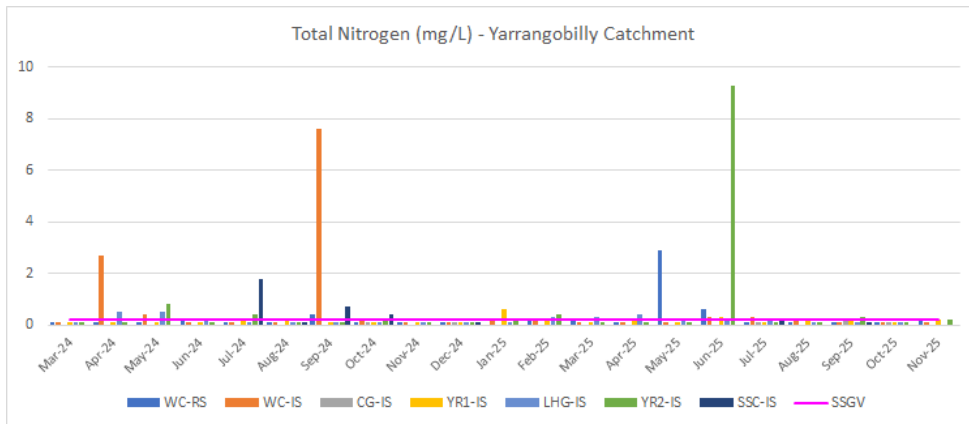
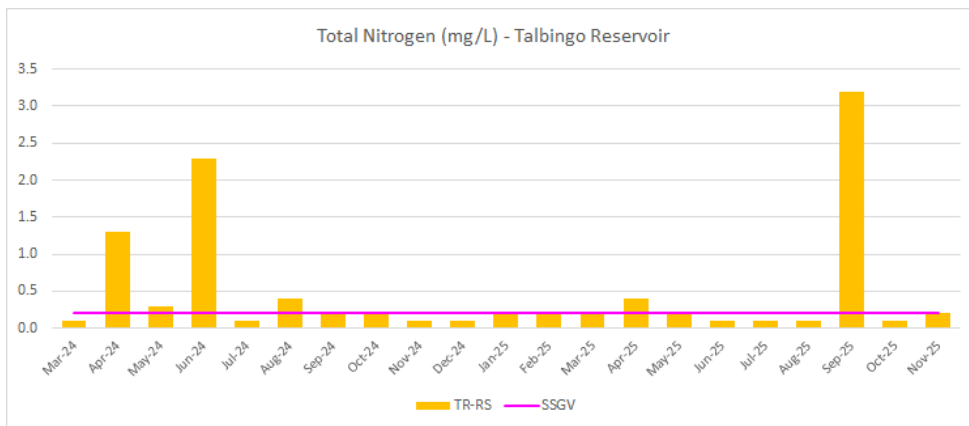
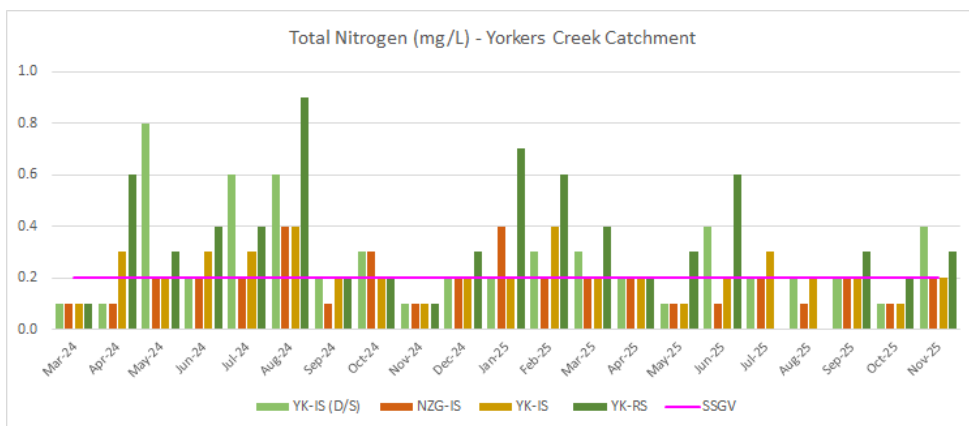
TN (mg/L) results during the November 2025 sampling period were either below the LOR of on-par with the SSGV across all sites and all catchments (Figure 46 – Figure 48), except for YK-RS and YK-IS(D/S) which recorded values above the SSGV (Figure 48).
