# MONTHLY CONSTRUCTION WATER QUALITY MONITORING REPORT

November 2025  
Project No.: 3200-0645  
Project: Transgrid Maragle 500/330 kV Substation  
Private & Confidential

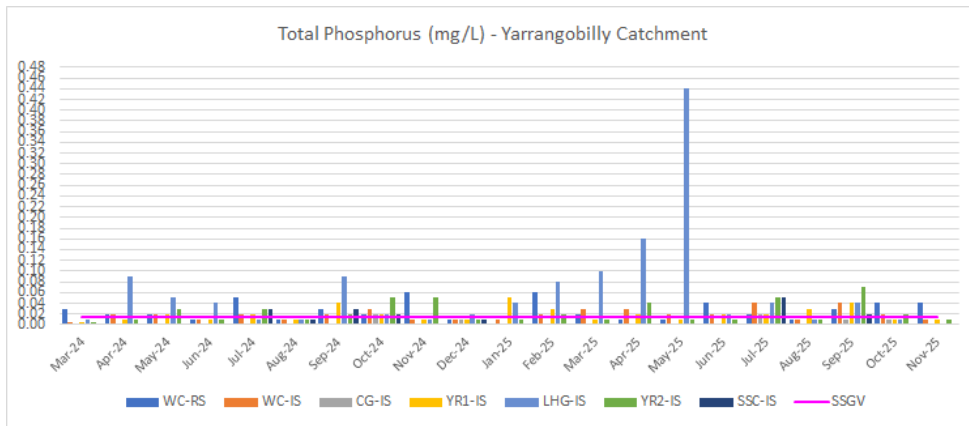
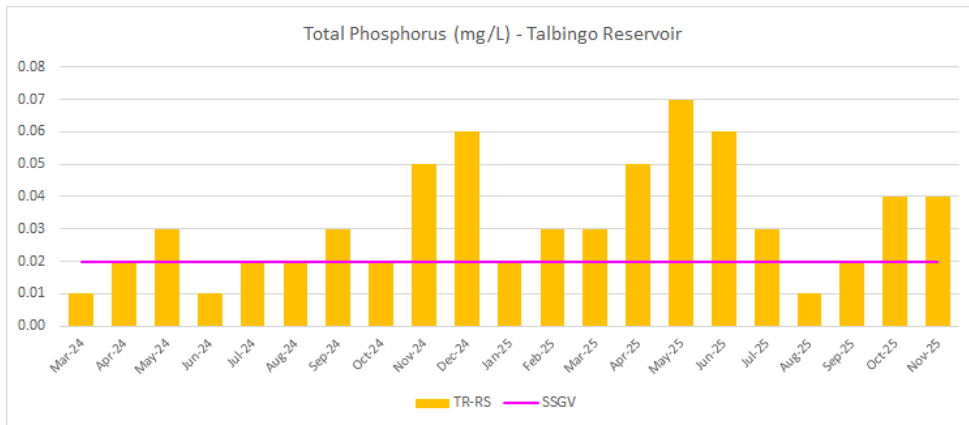
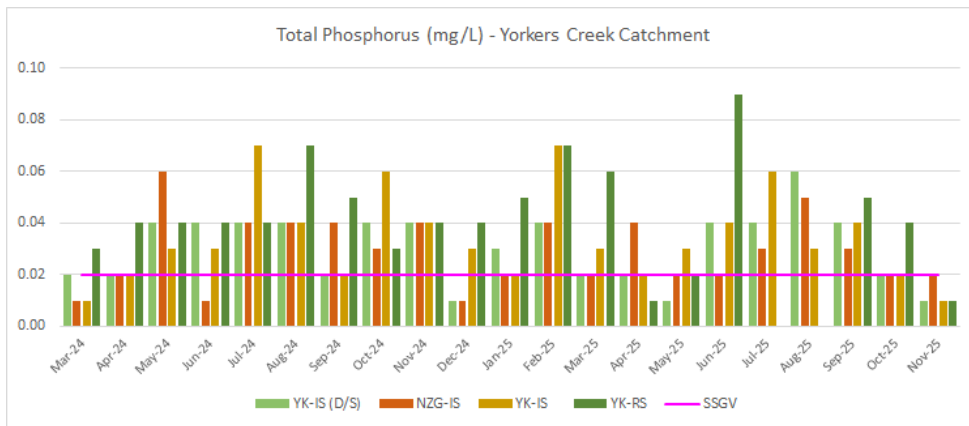
Total Phosphorus (mg/L) values were below the LOR at all sites within all catchments (Figure 49-Figure 51), except for two reference sites. WC-RS in the Yarrangobilly River Catchment (Figure 49) and TR-RS at Talbingo Reservoir (Figure 50) both exceeded the SSGV.

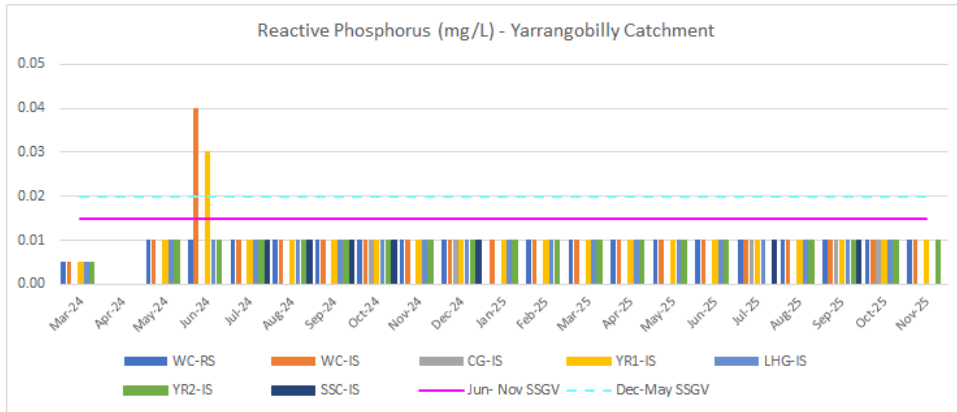
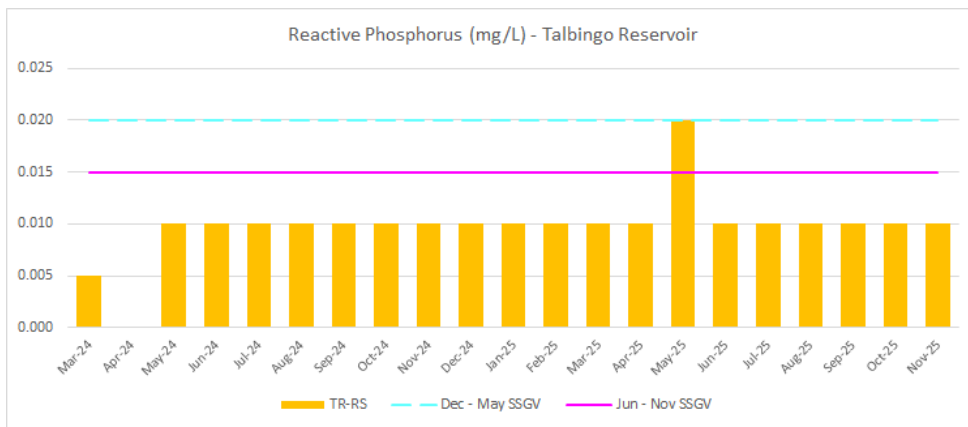
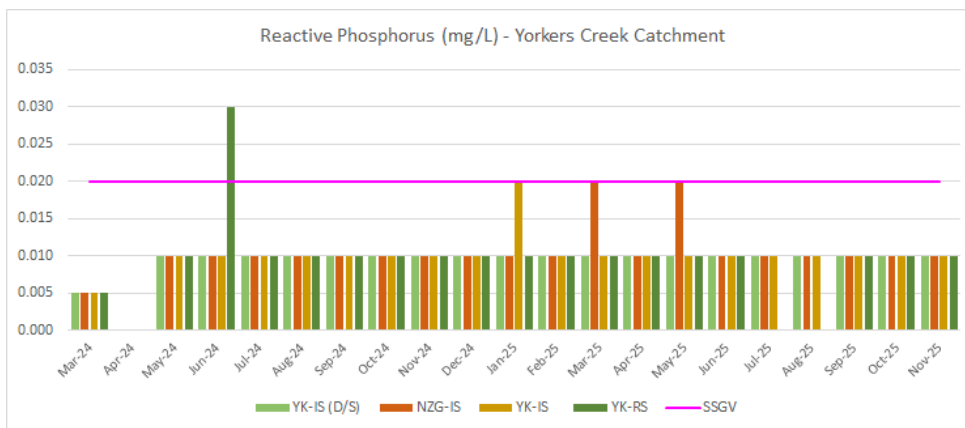
All sites across all catchments measured below the LOR for RP (mg/L), refer to Figure 51 to Figure 53.
